– MURPHY POND DAM –
VISUAL INSPECTION REPORT

Dam Name: Murphy Pond Dam

Consultant: GZA GeoEnvironmental, Inc.

Date of Inspection: September 27, 2016

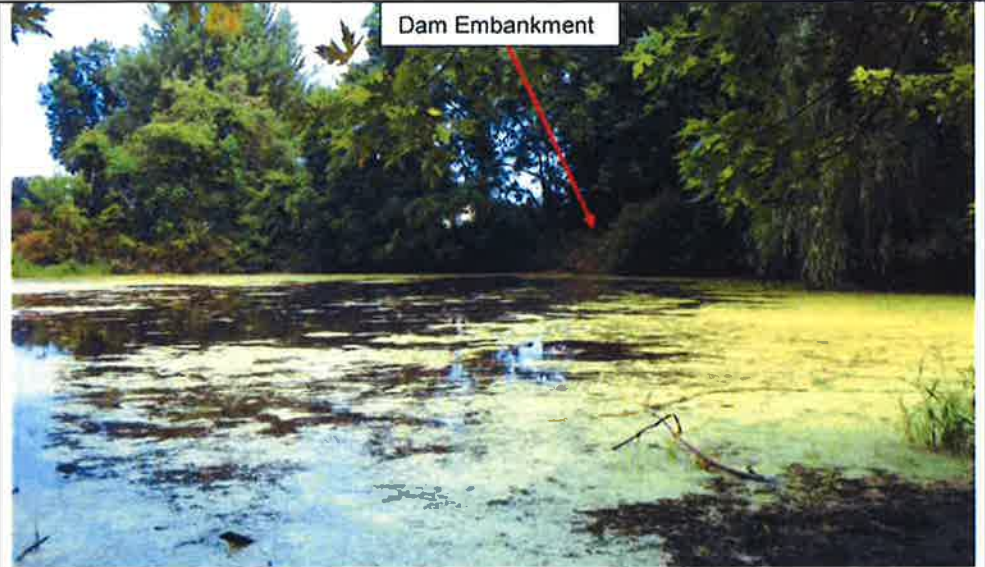
| Description: Overview of dam looking downstream from the right bank of the reservoir. Note the thick brush and mature trees growing on the embankment. | |

1. Cut the vegetation/brush and remove trees smaller than 3-inch diameter on the dam embankment (crest and upstream and downstream slopes) and the auxiliary spillway inlet and outlet.
2. Continue to maintain the grass on the right half of the dam embankment crest and auxiliary spillway.
3. Monitor seepage near the primary spillway outlet structure. Engage an engineer if conditions change.
4. Fill, compact, reseed and maintain grass within the bare areas located within the auxiliary spillway channel and dike.

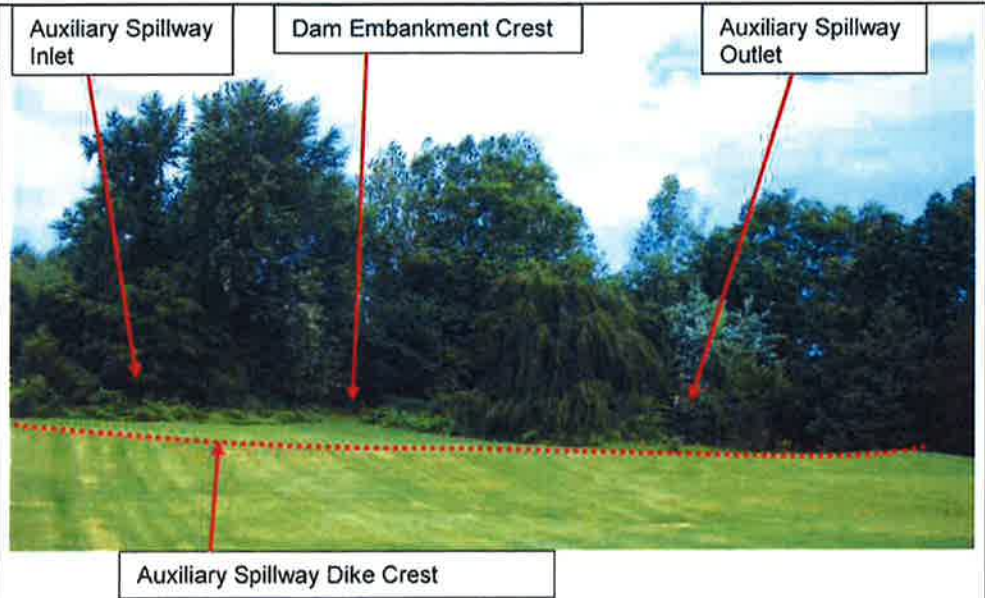
| Photo No.: 02 | Date: 9/27/16 |

| Description: Overview of the auxiliary spillway and dam embankment looking towards the right dam abutment from the upstream area of the auxiliary spillway. Note mature tree growth and thick brush on the auxiliary spillway inlet and outlet and the dam embankment. | |

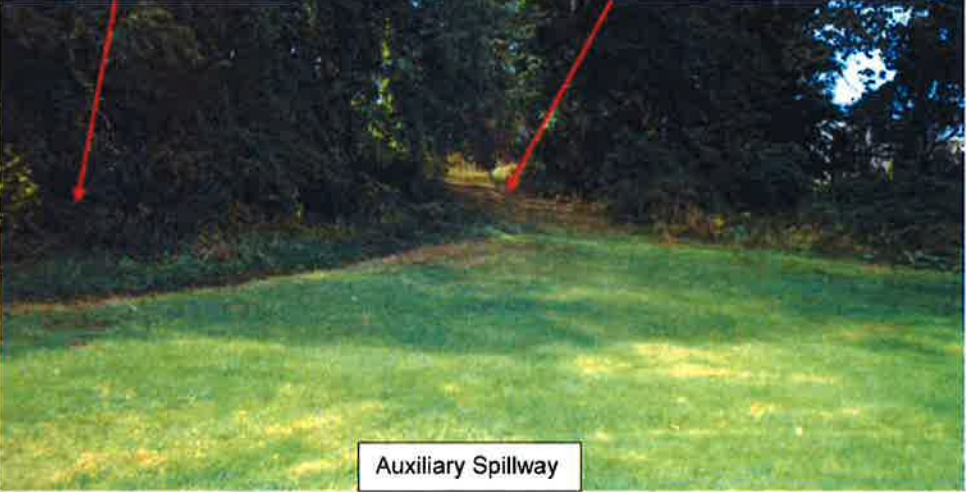
| Photo No.: 03 | Date: 9/27/16 | Auxiliary Spillway Inlet | Dam Embankment Crest |

| Description: Overview of auxiliary spillway and crest of embankment looking towards the dam embankment from the auxiliary spillway. Note mature trees and thick vegetation on the upstream and downstream slopes of the embankment. | | | |

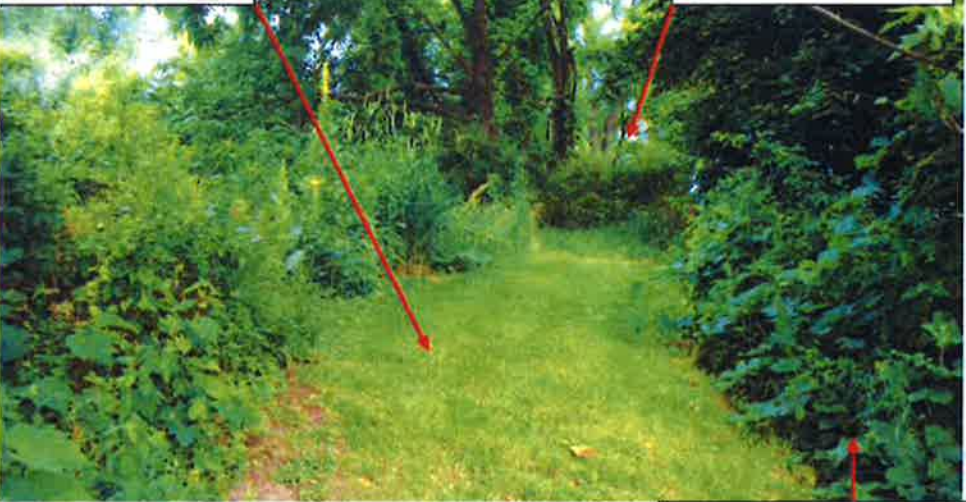
| Photo No.: 04 | Date: 9/27/16 | Embankment Crest | Left Abutment Contact |

| Description: Overview of embankment crest from the right abutment contact looking towards the left abutment contact. Note the thick brush and mature trees on left half of the crest and on the up and downstream embankment slopes. | | | |

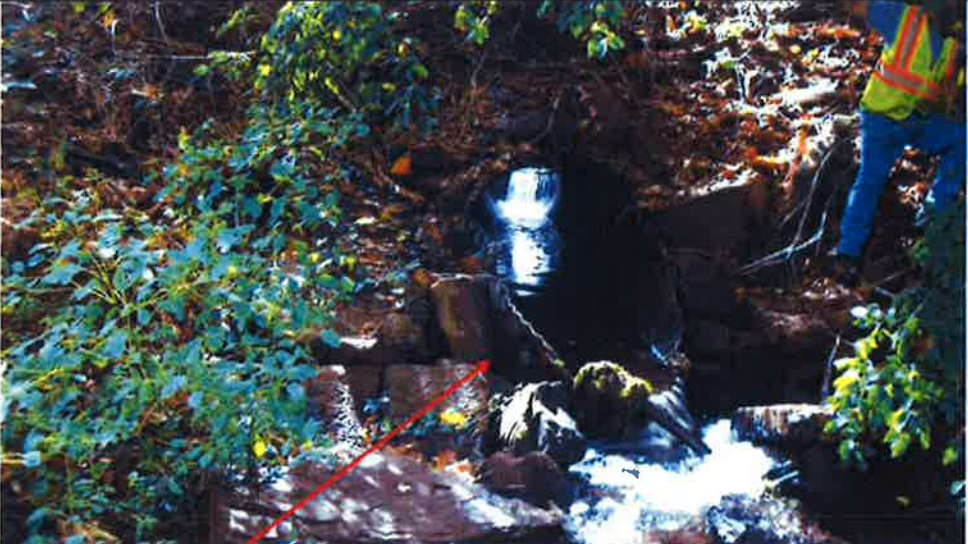
| | | | |
|---|---|--|---|
| Photo No.: 06 | Date: 9/27/16 |

Seepage/Foundation Drainage: Evidence of minor seepage was observed to the right of the primary spillway outlet pipe on the downstream slope. The ground surface next to the pipe was observed to be wet. Vision was obscured by the thick vegetation on the upstream slope, downstream slope, and left half of the crest.

| |
| Direction Photo Taken: Southwesterly | | | |
| Photographer: D. Barstow | | | |
| Description: Overview of the primary spillway outlet from the downstream channel looking upstream. Note apparent seepage to the right of the outlet pipe. | | | |
| | | <table border="1"><tr><td>Possible Seepage</td></tr></table> | Possible Seepage |
| Possible Seepage | | | |

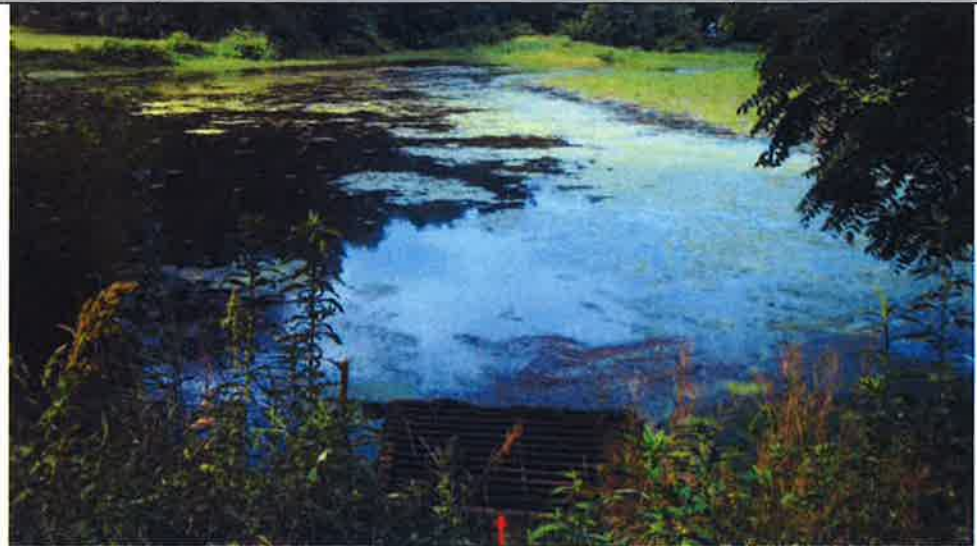
Description:
Overview of the impoundment from the upstream slope of embankment looking upstream.

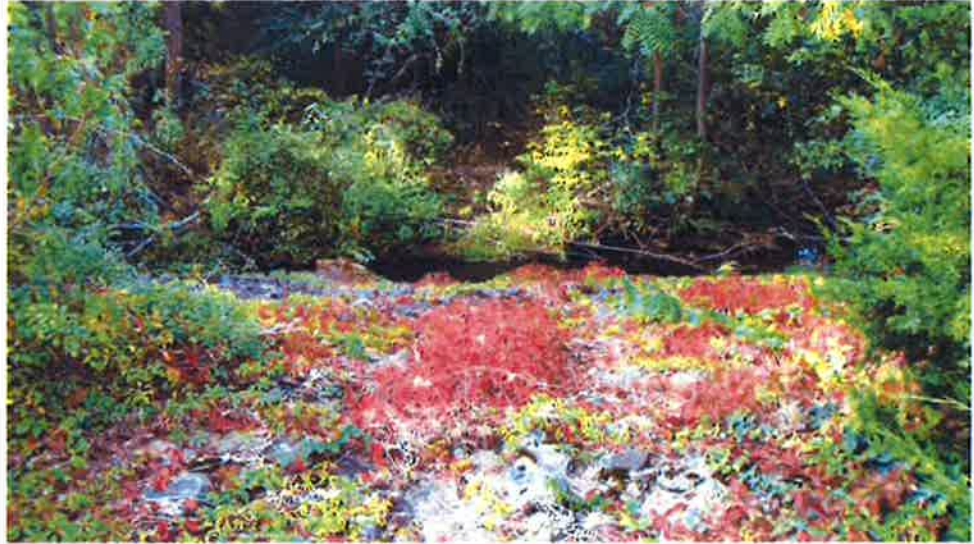
Riprap: The auxiliary spillway discharge area consists of grouted riprap which is in satisfactory condition.

Overview of the grouted riprap at the auxiliary spillway channel outlet to the downstream channel looking from towards the downstream channel from upstream. Note the sparse brush and ground cover growing in the auxiliary spillway.

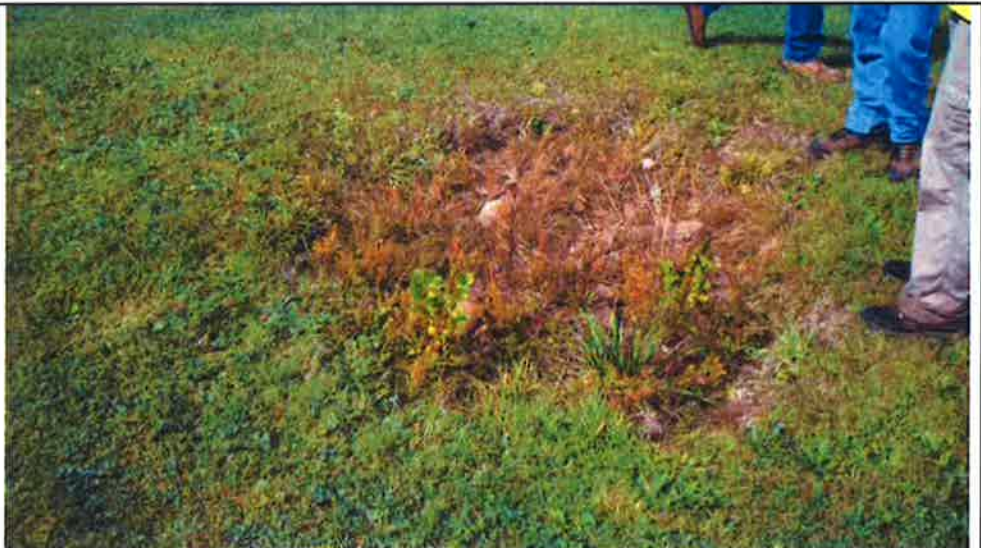
Photo No.: 16
Date: 9/27/16

Overview of depressed area in auxiliary spillway. The area appears to be a former excavation. Note the sparse vegetations and exposed sand and gravel at the ground surface.

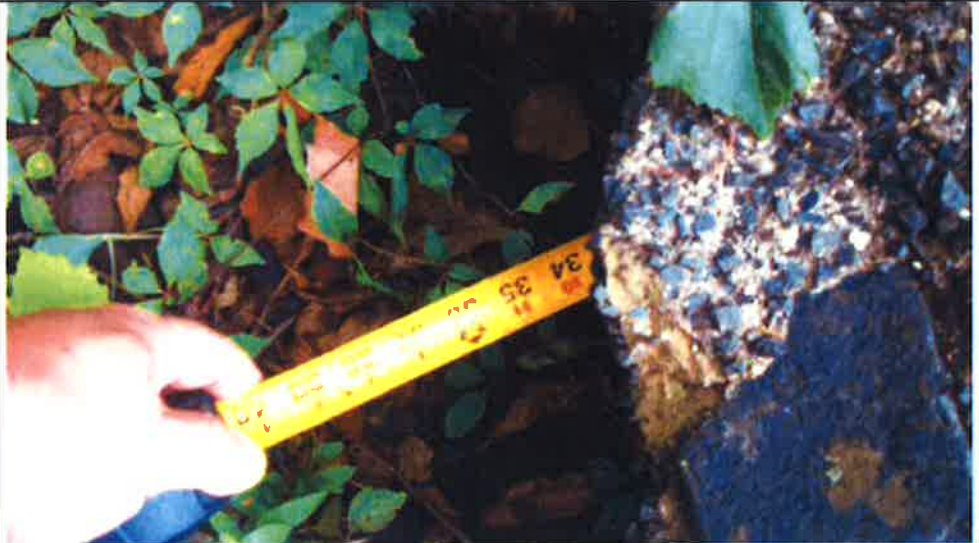
Scouring: Scour was observed along the toe of the auxiliary spillway grouted riprap discharge area slope. The toe of the lower portion of the auxiliary spillway discharge area was undermined up to 36 inches.

Scour along the right side of the downstream channel at the toe of the auxiliary spillway grouted riprap slope, looking downstream from the downstream channel.
