# *MILL WOODS SWIMMING POND DAM #1*

## VISUAL INSPECTION REPORT

Dam Name: Mill Woods Swimming Pond Dam #1  
CTDEEP ID#: 15906  
Owner: Town of Wethersfield  
Town: Wethersfield, Connecticut  
Consultant: GZA GeoEnvironmental, Inc.  
Date of Inspection: September 27, 2016

Re: Visual Inspection Report  
Mill Woods Swimming Pond Dam #1  
CTDEEP # 15906

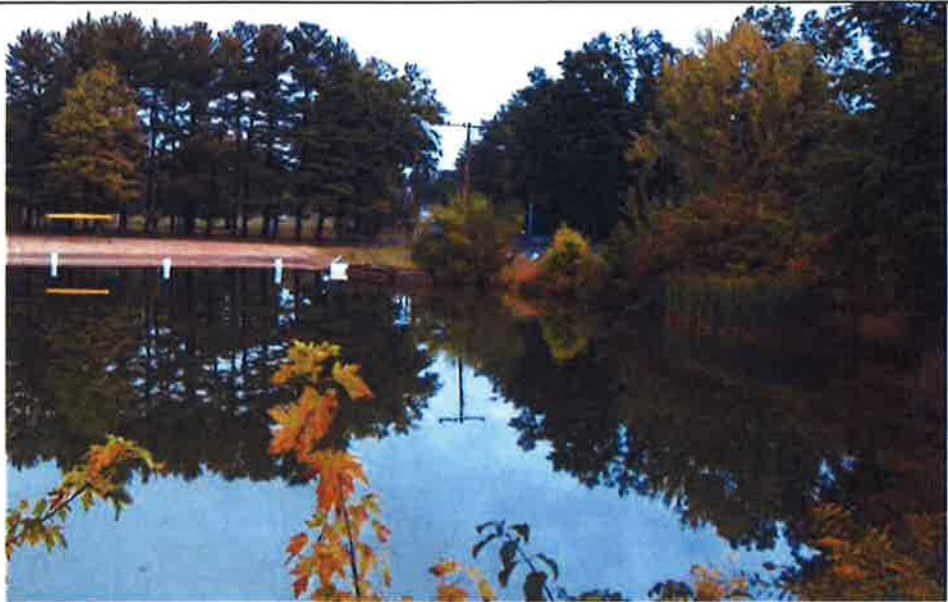
<b>Photo No.:</b> 01	<b>Date:</b> 9/27/16
<b>Direction Photo Taken:</b> Northerly	
<b>Photographer:</b> D. Barstow	
<b>Description:</b> Overview of dam from upstream.

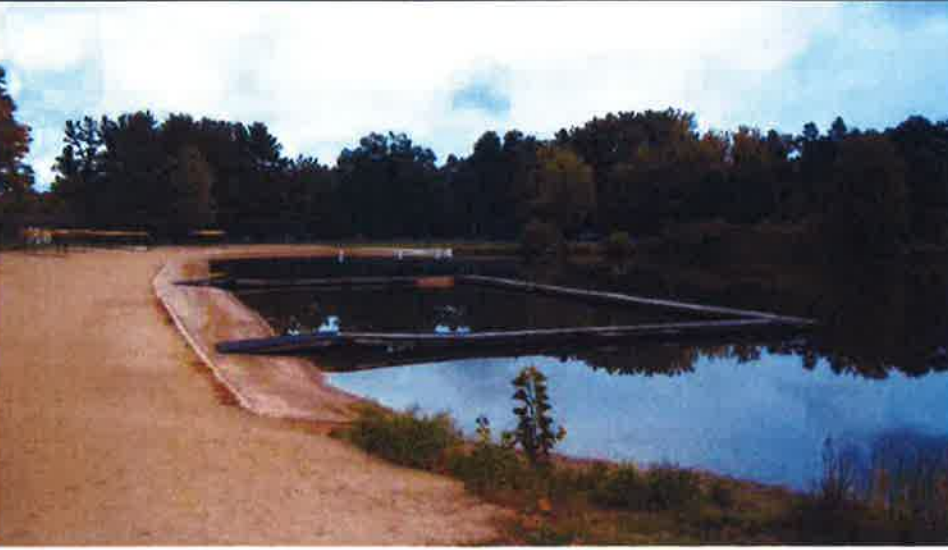
<b>Photo No.:</b> 02	<b>Date:</b> 9/27/16
<b>Direction Photo Taken:</b> Northerly	
<b>Photographer:</b> D. Barstow	
<b>Description:</b> Overview of reservoir area from upstream beach area located left of the primary spillway.

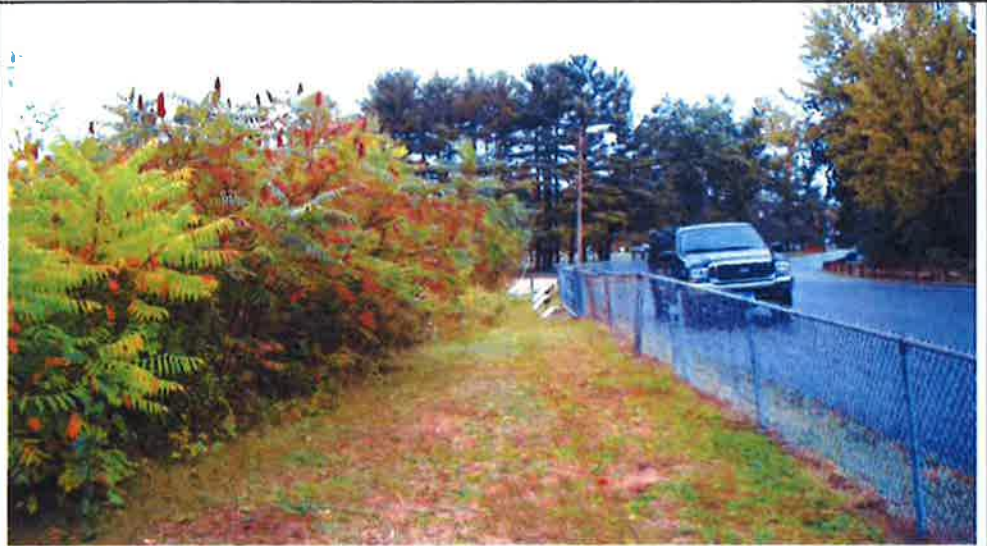
<b>Photo No.:</b> 03	<b>Date:</b> 9/27/16
<b>Direction Photo Taken:</b> Northwesterly	
<b>Photographer:</b> D. Barstow	
<b>Description:</b>  Overview of upstream face and crest of embankment from right abutment. Note vegetation and brush on upstream face.

1. Remove trees including root balls on upstream slopes, downstream slopes, and within 25 feet of the dam. Fill, compact, seed and maintain grass upon completion.
2. Repair disconnected joints in the left and right 3-foot-diameter outlet pipes for the primary spillway.

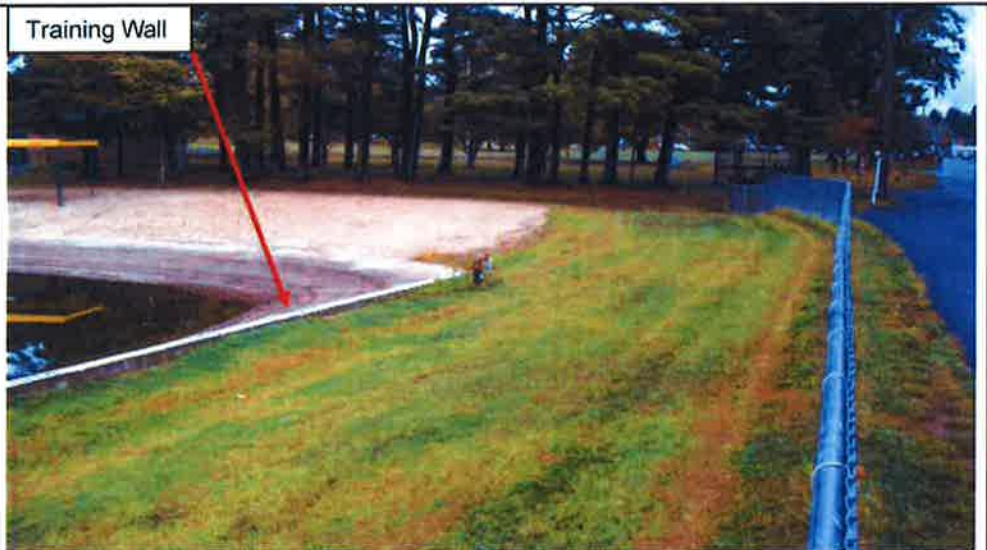
<b>Photo No.:</b> 04	<b>Date:</b> 9/27/16
<b>Direction Photo Taken:</b> Northwesterly	
<b>Photographer:</b> D. Barstow	
<b>Description:</b>  Overview of upstream embankment slope looking towards the left abutment and spillway training wall.

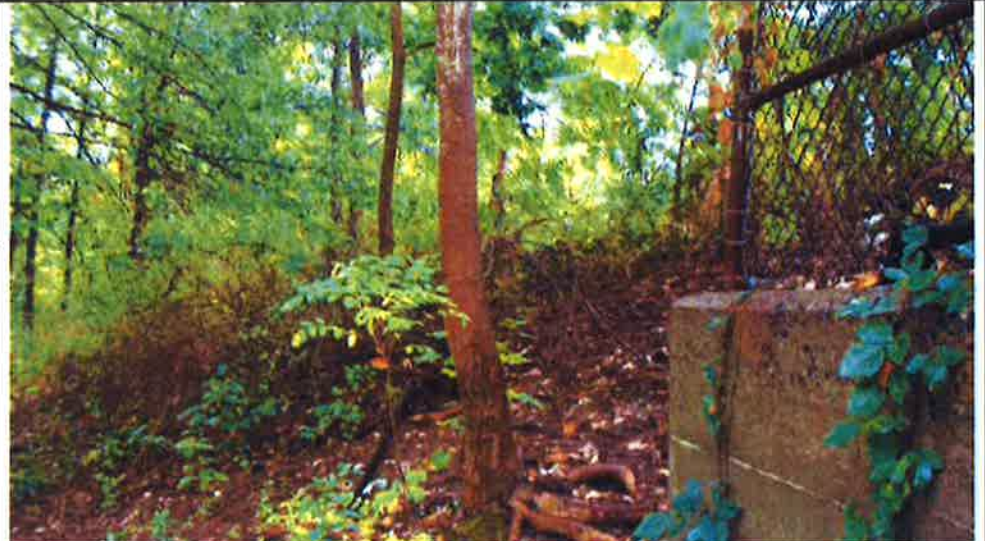
**Seepage/Foundation Drainage:** None observed. Downstream slope was heavily vegetated with brush and mature trees. Vision was obscured.

<b>Photo No.:</b> 05	<b>Date:</b> 9/27/16
<b>Direction Photo Taken:</b> Southerly	
<b>Photographer:</b> D. Barstow	
<b>Description:</b> Overview of downstream embankment slope. Note thick brush and mature trees on slope.

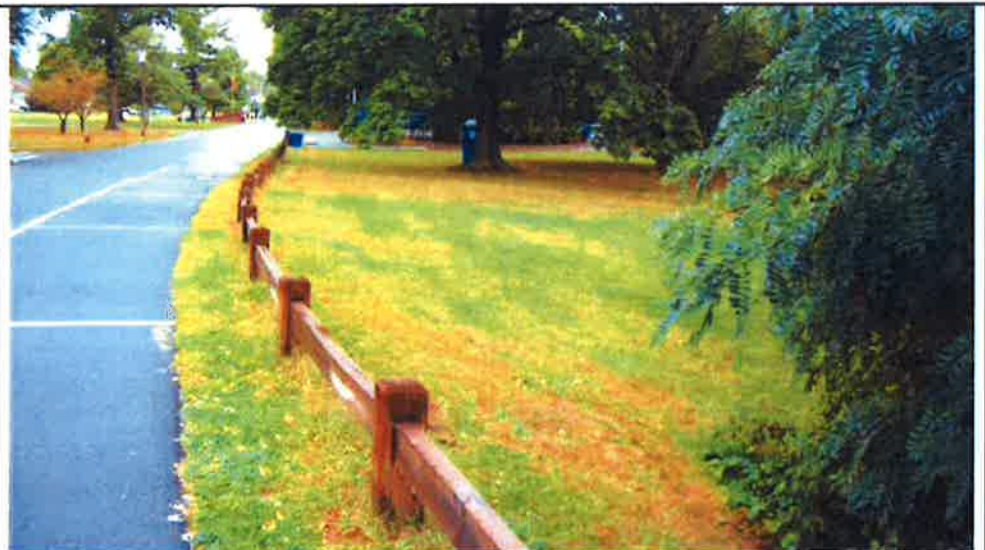
<b>Photo No.:</b> 06	<b>Date:</b> 9/27/16
<b>Direction Photo Taken:</b> Northerly	
<b>Photographer:</b> D. Barstow	
<b>Description:</b> Overview of downstream embankment slope looking towards the left abutment.

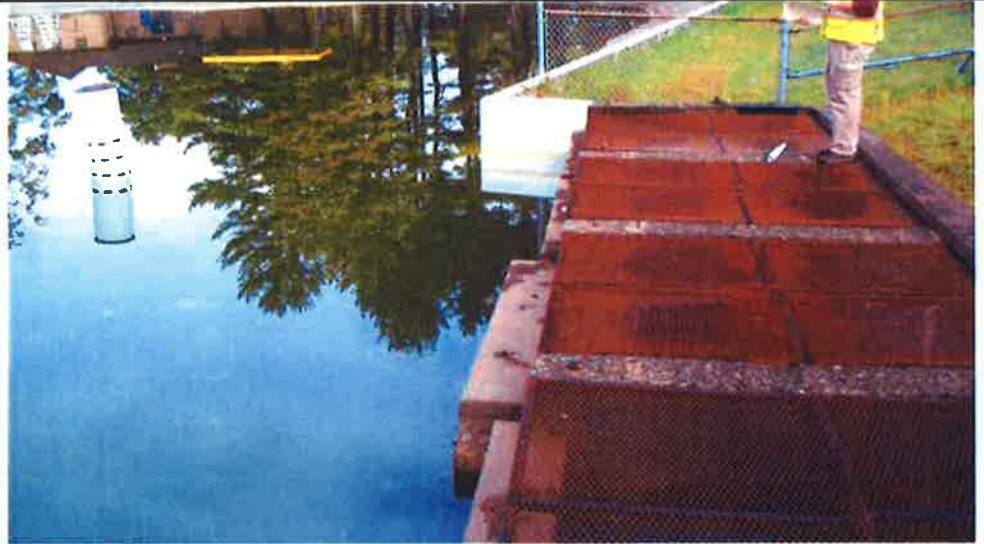
<b>Photo No.:</b> 07	<b>Date:</b> 9/27/16
<b>Direction Photo Taken:</b> Northerly	
<b>Photographer:</b> D. Barstow	
<b>Description:</b>  Overview of primary spillway from the embankment. The white PVC pipe to the left is a filter for the pond.

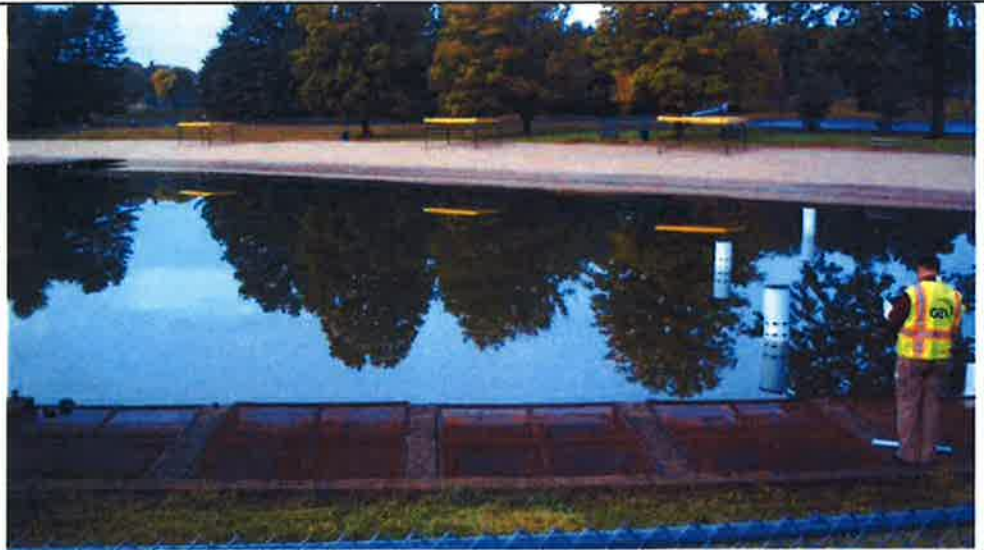
<b>Photo No.:</b> 08	<b>Date:</b> 9/27/16
<b>Direction Photo Taken:</b> Westerly	
<b>Photographer:</b> D. Barstow	
<b>Description:</b>  Overview of primary spillway and approach area from the dam crest.

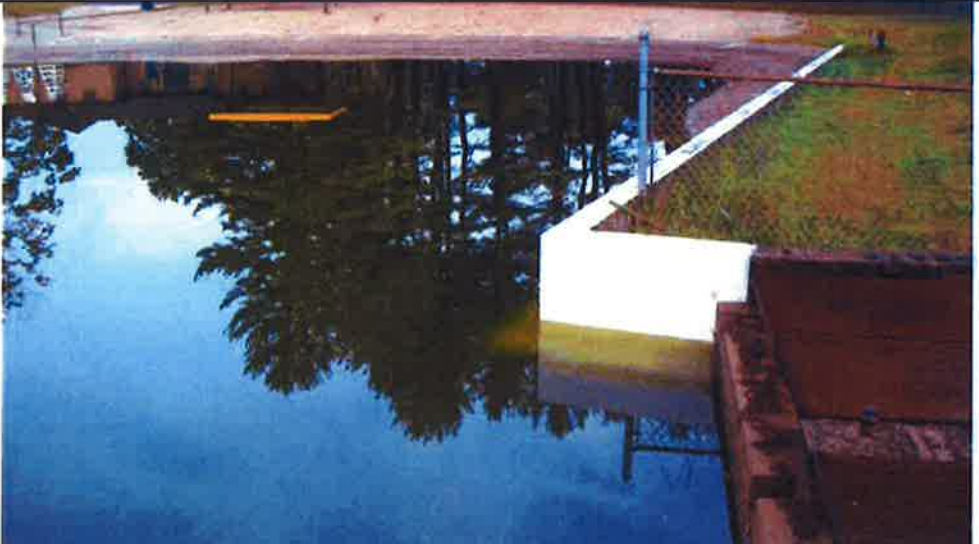
<b>Photo No.:</b> 09	<b>Date:</b> 9/27/16	 
<b>Direction Photo Taken:</b> Southerly		
<b>Photographer:</b> D. Barstow		
<b>Description:</b> Overview of the auxiliary spillway from the primary spillway.

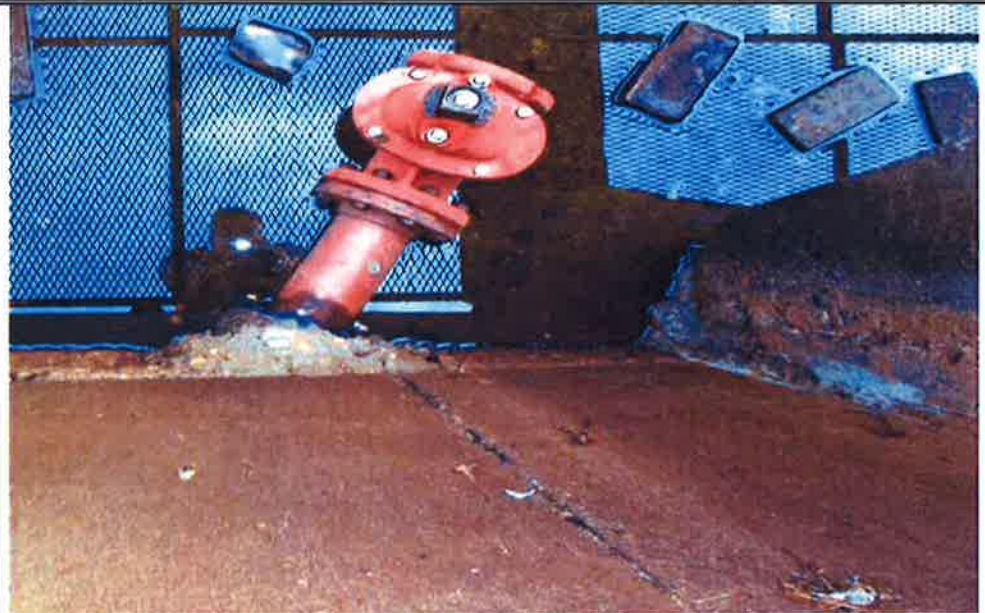
**Other:** Several bricks were observed on the bottom of the drop inlet structure.

Overview of bottom of primary drop inlet structure and ductile iron outlet from downstream headwall. Note brick debris on the bottom of the drop inlet structure.

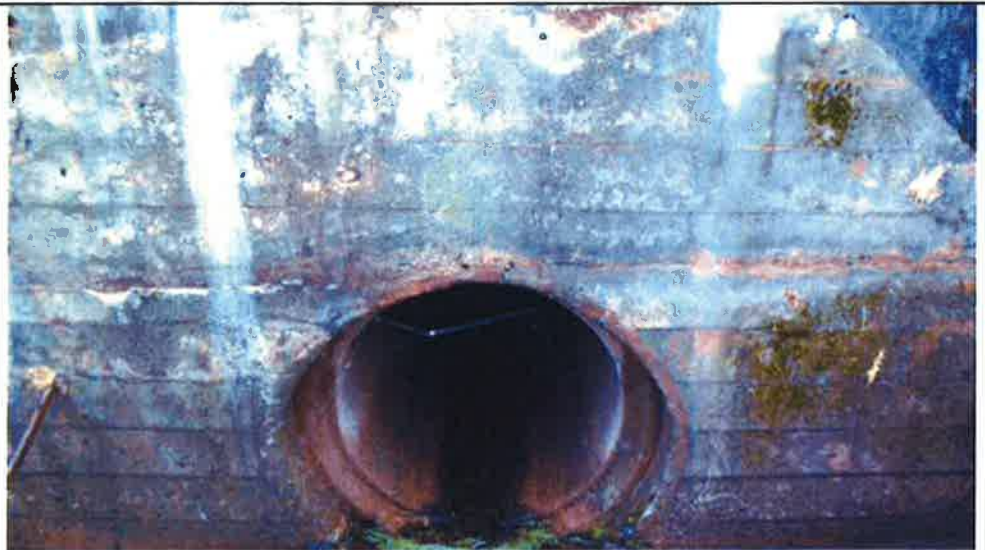
**Photo No.:**  
12

Downstream headwall and central 42-inch-diameter RCP outlet pipe in the primary drop inlet structure. Note minor spalling, minor cracking, and very minor efflorescence on headwall.

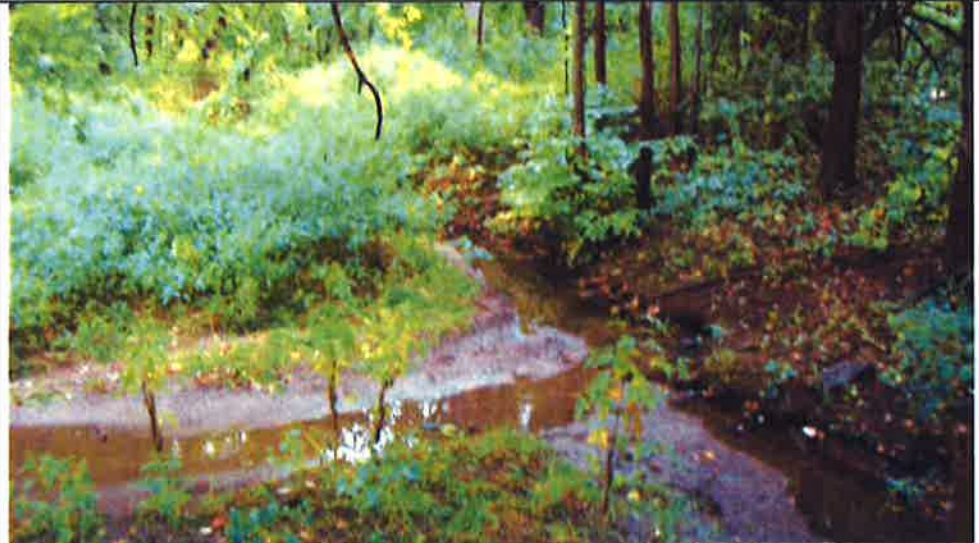
Overview of downstream channel at the convergence of Goff Brook and Mill Woods Swimming Pond Dam #1 discharge channel looking downstream.

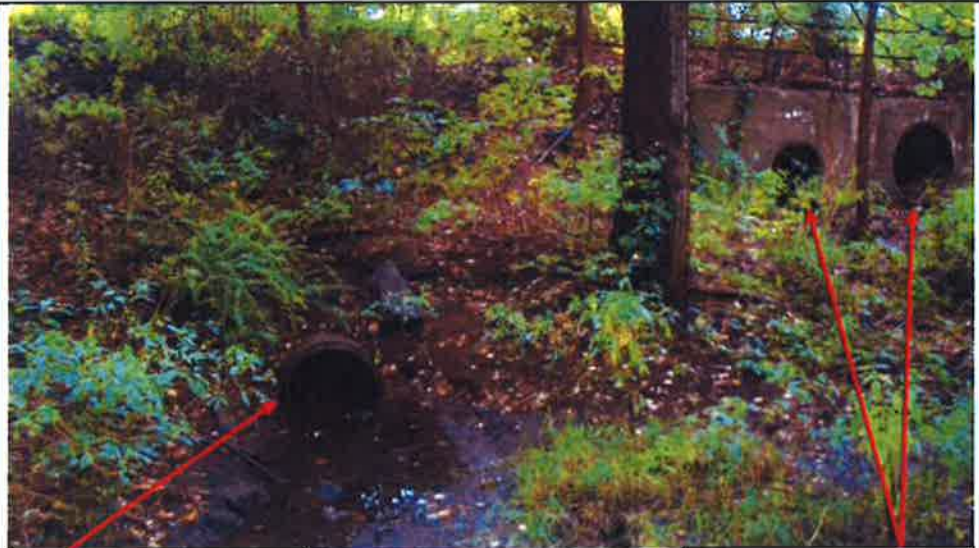
Overview of auxiliary spillway outlet pipe (left) and primary spillway outlet pipes and headwall (right).

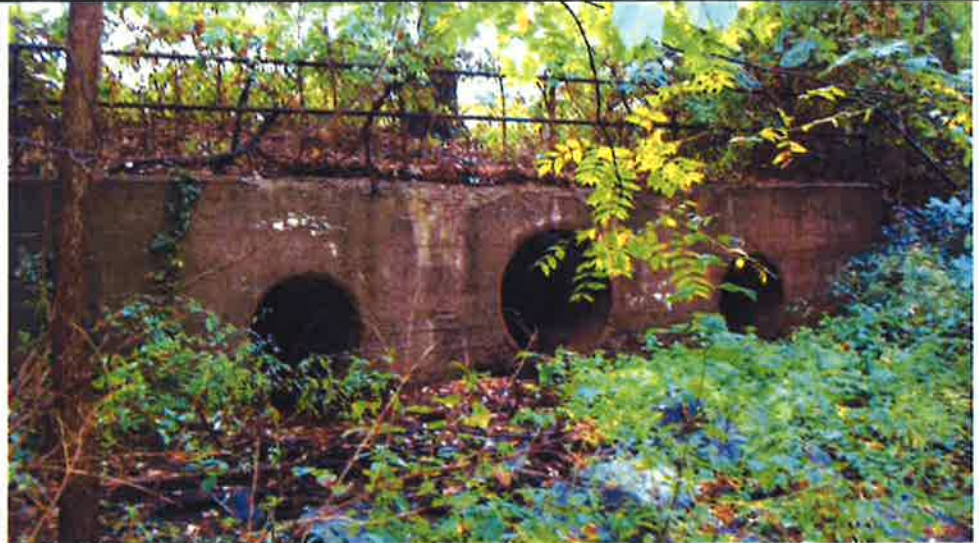
**Concrete Condition:** Spalling (up to 2 inches) was observed on the top of the concrete headwall.

Overview of primary spillway outlet pipes. Note exposed aggregate and spalling on headwall.

1. Repair the chain link fence, concrete spalling at the top of headwall and scour below the primary spillway outlet pipes.

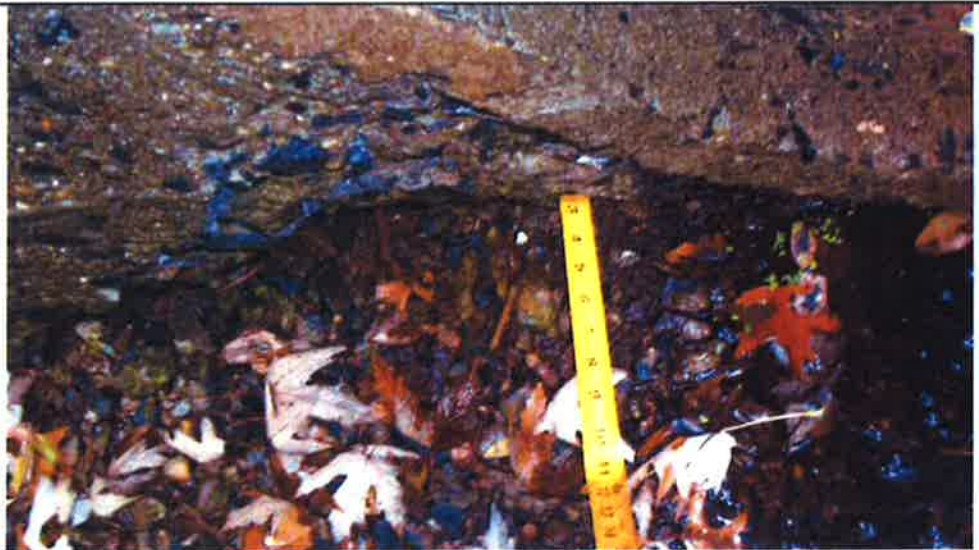
**Photo No.:**  
16

**Scouring/Undermining:** Up to 3-inches of spalling/scour was observed below each of the RCP pipes on the headwall.

Concrete spalling and erosion of headwall at central outlet pipe discharge to downstream channel.

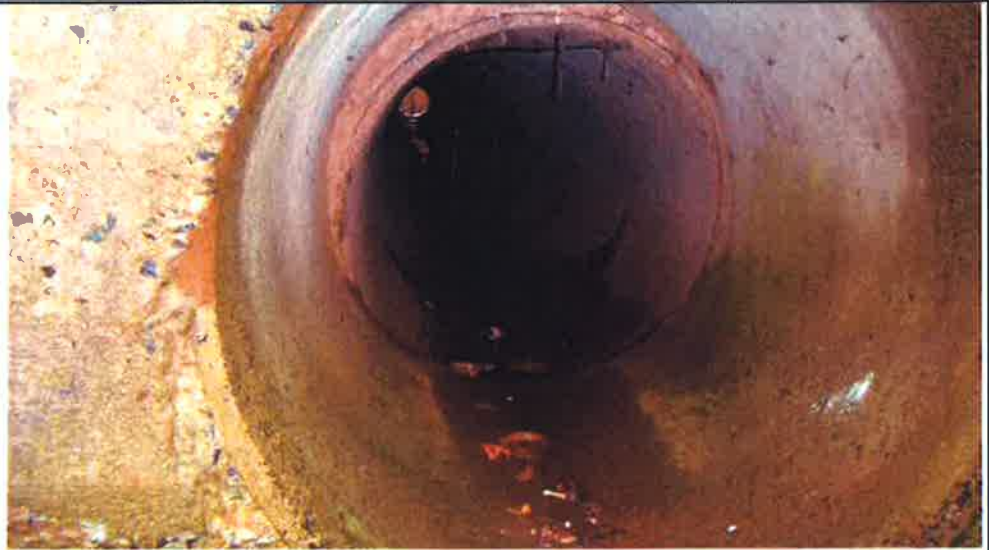
Disconnected joints were observed in the left and right 3-foot-diameter RCP outlet pipes from the primary spillway. Disconnected joint (offset up to 4-inches) was observed about 4 feet from the pipe discharge.
