– *WINTERGREEN WOODS DAM* –
VISUAL INSPECTION REPORT

Dam Name: Wintergreen Woods Dam
CTDEEP ID#: 15912
Owner: Town of Wethersfield
Town: Wethersfield, Connecticut
Consultant: GZA GeoEnvironmental, Inc.
Date of Inspection: September 27, 2016

Re: Visual Inspection Report
Wintergreen Woods Dam
CTDEEP # 15912

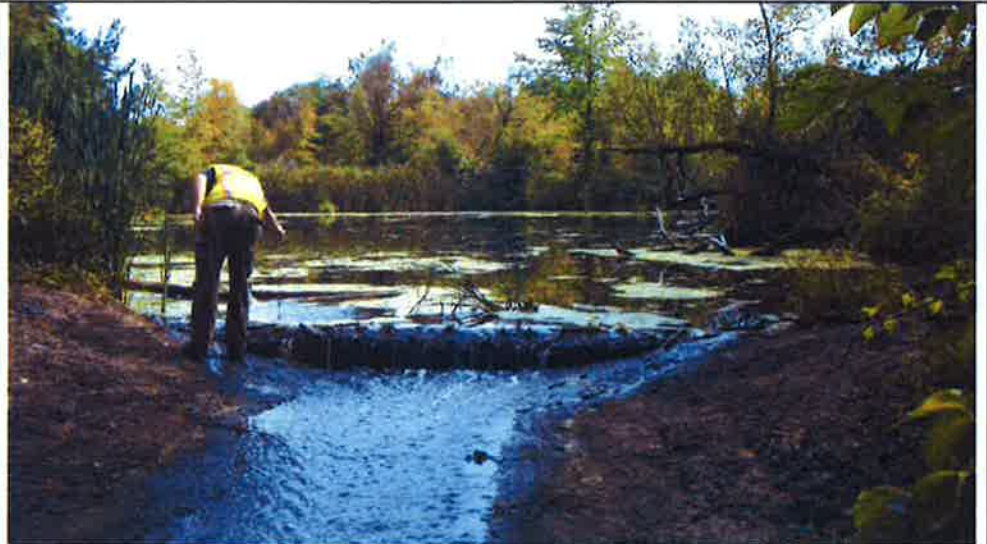
Photo No.: 01	Date: 9/27/16
Direction Photo Taken: Southerly	
Photographer: D. Barstow	
Description: Overview of spillway and impoundment from downstream. Note severe spalling on spillway crest.

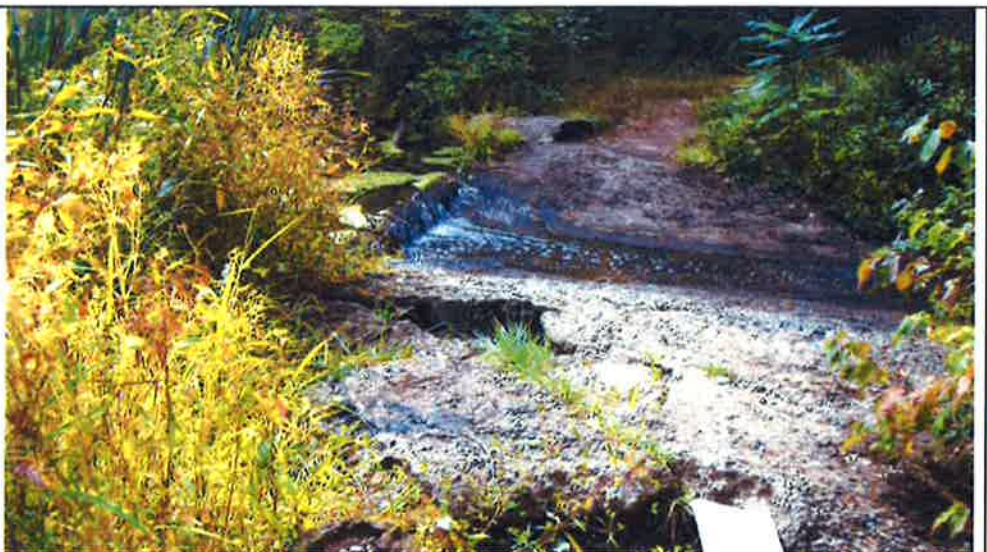
Photo No.: 02	Date: 9/27/16
Direction Photo Taken: Southwesterly	
Photographer: D. Barstow	
Description: Overview of the spillway, apron and embankment crest from right of spillway. Note the heavy vegetation/brush on the upstream and downstream slopes and cracked apron.

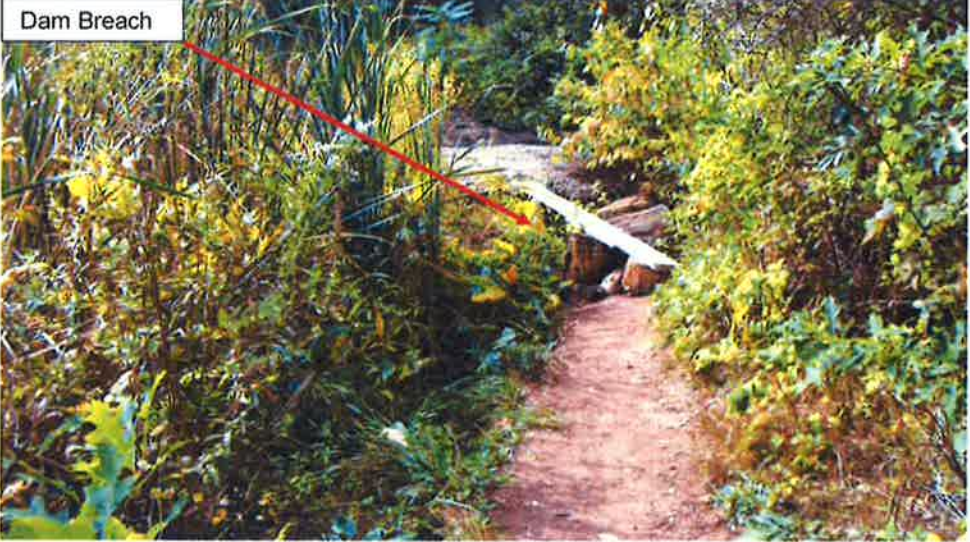
Photo No.: 03	Date: 9/27/16	Dam Breach

Settlement/Alignment/Movement: An 18-foot-wide, 2- to 3-foot deep breach in the right embankment was observed to the right of the spillway. An approximate 4.5-foot-wide channel of water (about 6 inches deep) was observed flowing through the breach in the embankment and discharging to Folly Brook. In addition, the walking path on the dam crest was rutted from foot traffic. Heavy vegetation obscured the view of the upstream and downstream embankment slopes.

Direction Photo Taken: Southwesterly			
Photographer: D. Barstow			
Description: Overview of right embankment near the spillway. Note heavy vegetation/brush on upstream and downstream slopes and dam breach near the apron. The logs and board serve as a bridge over the breach. Bare earth on the embankment crest.

1. Repair the breach in the right embankment. Backfill the area with low permeability fill placed in the dry and in compacted in controlled lifts.
2. Repair the portions of the embankment that have been undercut/undermined at the edges of the concrete discharge apron using either compacted low permeability fill or flowable fill.
3. Repair the deteriorated concrete and exposed rebar on the spillway weir and training walls to mitigate further deterioration.
4. Consider performing the recommended repair work during the dry season to limit the amount of water control (i.e. coffer damming) needed to allow the work to occur in the dry.

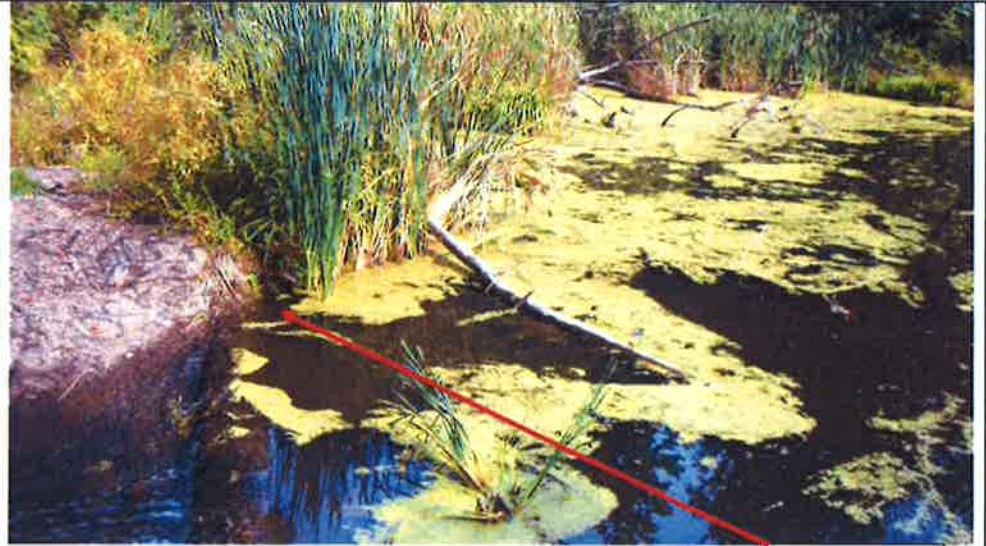
Training Wall

Photo No.: 05	Date: 9/27/16
Direction Photo Taken: Northeasterly	
Photographer: D. Barstow	
Description: Overview of right training wall and upstream face of the right embankment. Note heavy brush.

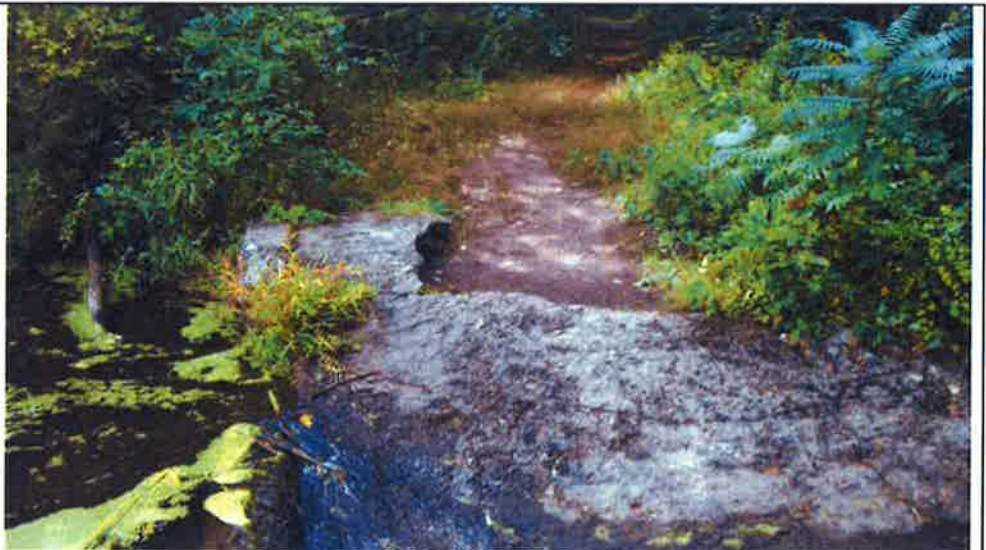
Photo No.: 06	Date: 9/27/16
Direction Photo Taken: Southwesterly	
Photographer: D. Barstow	
Description: Overview of crest on left embankment. Note the bare earth on crest and heavy vegetation on upstream and downstream embankment slopes.

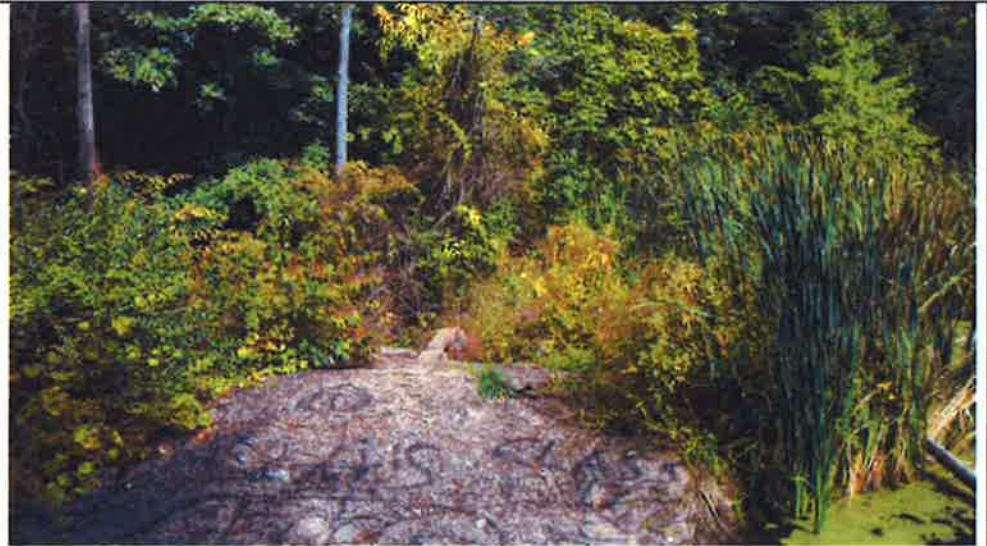
Photo No.: 07	Date: 9/27/16
Direction Photo Taken: Easterly	
Photographer: D. Barstow	
Description: Overview of crest on right embankment. Note the and heavy vegetation on upstream and downstream embankment slopes.

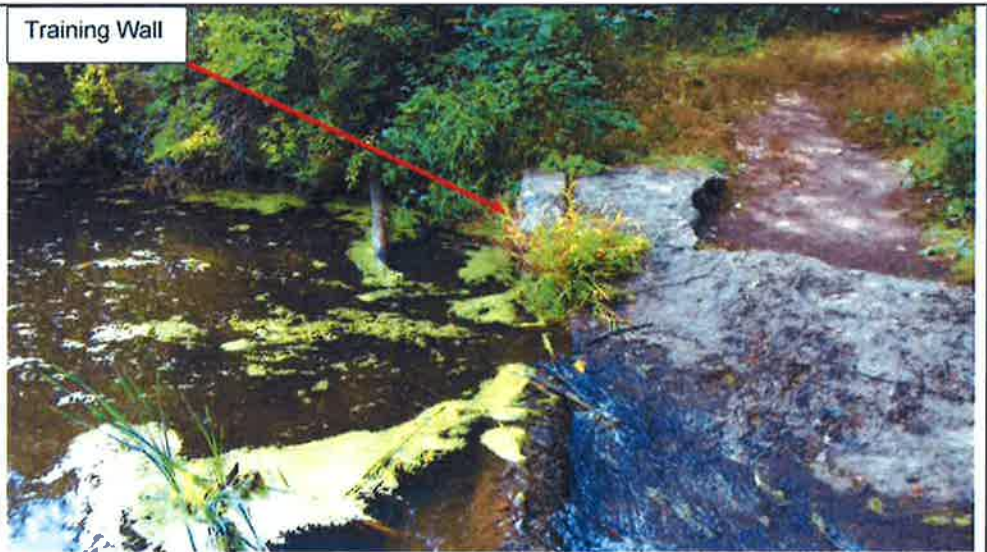
Concrete Condition: Poor – spalling and 1.5-inches of rebar were observed on the principal spillway and spalling and rebar were observed on the left training wall.

Photo No.: 08	Date: 9/27/16
Direction Photo Taken: Southwesterly	
Photographer: D. Barstow	
Description: Overview of left training wall.

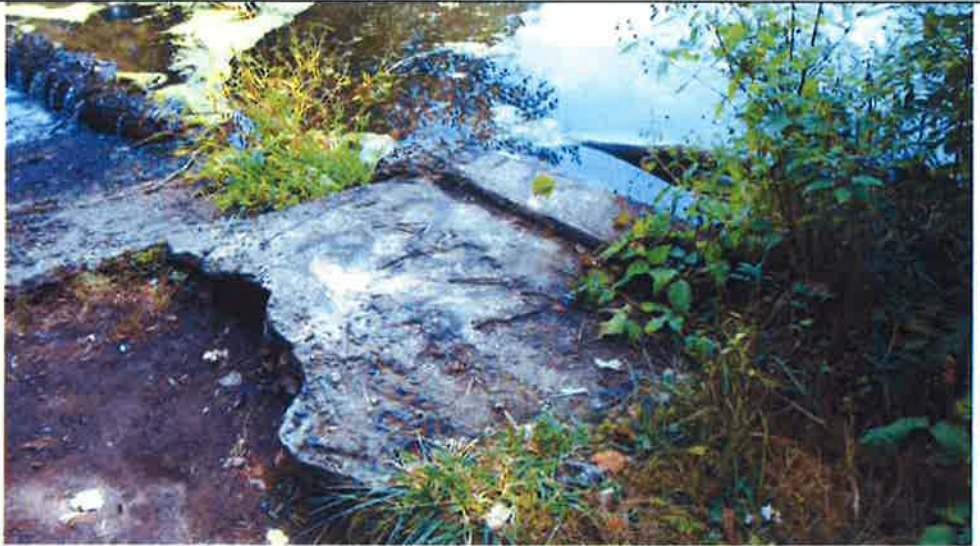
Photo No.: 09	Date: 9/27/16
Direction Photo Taken: Southeasterly	
Photographer: D. Barstow

Scouring/Undermining: The discharge apron is damaged and the concrete is missing in several areas near the embankment contacts. The apron is eroded and undercut by up to about 2 feet on the right and left sides and at the discharge end, where it ties into Folly Brook.

Description:
Overview of apron. Note cracks and missing sections of apron.

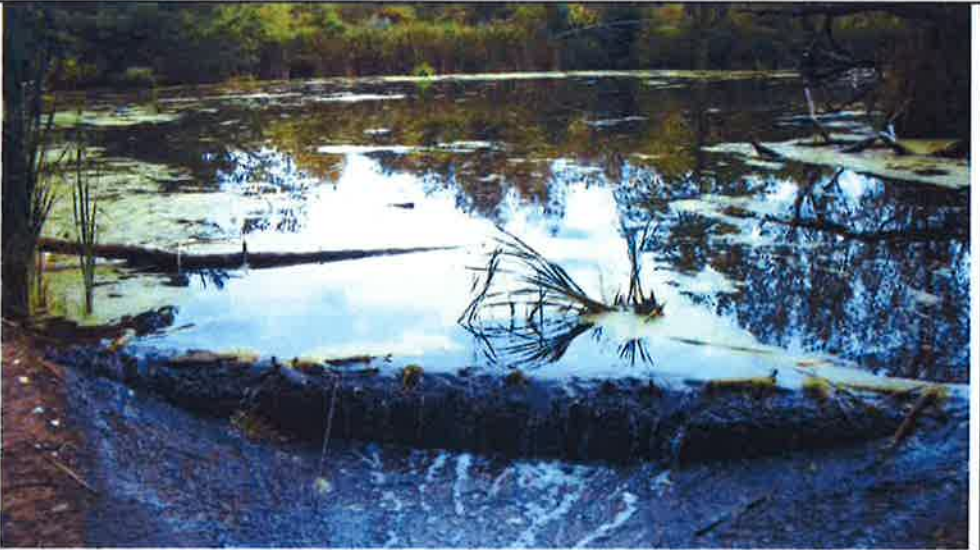
Photo No.: 10	Date: 9/27/16
Direction Photo Taken: Southerly	
Photographer: D. Barstow

Description:
Overview of weir and impoundment area. Note severe spalling and exposed steel rebar.

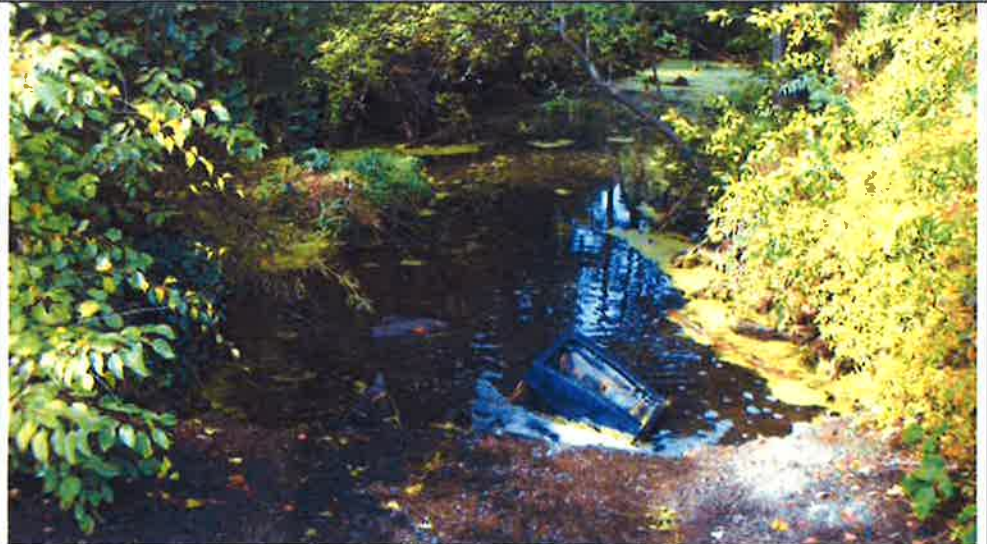
Debris: A broken television was observed in the brook at the end of the discharge apron. Vegetation and brush were observed overhanging the downstream channel.

Other: Undercutting was observed on the left bank of the downstream channel. The bank undercutting was observed starting at the apron and extending approximately 100 feet downstream.

Photo No.: 11	Date: 9/27/16
Direction Photo Taken: Northwesterly	
Photographer: D. Barstow	
Description: Downstream channel (Folly Brook). Note television in brook and undercutting of left bank of the brook.

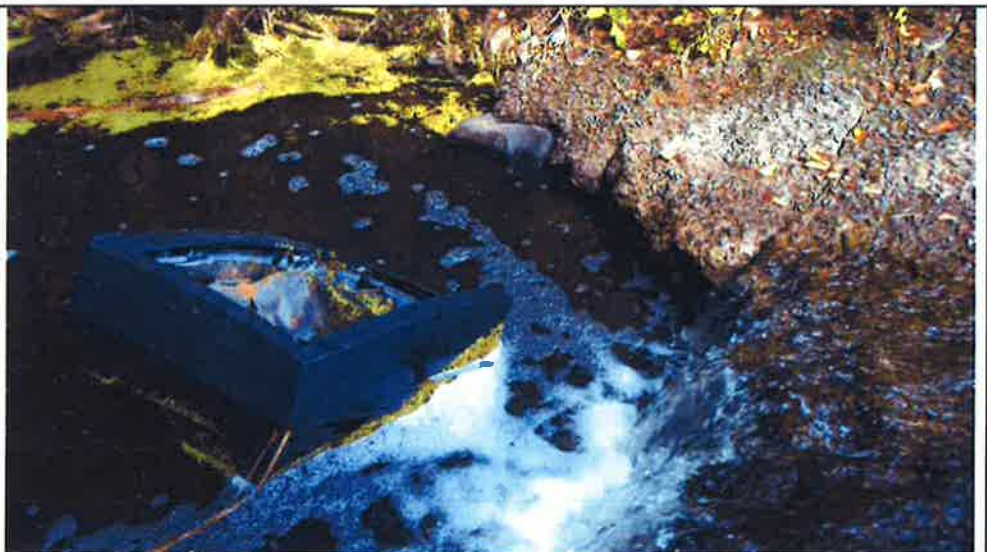
Photo No.: 12	Date: 9/27/16
Direction Photo Taken: Northeasterly	
Photographer: D. Barstow	
Description: Undermining of apron at point of discharge to Folly Brook. Undermining is approximately 24-inches.

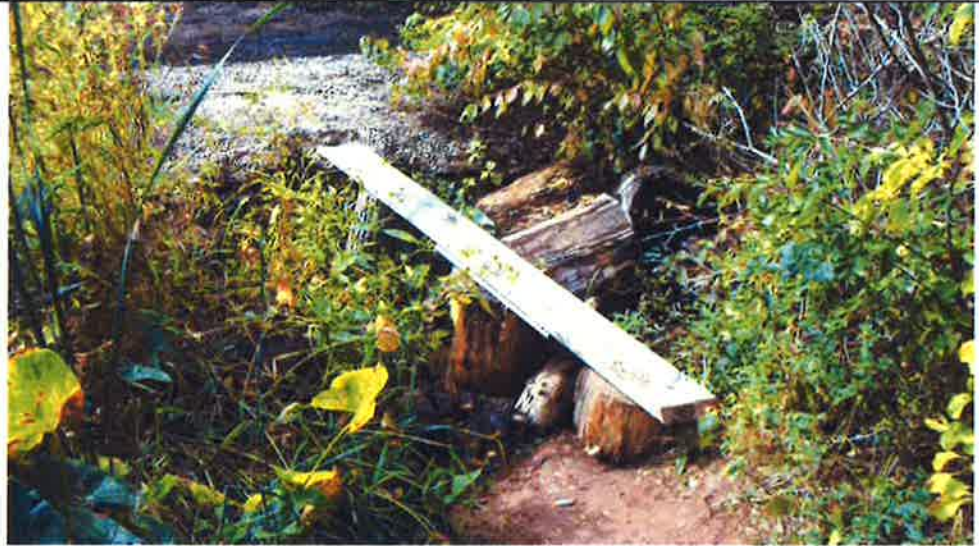
Other: Several logs were observed within the dam breach. A wooden board was placed over the logs and is used as a bridge over the breach.

Description:
Overview of breach in the right embankment looking left towards spillway. The board is used as a bridge to cross the breach. The logs were placed to support the board.

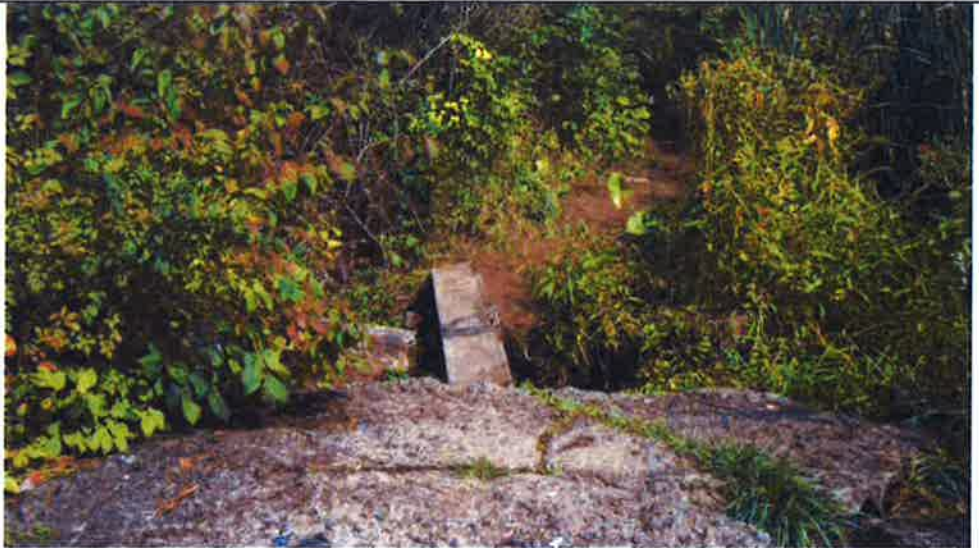
Photo No.: 14
Date: 9/27/16

Description:
Overview of breach in the right embankment looking right towards the embankment.

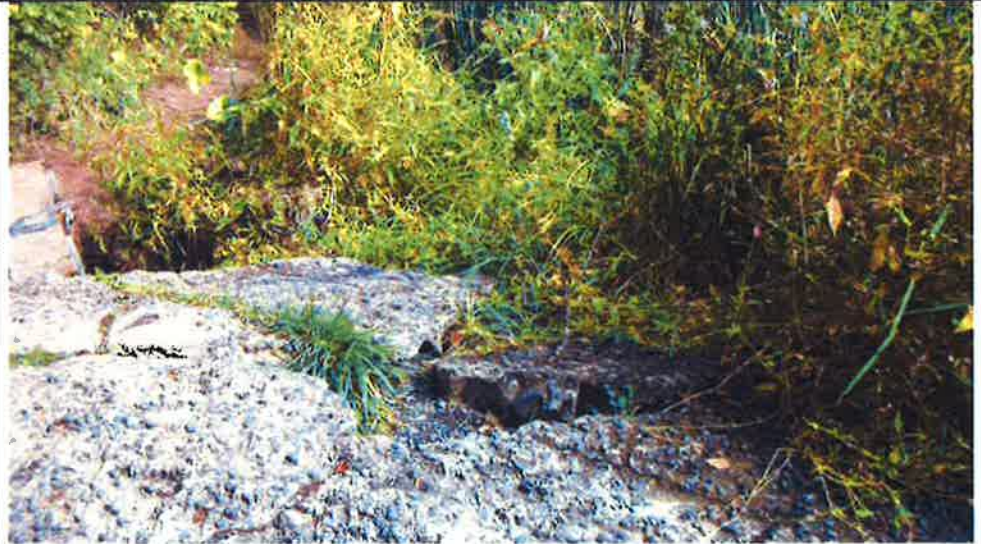
Description:
Overview of breach in the right embankment. Note cracks and missing sections of apron.
