**– *MILL WOODS PARK POND DAM* –**  
**VISUAL INSPECTION REPORT**

Dam Name: Mill Woods Park Pond Dam

Date of Inspection: September 27, 2016

Re: Visual Inspection Report  
Mill Woods Park Pond Dam  
CTDEEP # 15903

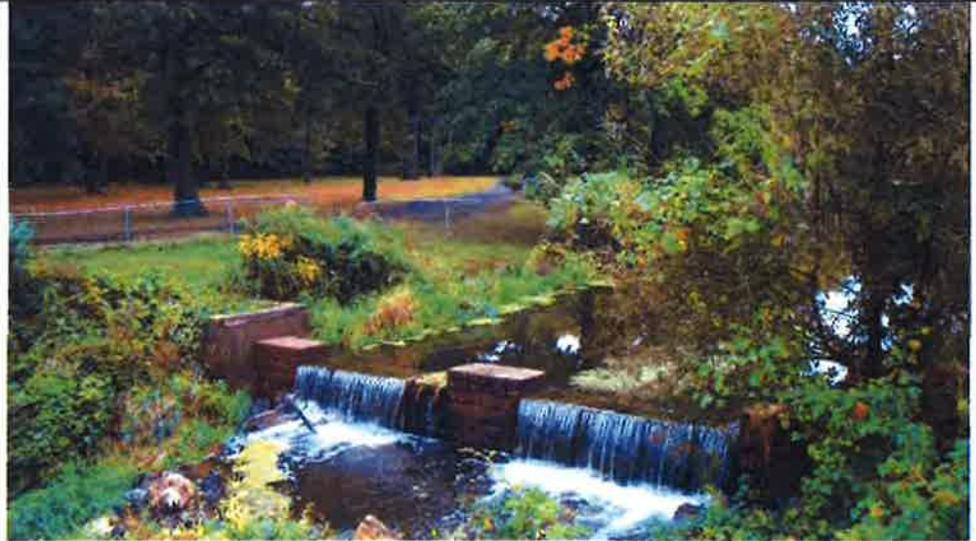
Overview of dam and spillway from downstream.

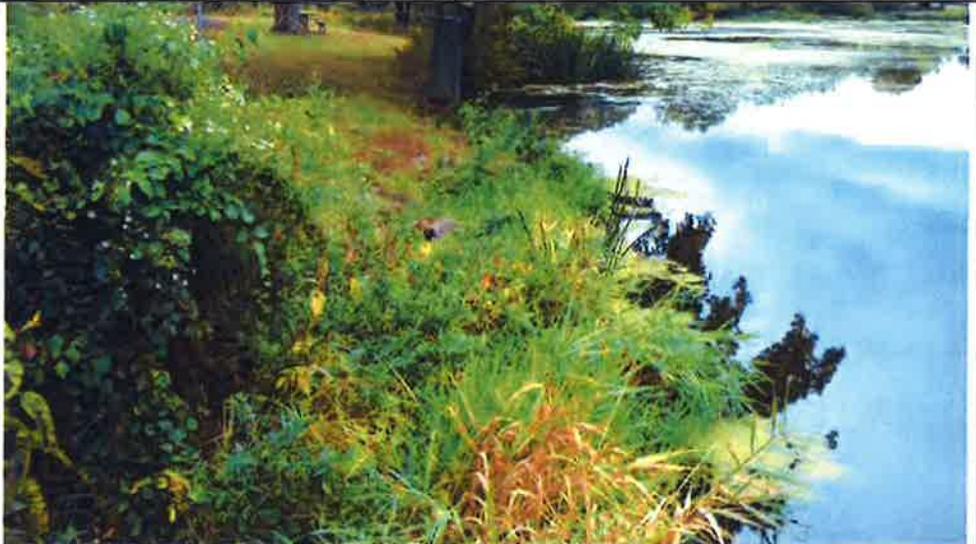
**Photo No.:**  
02

**Vegetative Cover:** The upstream and downstream embankment slopes were covered with thick brush. Several trees (diameters up to 18-inch) were observed on the upstream slope near the embankment contacts. The crest of the dam to the left of the spillway is maintained grass.

Overview of the upstream face of the embankment looking from the right abutment towards upstream. Note the thick brush and vegetation.

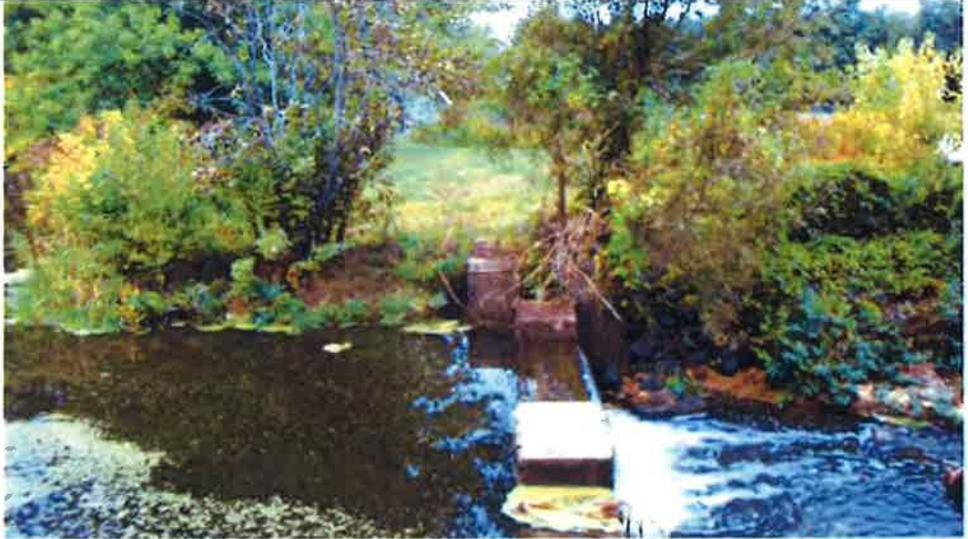
<b>Photo No.:</b> 03	<b>Date:</b> 9/27/16

<b>Direction Photo Taken:</b> Westerly		
<b>Photographer:</b> D. Barstow		
<b>Description:</b>  Overview of the upstream and downstream face of the embankment looking from the right abutment towards the spillway. Note thick brush and vegetation on upstream and downstream slope.

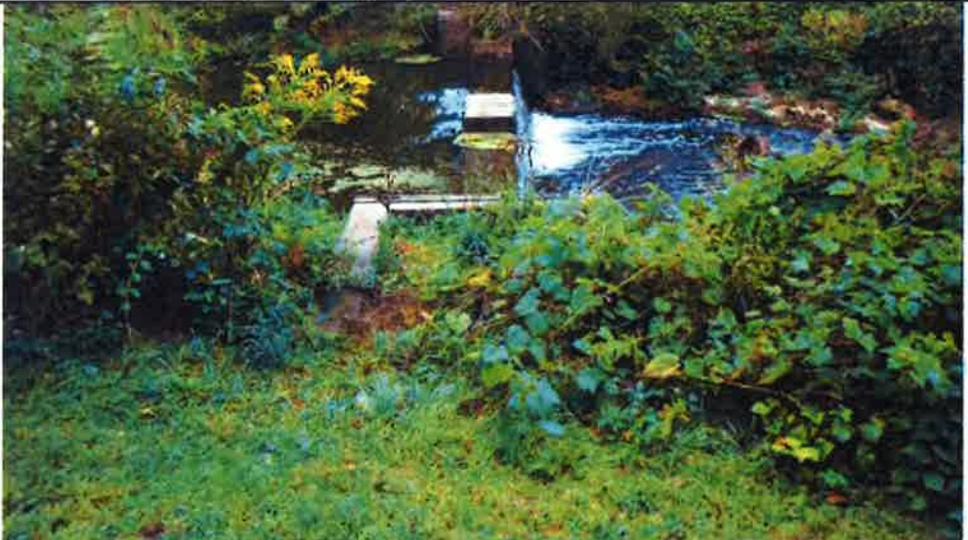
<b>Photo No.:</b> 04	<b>Date:</b> 9/27/16

<b>Direction Photo Taken:</b> Westerly		
<b>Photographer:</b> D. Barstow		
<b>Description:</b>  Overview of the dam crest, spillway and training walls looking from the right abutment. Note vegetation on upstream and downstream slope.

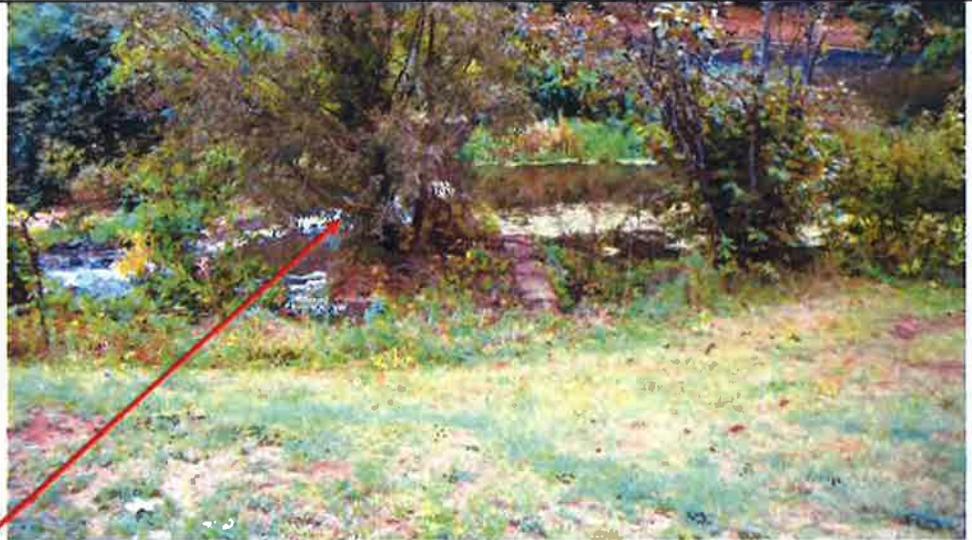
Overview of the dam crest, spillway and training walls looking from the embankment crest left of the spillway. Note the trees and brush.

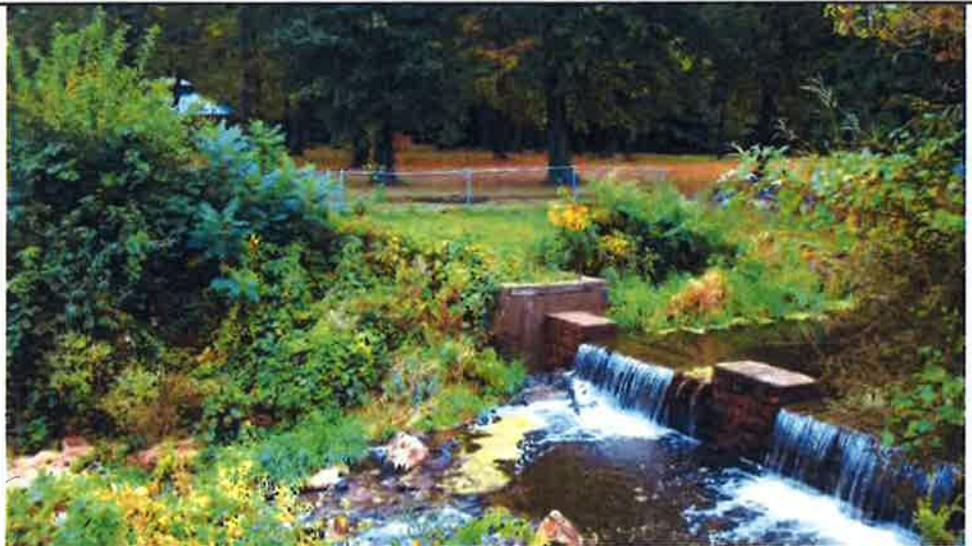
**Photo No.:**  
06

Overview of the downstream face of the embankment looking from the downstream slope left of the spillway. Note the thick brush and vegetation.

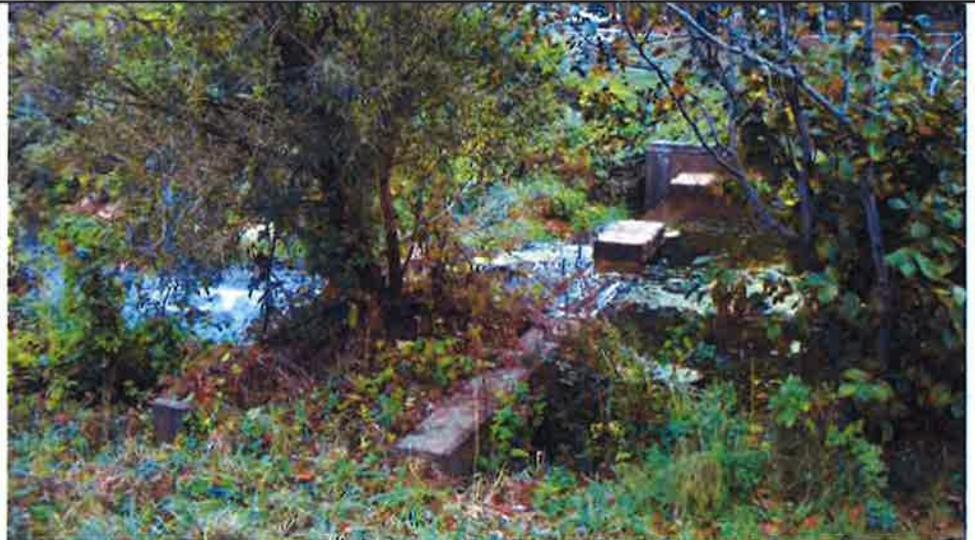
Overview of spillway looking from the embankment crest left of the spillway. Note trees and brush on top of left training wall and upstream embankment slope.

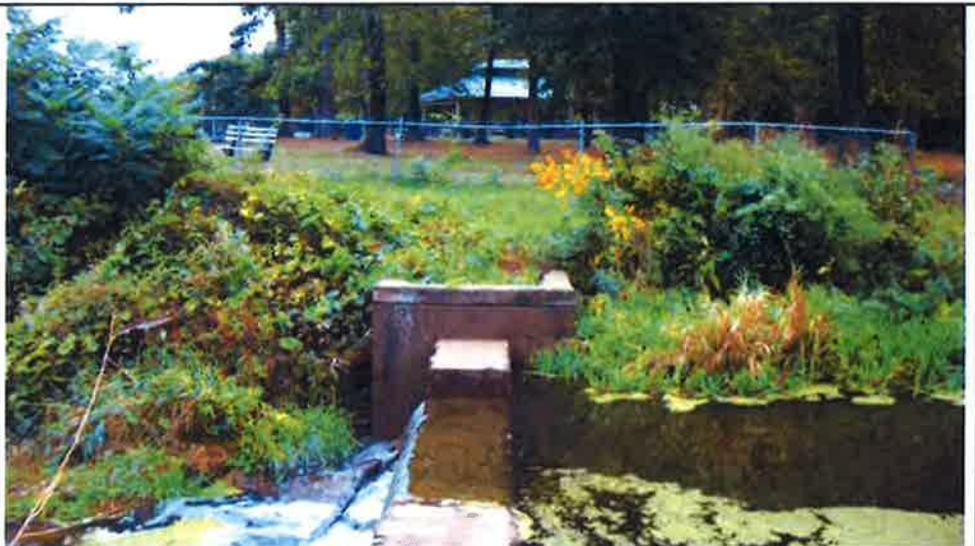
**Photo No.:**  
08

Overview of right training wall looking from left training walls.

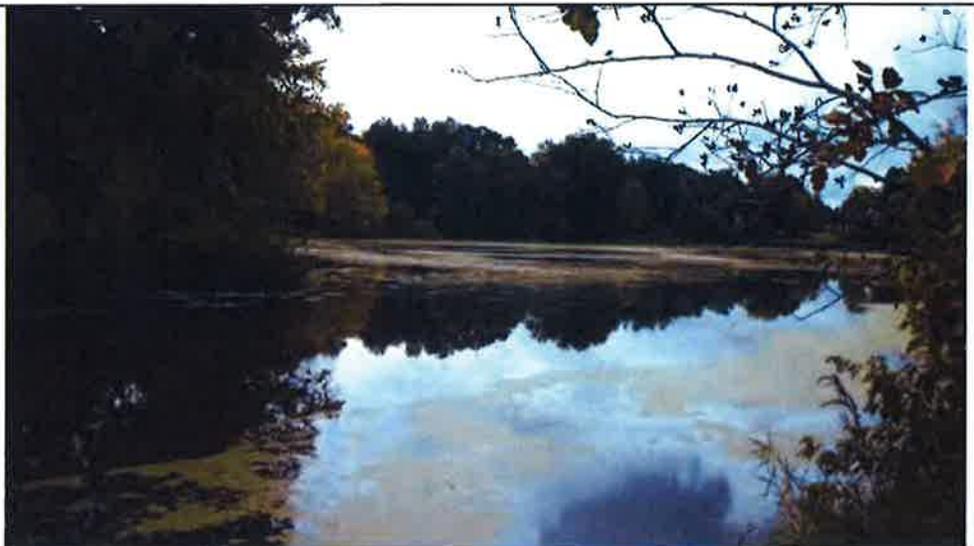
**Photo No.:**  
10

Overview of reservoir area looking from the embankment left of the spillway.

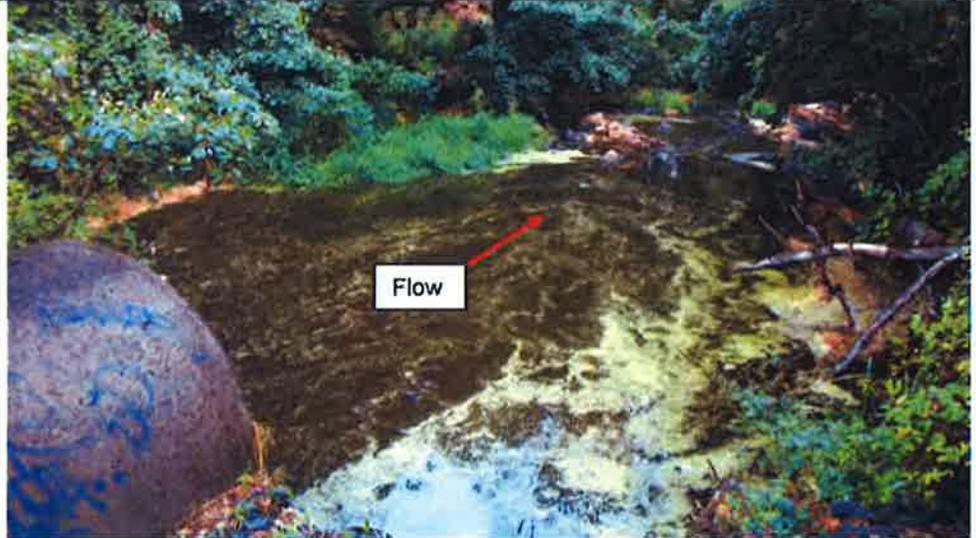
Overview of downstream channel approximately 380-feet downstream of the dam. The 60-inch-diameter, reinforced concrete pipe passes under the access road to Mill Woods Park and discharges to Goff Brook.

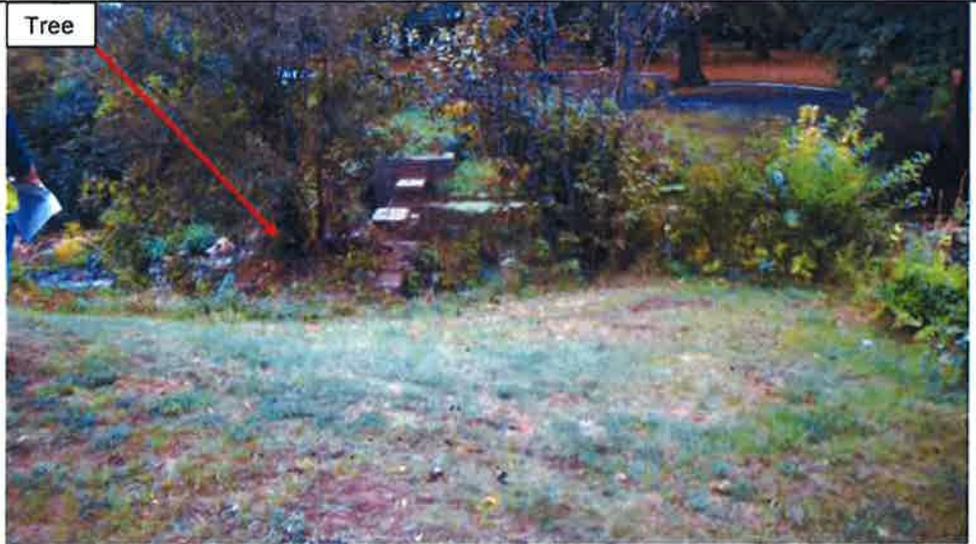
Photo No.:  
12

**Other:** Erosion was observed behind the left and right training wall contacts with the embankment. The erosion appears to be from spillway flow overtopping the training walls. The 2001 Construction Plan Set indicates that the 100-year flood is at El. 74.0 feet, which is about 1.8 feet above the top of the training walls. Two trees (8-inch-diameter) were observed in the left training wall.

Tree growing in the left training wall and heavy brush on upstream and downstream embankment slopes.

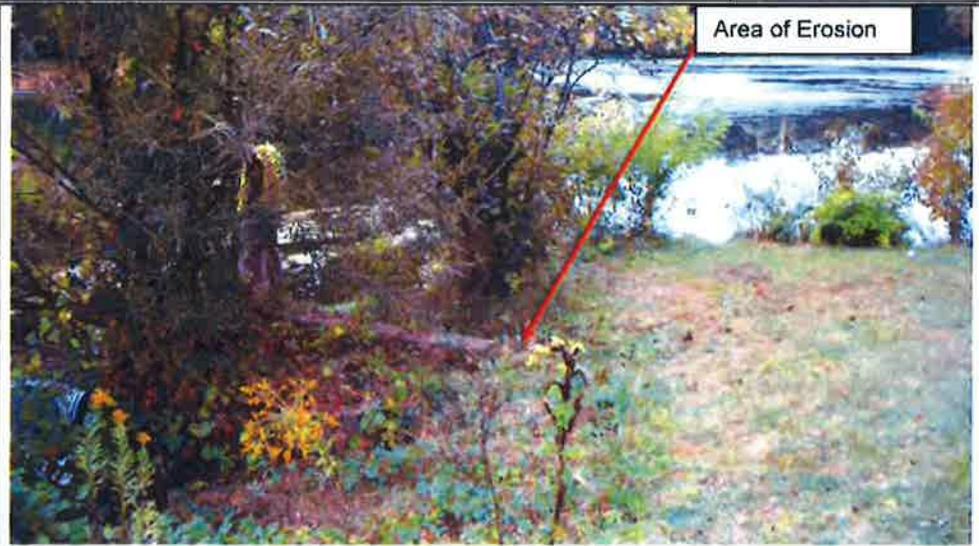
**Description:**  
Overview of left side of spillway showing an area of potential overtopping.

1. Perform a hydrologic and hydraulic (H&H) analysis to determine the appropriate spillway design flood, evaluate spillway capacity, and evaluate anticipated overtopping depths. Based on our observations that the flow appears to have overtopped the training walls and the Town has observed overtopping of the road near the 60-inch diameter pipe (culvert) in the past, evaluate options to either: increase hydraulic capacity of the spillway and culvert, harden the embankment to withstand overtopping, or develop an operations procedure that includes draining the impoundment prior to flooding events to mitigate overtopping potential.

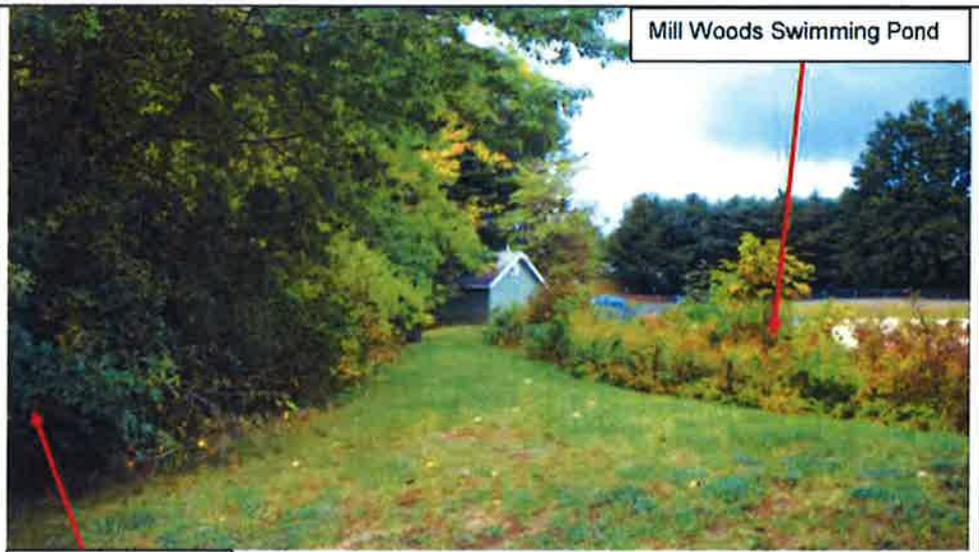
**Photo No.:**  
14

**Description:**  
Overview of the dam embankment looking from the spillway contact to the left abutment. Note: mature trees and thick brush on the upstream embankment slope and thick brush on the downstream embankment slope.

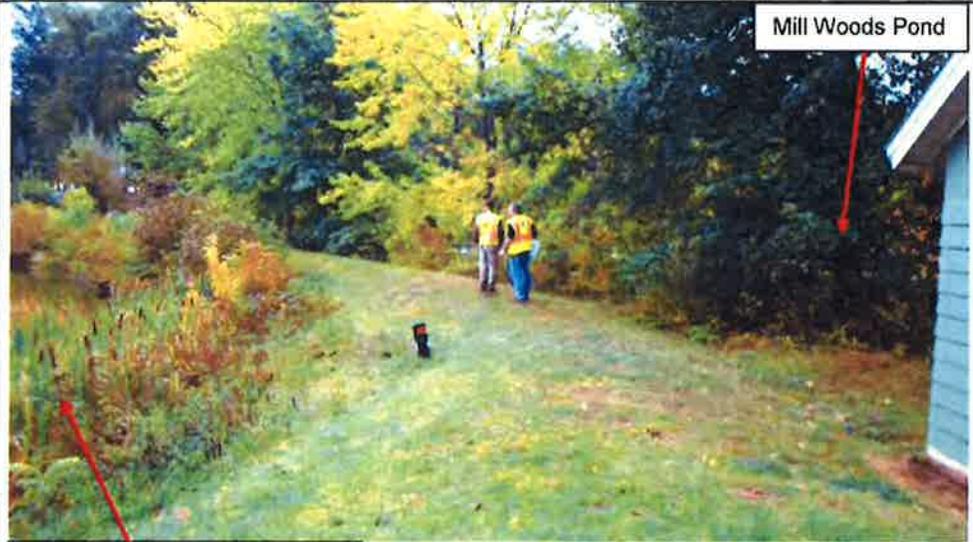
Description:  
Overview of the dam embankment looking from the left abutment. Note: mature trees and thick brush on the upstream embankment slope and thick brush on the downstream embankment slope.

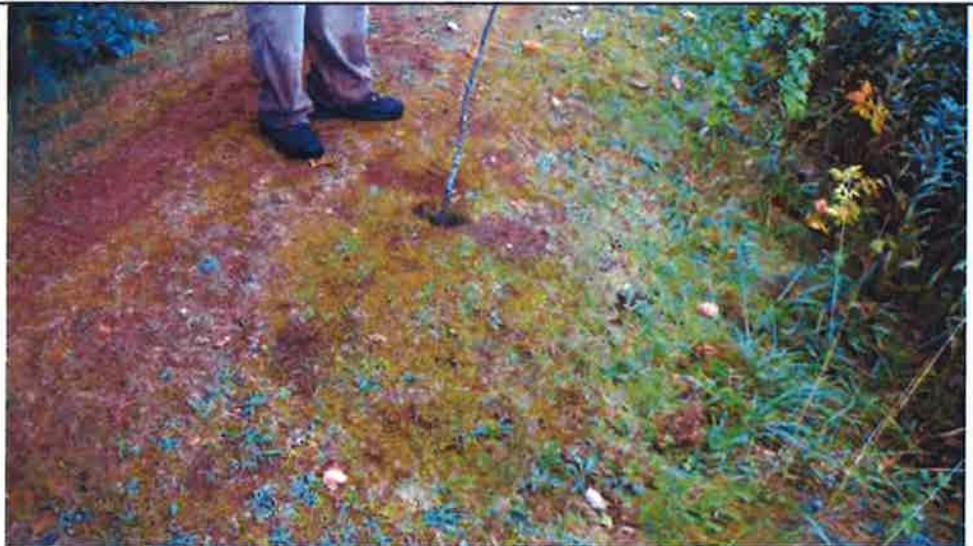
**Erosion/Burrows:** A cluster of 6-inch deep and 4-inch diameter animal burrows were observed within a 6-foot by 6-foot area on the dam crest left of the spillway. Undercutting was observed on the upstream toe of the embankment.

Description:  
One of the cluster of 6-inch deep animal burrows located on the dam crest, left of the spillway.

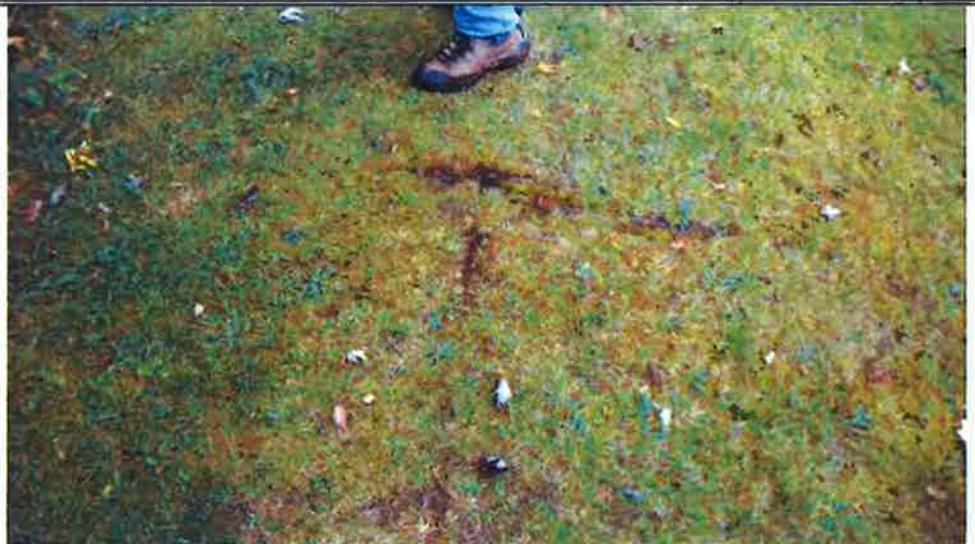
**Description:**  
Exposed tree roots on dam crest, left of the spillway.

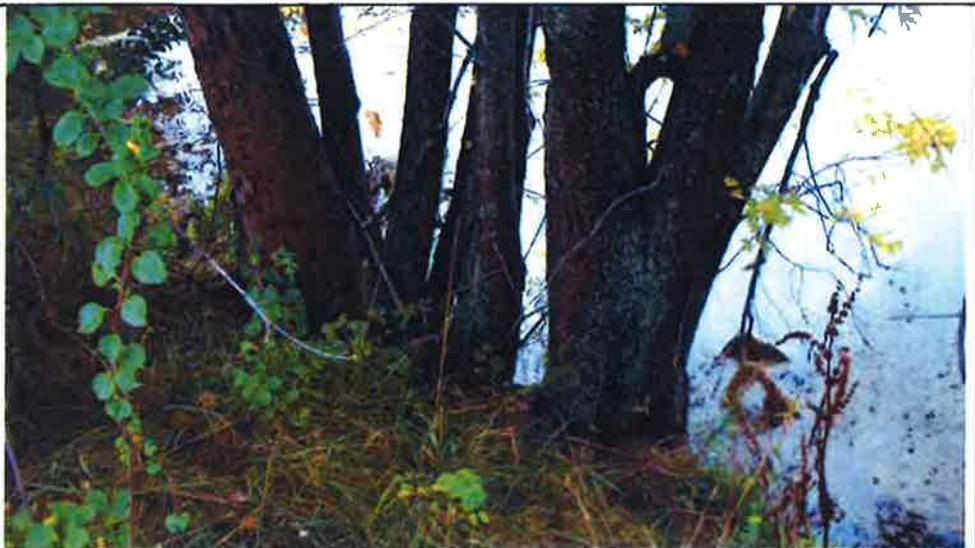
**Photo No.:**  
18

**Description:** Mature trees (up to 24-inch diameter) and thick brush on the upstream embankment slope and at water line.
