– GRISWOLD POND DAM –
VISUAL INSPECTION REPORT

Dam Name: Griswold Pond Dam

Date of Inspection: September 27, 2016

Re: Visual Inspection Report
Griswold Pond Dam
CTDEEP # 15904

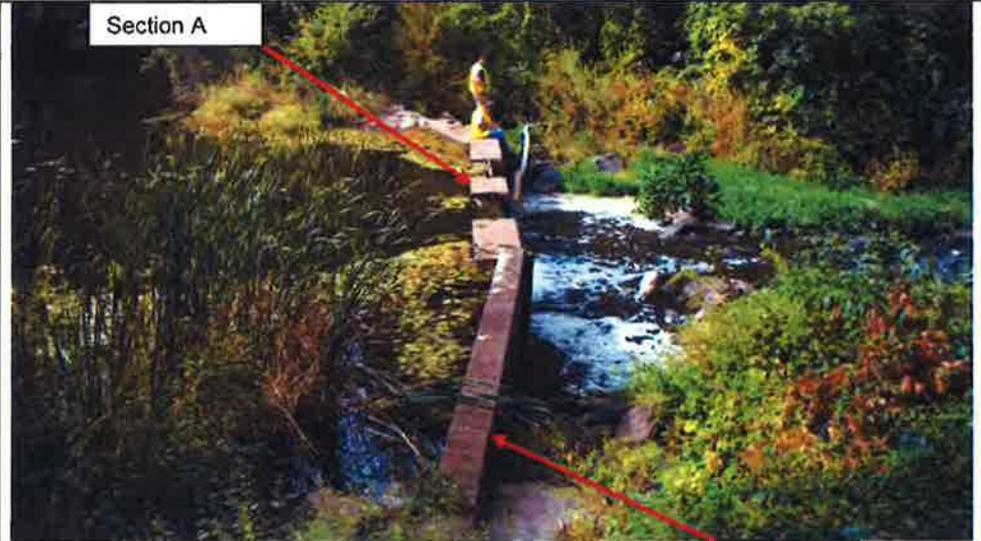
Photo No.: 01	Date: 9/27/16
Direction Photo Taken: Westerly	
Photographer: D. Barstow	
Description: Overview of spillway (Section A and Section B) from right abutment.

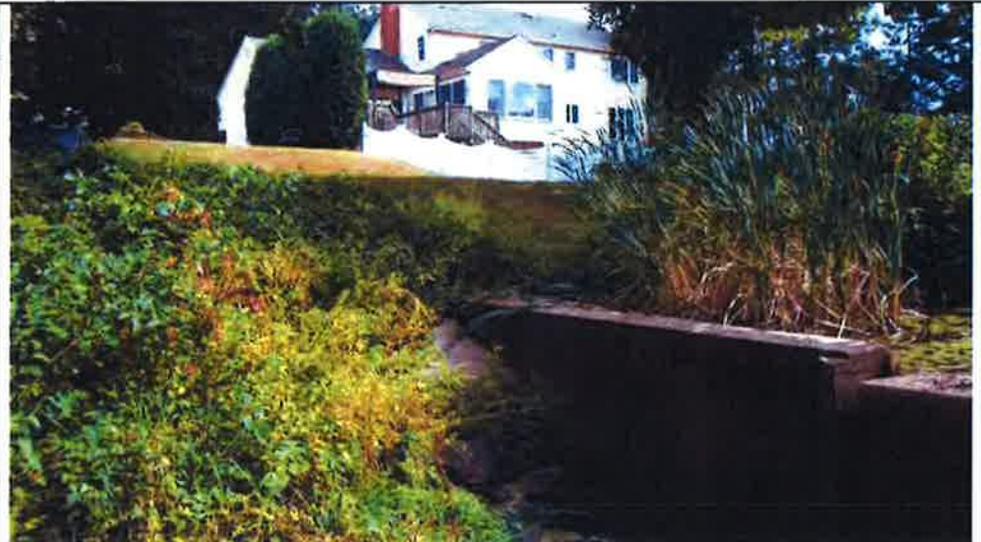
Photo No.: 02	Date: 9/27/16
Direction Photo Taken: Southeasterly	
Photographer: D. Barstow	
Description: Overview of right abutment from the downstream channel. Note: thick brush and vegetation on the embankment crest, upstream and downstream slopes.

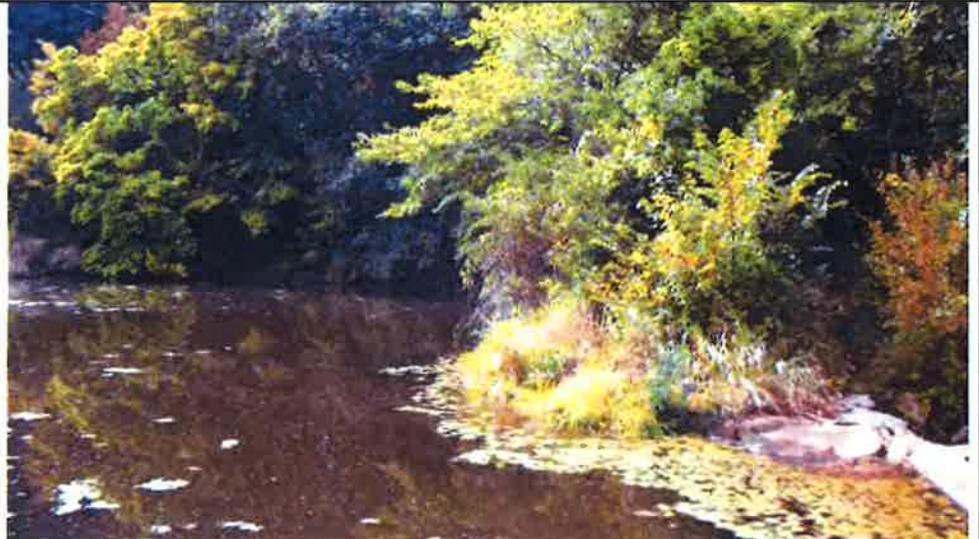
Photo No.: 03	Date: 9/27/16
Direction Photo Taken: Westerly	
Photographer: D. Barstow	
Description: Overview of upstream embankment slope from the right abutment. Note the thick brush and mature trees on the crest and upstream slope.

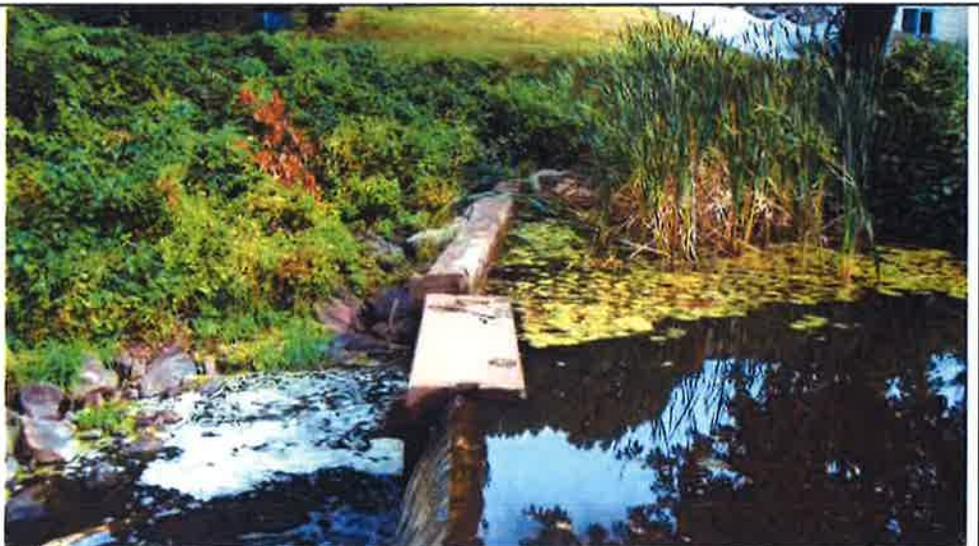
Photo No.: 04	Date: 9/27/16
Direction Photo Taken: Easterly	
Photographer: D. Barstow	
Description: Overview of the right abutment from Spillway Section A. Note the thick brush on the embankment and vegetation growing in the impoundment.

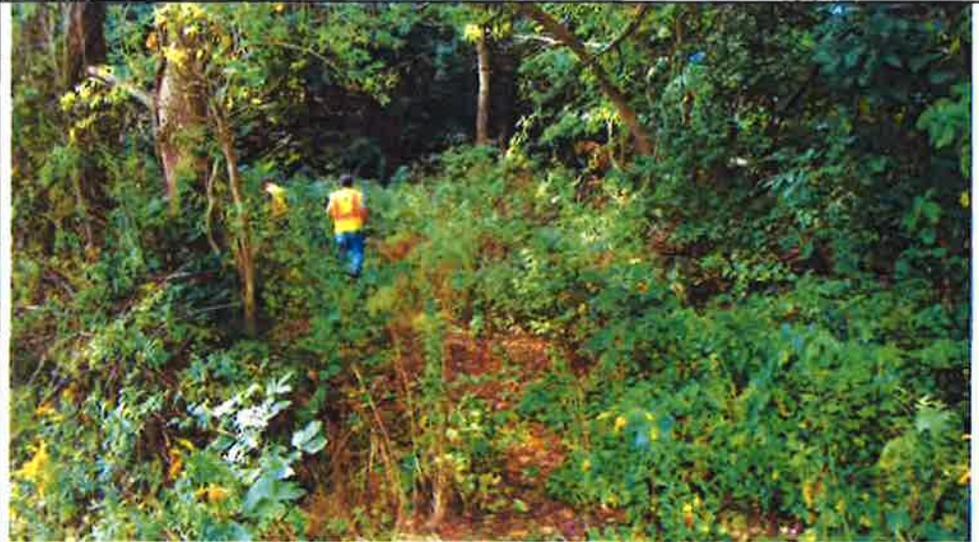
Photo No.: 05	Date: 9/27/16
Direction Photo Taken: Westerly	
Photographer: D. Barstow	
Description: Overview of dam crest looking towards the left abutment. Note thick brush and mature trees on the embankment crest and upstream and downstream slopes.

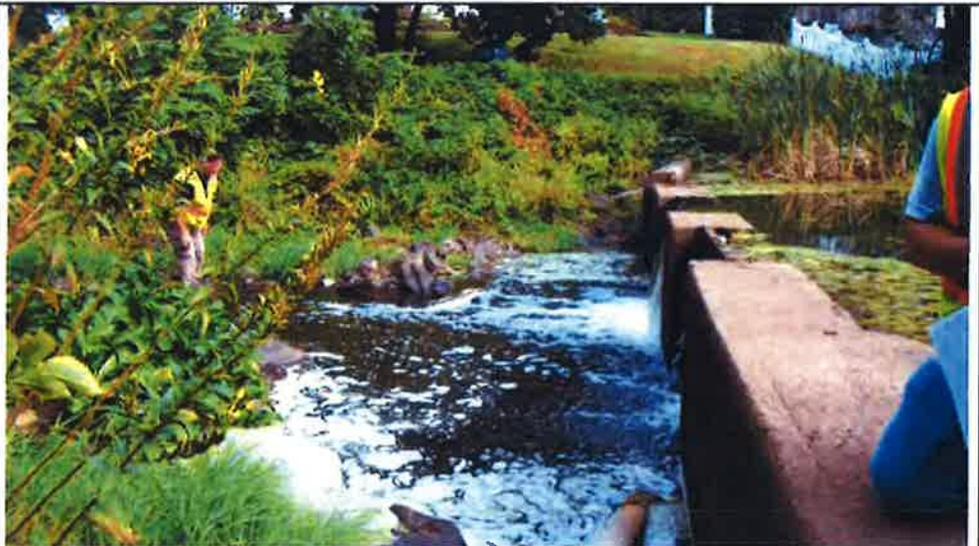
Photo No.: 06	Date: 9/27/16
Direction Photo Taken: Easterly	
Photographer: D. Barstow	
Description: Overview of downstream channel from the Section A abutment with the embankment.

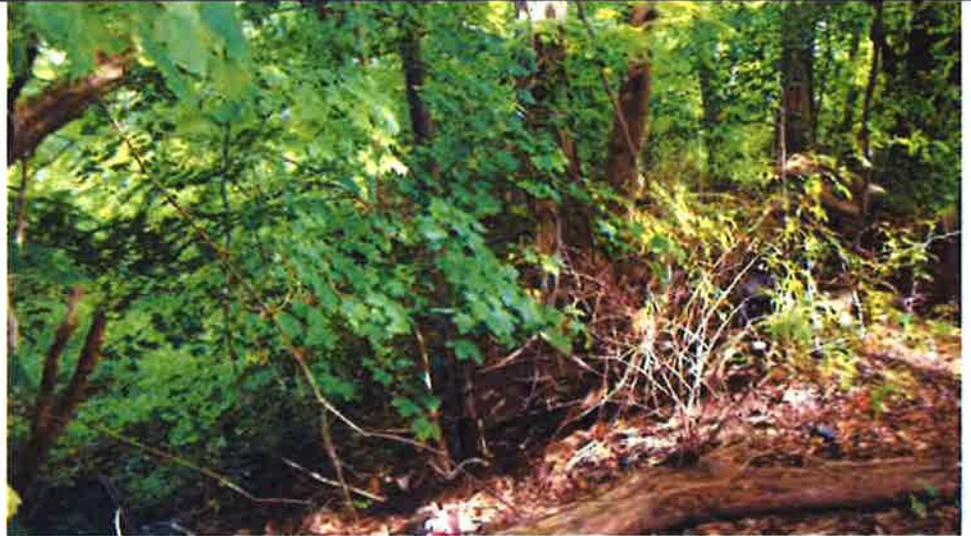
Photo No.: 07	Date: 9/27/16
Direction Photo Taken: Easterly	
Photographer: D. Barstow	
Description: Overview of downstream slope looking from the left abutment. Note dense brush and mature trees on the embankment slope.

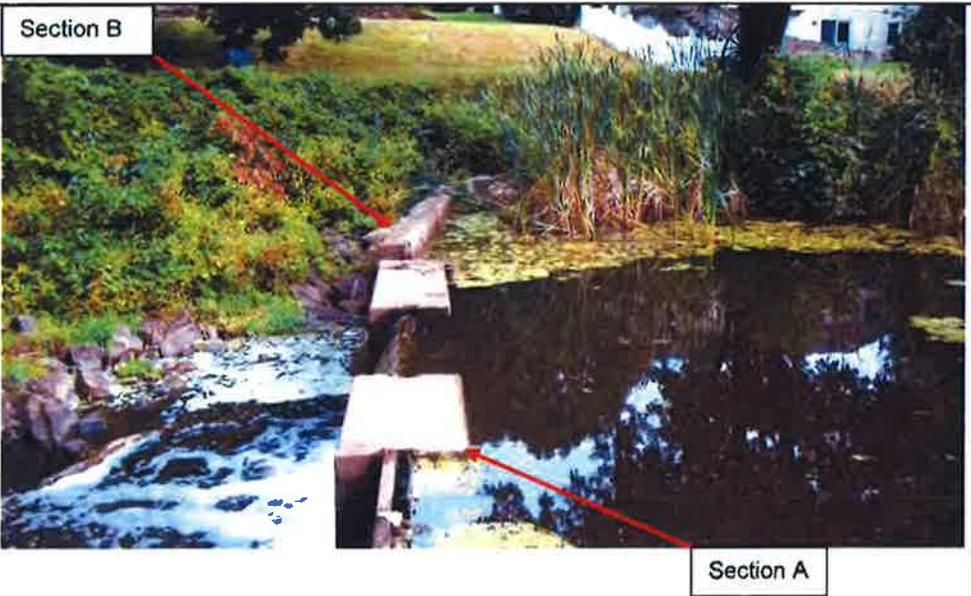
General Condition: Poor – due to the misalignment of Section B with Section A (see below)

Photo No.: 08	Date: 9/27/16
Direction Photo Taken: Easterly	
Photographer: D. Barstow	
Description: Overview of Section A and Section B from the Section A abutment with the embankment. Note Section B has moved and rotated about 3- to 4-inches downstream. The downstream wall face is beyond vertical.

5. Evaluate options for repairs or removal and replacement of the spillway at Section B. Monitor Section B on monthly basis until the Section B repair or replacement is complete.

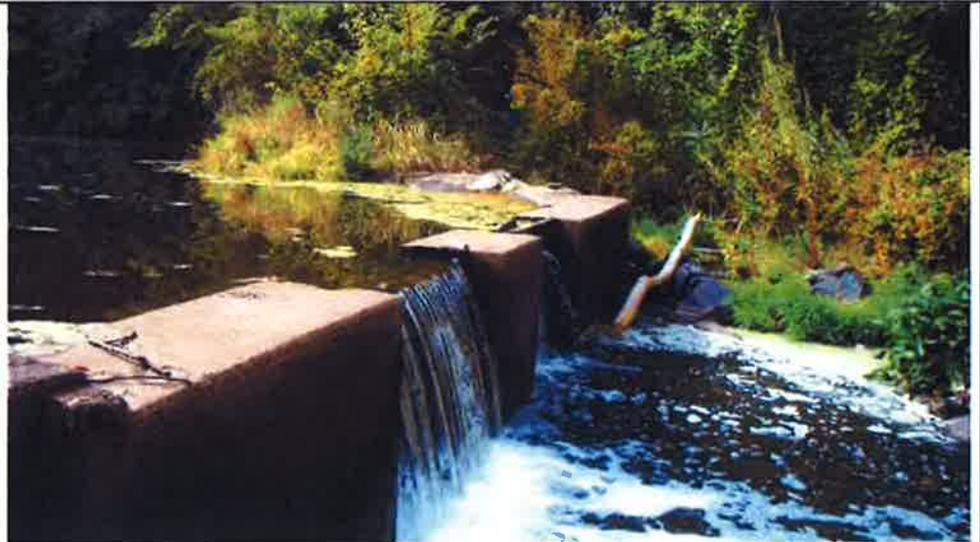
Photo No.: 09	Date: 9/27/16
Direction Photo Taken: Westerly	
Photographer: D. Barstow	
Description: Overview of Section A from downstream looking toward the left abutment.

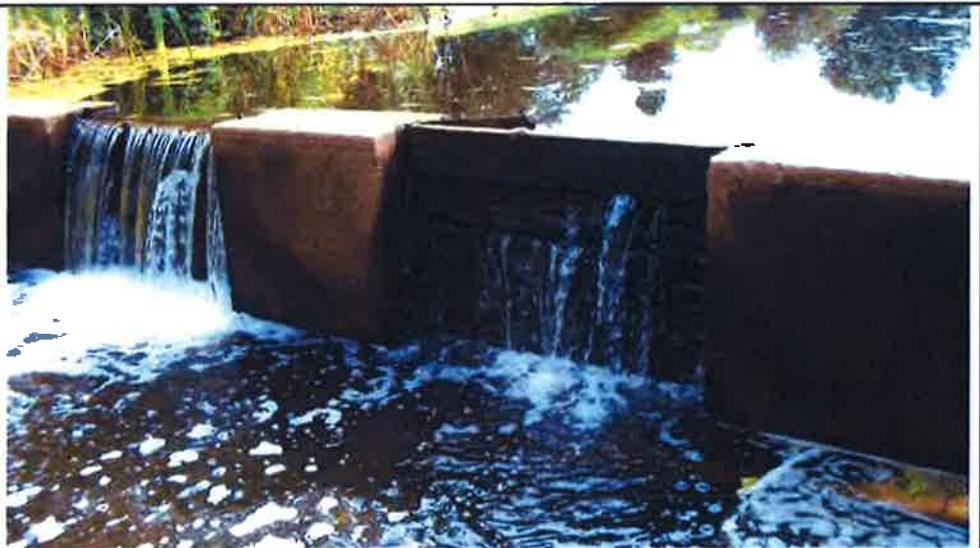
Other: The stop logs do not appear to have been replaced recently and are in poor condition. Water was observed flowing (estimated to be greater than 10 gallons per minute) from the spaces between the stop logs.

Photo No.: 10	Date: 9/27/16
Direction Photo Taken: Southeasterly	
Photographer: D. Barstow	
Description: Overview of Section A from downstream looking towards the right abutment. Note stop logs in weir and water seeping through stop logs.

1. Replace the worn or damaged stop logs in the Section A bays.

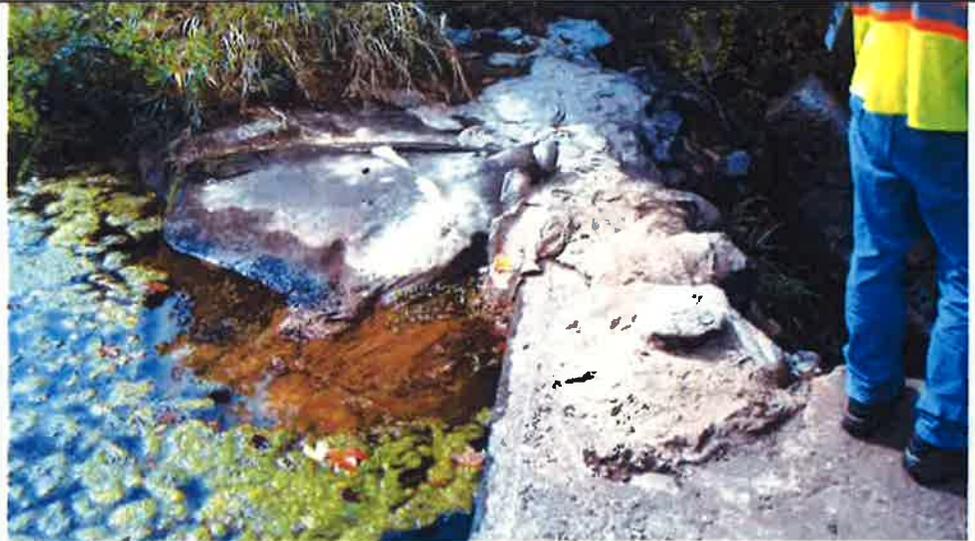
Repair at the Section A contact with the embankment. The repair consists of grout-filled fabric bags and grouted rip rap.

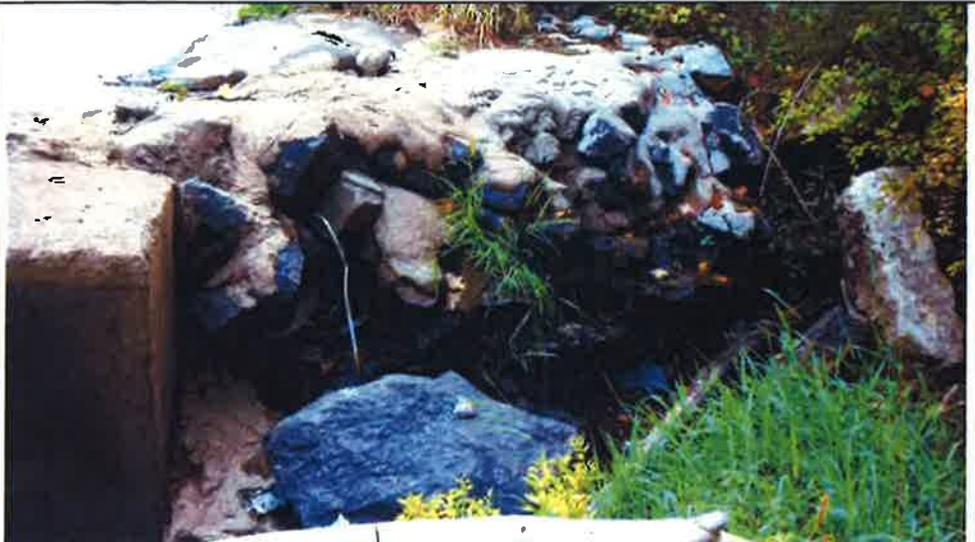
Photo No.:
12

Seepage/Foundation Drainage: Observations were obscured by the thick brush and vegetation. The embankment at the contact with the left side of Section A and the embankment at the contact with the right side of Section B were previously repaired with grouted riprap and grout-filled fabric bags. Seepage was observed on the downstream face at both of the repaired locations. The seepage was visually estimated to be about 10 gallons per minute to the left of the Section A and less one gallon per minute to the right of the Section B.

Repair at the Section A contact with the embankment looking upstream. Seepage through the riprap and grout was observed and estimated to be approx. 10 gallons per minute.

4. Evaluate options to repair the embankment at the left and right abutments with the spillway (Section A and Section B). Monitor the previous embankment repairs in these areas on a monthly basis until the new embankment repairs are complete.

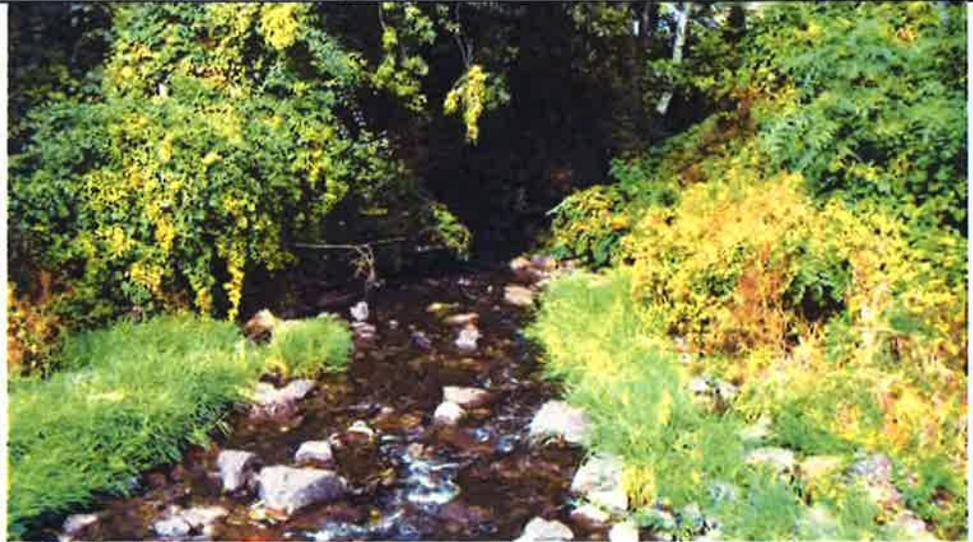
Overview of downstream channel (Goff Brook) looking downstream from the spillway. Note rip-rap in channel.

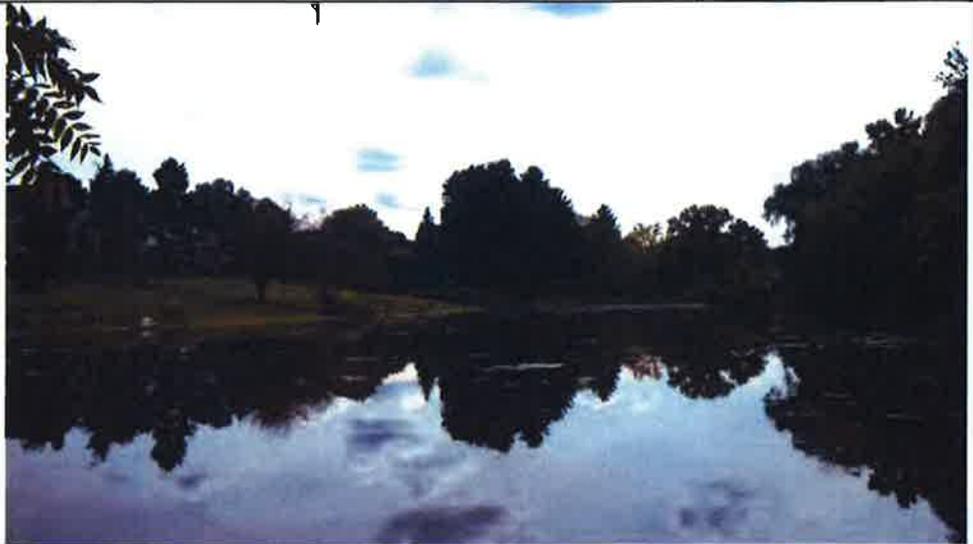
Photo No.: 14
Date: 9/27/16

Overview of reservoir area (Griswold Pond) looking upstream from the spillway.

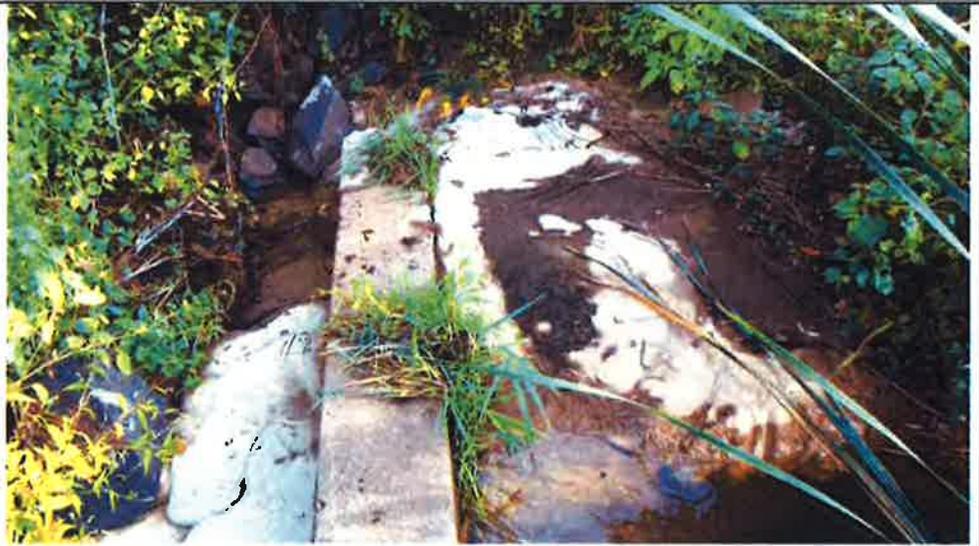
Erosion/Burrows: Minor erosion of the embankment was observed to the right of the Section B. The erosion appears to be about 2 inches or less and allows water to flow around the spillway before reaching the Section B elevation.

Photo No.: 15	Date: 9/27/16
Direction Photo Taken: Easterly	
Photographer: D. Barstow	
Description: Repair at the Section B contact with the embankment looking towards the right abutment. The repair appears to consist of grouted riprap and grout filled fabric bags. Minor seepage through the riprap and grout was observed.

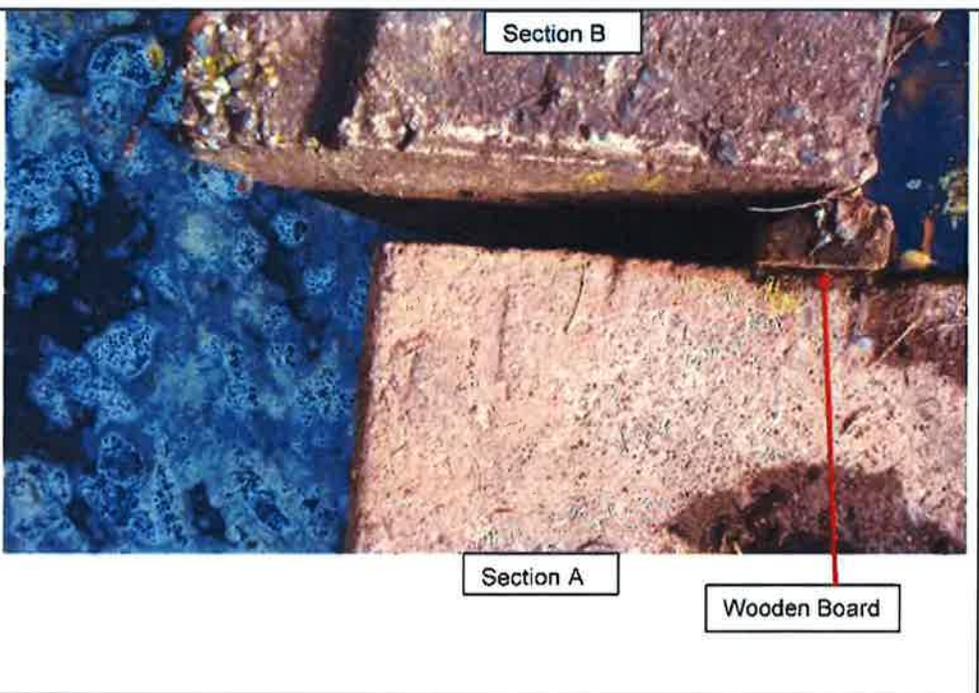
Seepage/Foundation Drainage: Section B movement has opened a gap between Section A and Section B. The gap is approximately 1.5-inches wide at the top and a wooden board has been installed in the gap to reduce seepage. Seepage was observed in the gap and visually estimated to be about 5 gallons per minute.

Photo No.: 16	Date: 9/27/16
Direction Photo Taken: Easterly	
Photographer: D. Barstow	
Description: Gap between Section A and Section B. Note the wooden board placed in the 1.5-inch crack. Water was observed seeping at approx. 5 gallons per minute through the crack.
