# 2015 Safe Routes to School Walk Audit Findings Report

SILAS DEANE  
MIDDLE SCHOOL  
*"Learning Today...Leading Tomorrow"*

*Silas Deane Middle School  
Wethersfield, CT*

**September 2015**

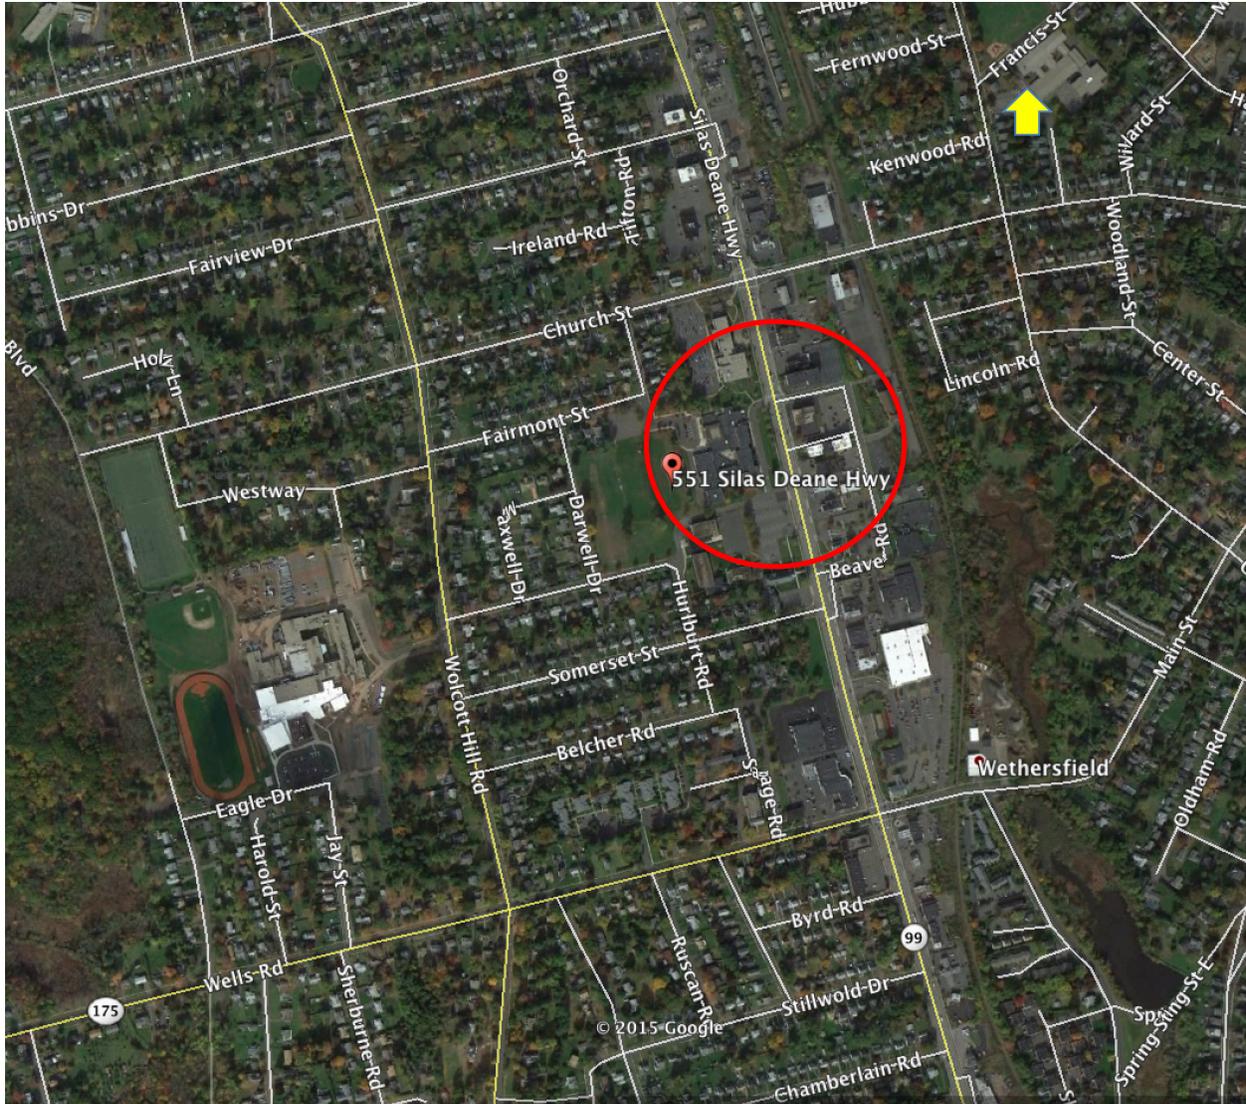
Figure 1: Silas Deane Middle School study area

**Figure 1** shows an overview of the Silas Deane Middle School study area.

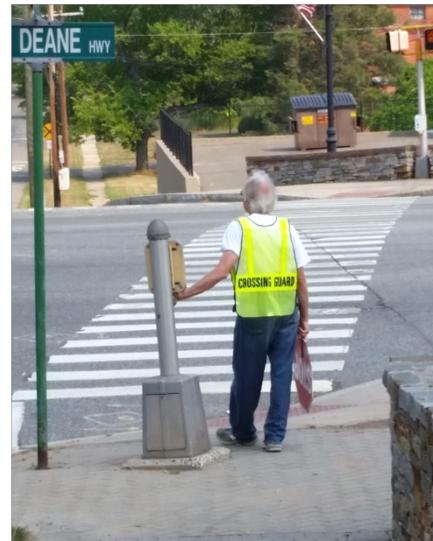
The Town of Wethersfield has assigned two crossing guards dedicated to students walking to and from Silas Deane Middle School. As shown in **Figure's 2 and 3**, one crossing guard is stationed at the intersection of Silas Deane Highway and Church Street from 7:00-8:15 a.m. and 2:00-3:15 p.m. The other crossing guard is located at the intersection of Wolcott Hill Road and Church Street (Figure 3). In addition to the two crossing guards located to the north of school grounds, the principal, a police resource officer, and two other staff members observe the arrival process.

**Figure 2: Crossing Guard On Silas Deane Highway At Church Street**

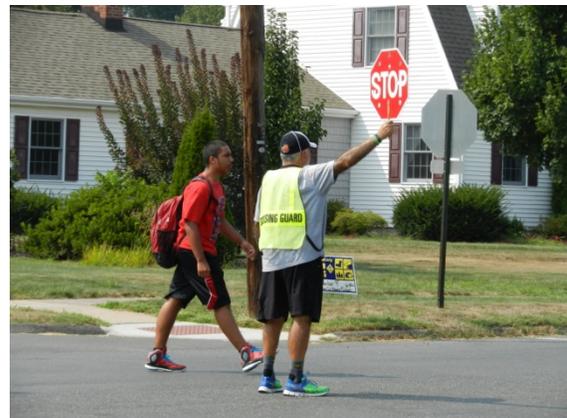
**Figure 3: Crossing guard on Wolcott Hill Road at Church Street**

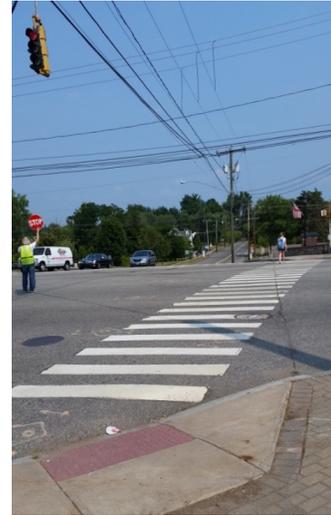
At major intersections surrounding Silas Deane Middle School are Americans with Disabilities Act (ADA) Compliant sidewalk ramps with detectable warning strips. Specifically, at the intersection of Silas Deane Highway and Church Street, there are four ADA Compliant ramps, crosswalks, and fully-operational pedestrian equipment (**Figure 4**).

**Figure 4: ADA Compliant ramps on Silas Deane Highway at Church Street**

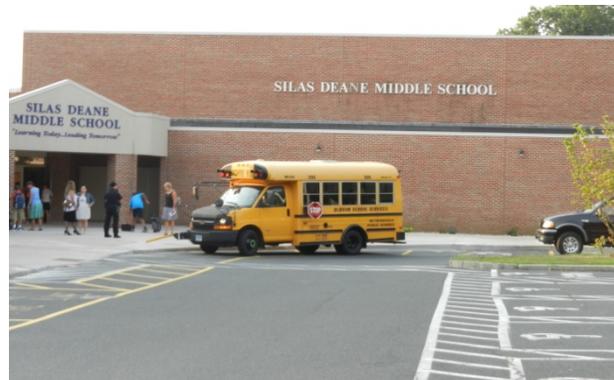
Students are allowed to enter the building starting at 7:30 a.m. The first school bell rings at 7:45 a.m. and thus, the regular drop-off occurs between 7:30 a.m. and 7:45 a.m. The school has a one-lane drop-off and pickup configuration. Lower occupancy buses and parents dropping off their children at the school share one lane and stop momentarily in the fire lane. After drop-off, vehicles move left out of the fire lane and leave the parking lot (**Figure 5**). By 7:50 a.m. the queue is essentially dissipated. The drop-off process functions rather smoothly with a maximum queue of about 10 vehicles. Students generally exited the vehicles towards the sidewalk and not into traffic. Along the west entrance to Silas Deane Middle School, there is a nine-foot sidewalk on the right side of the driveway and a six-foot sidewalk on the left side of the driveway.

**Figure 5: Drop-off process at Silas Deane Middle School**

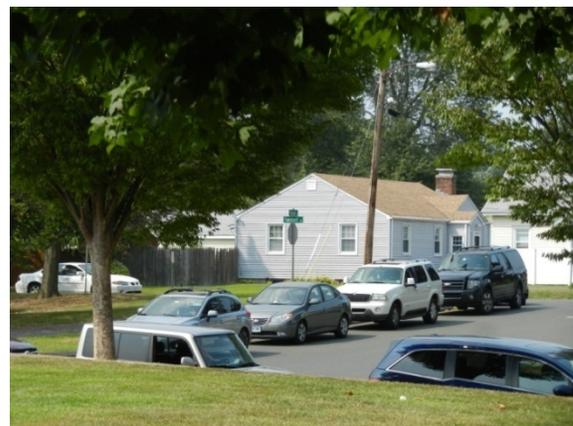
While the pickup process functions relatively smoothly, the maximum queue extends out to the intersection of Church Place and Fairmont Street (**Figure 6**). The first dismissal bell rings at 2:21 p.m., but only a few students exit the building at this time. At 2:25 p.m., several hundred students exit the building and a low capacity bus enters the pickup loop around the same time. This bus temporarily comes in conflict with parents picking up their children. The queue starts to dissipate at 2:30 p.m.

**Figure 6: Queue during dismissal process**

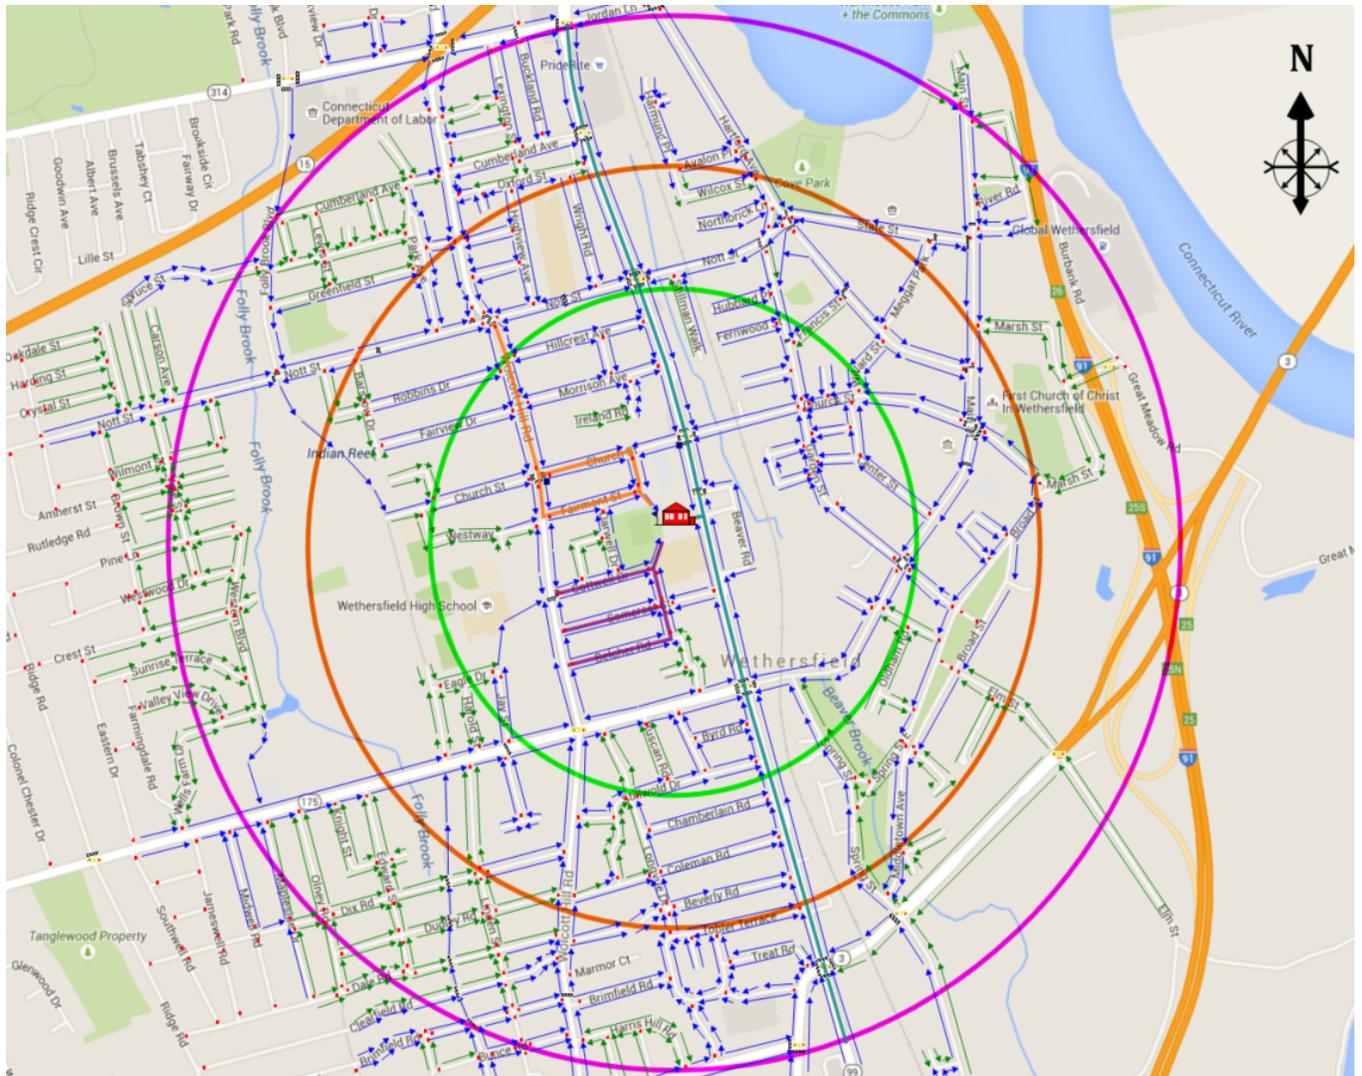
Figure 7: Silas Deane Middle School Walking Routes Map

**Table 1** provides an overview of key findings for streets within the immediate area and **Figure 7** provides a pictorial representation of the three walking routes to Silas Deane Middle School.

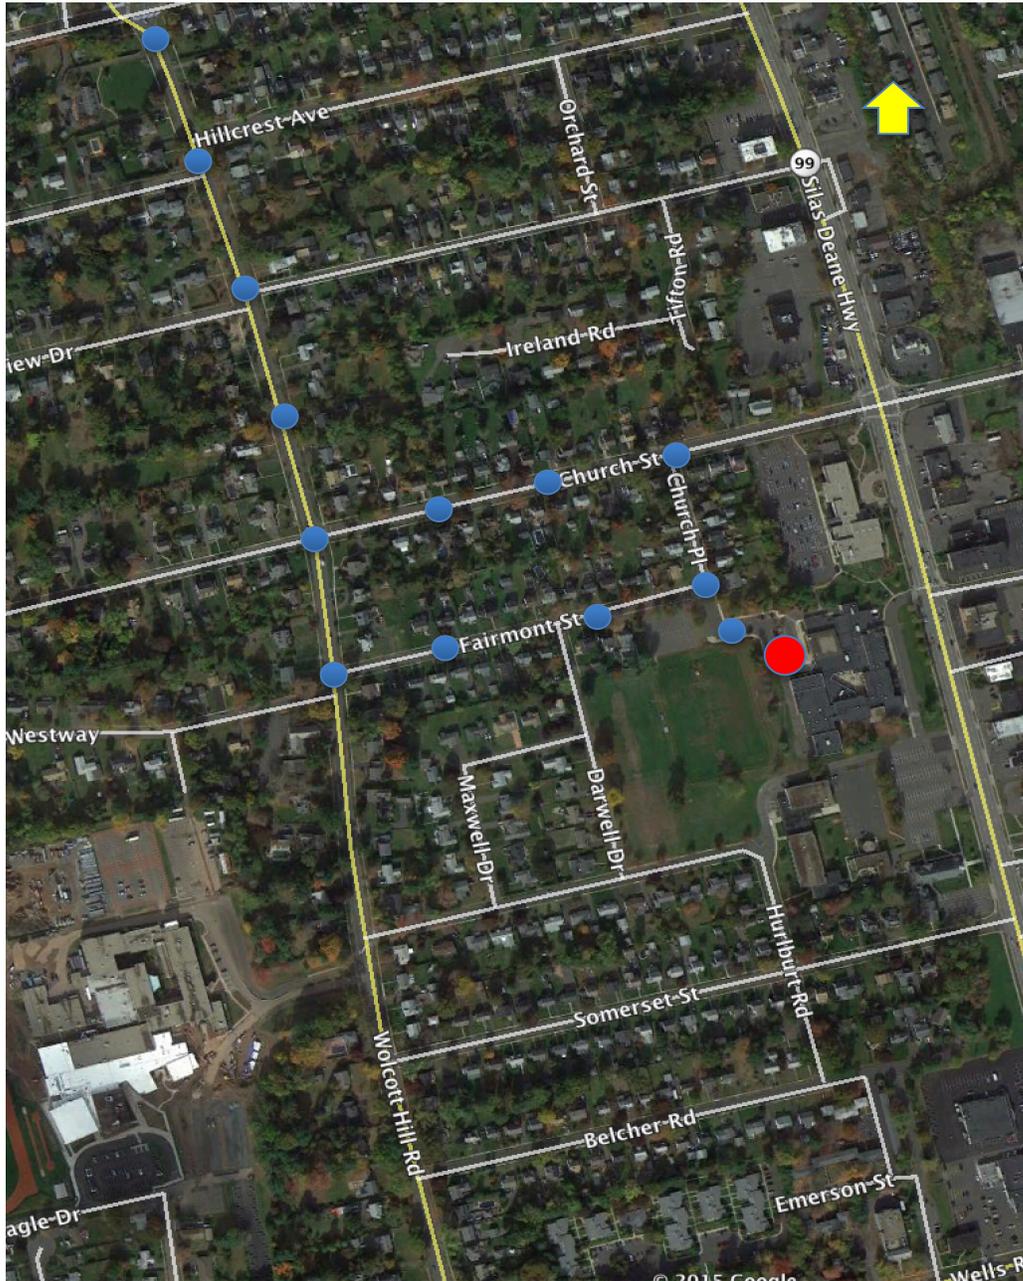
Figure 8: Walking Route 1 - Wolcott Hill Road / Church Street / Fairmount Street / Church Place

Walking Route 1 starts along Wolcott Hill Road to either Church Street or Fairmount Street, then continuing to Church Place and the Silas Deane Middle School Campus.

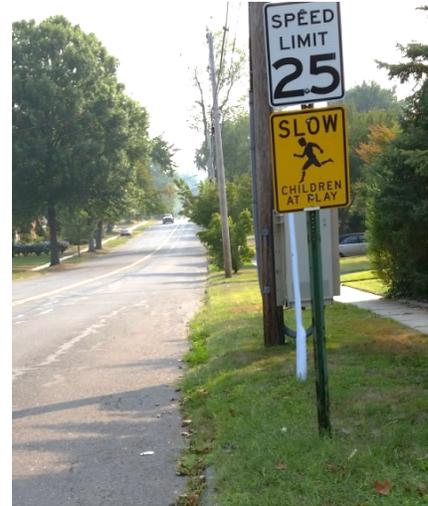
There is no posted speed limit on Wolcott Hill Road and Church Place, but the speed limit on Church Street and Fairmont Street is 25 mph. Wolcott Hill Road and Church Street both have higher volume than the residential roads of Church Place and Fairmont Street. Though Church Street has a higher volume of traffic, **Figure 9** shows the posted 25 mph speed limit. As eastbound Church Street traffic approaches Church Place, school zone signage reinforces the speed limit within the Silas Deane Middle School zone (**Figure 10**). Additionally, Church Place also has similar signage to warn drivers that they are in a school zone (**Figure 11**).

Figure 9: Speed limit sign on Church Street

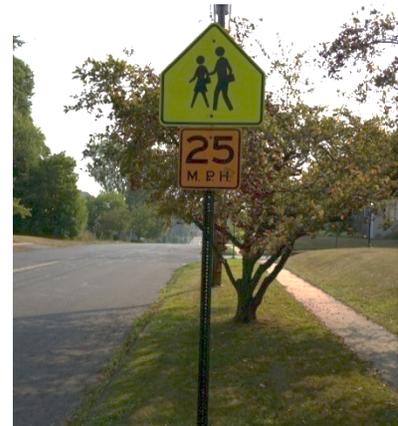
Figure 10: School zone signage on eastbound Church Street approaching Church Place

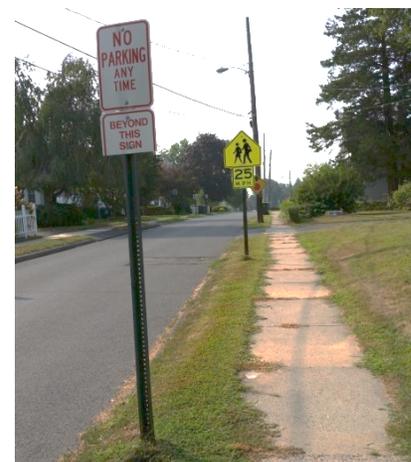
Figure 11: School zone signage on southbound Church Place

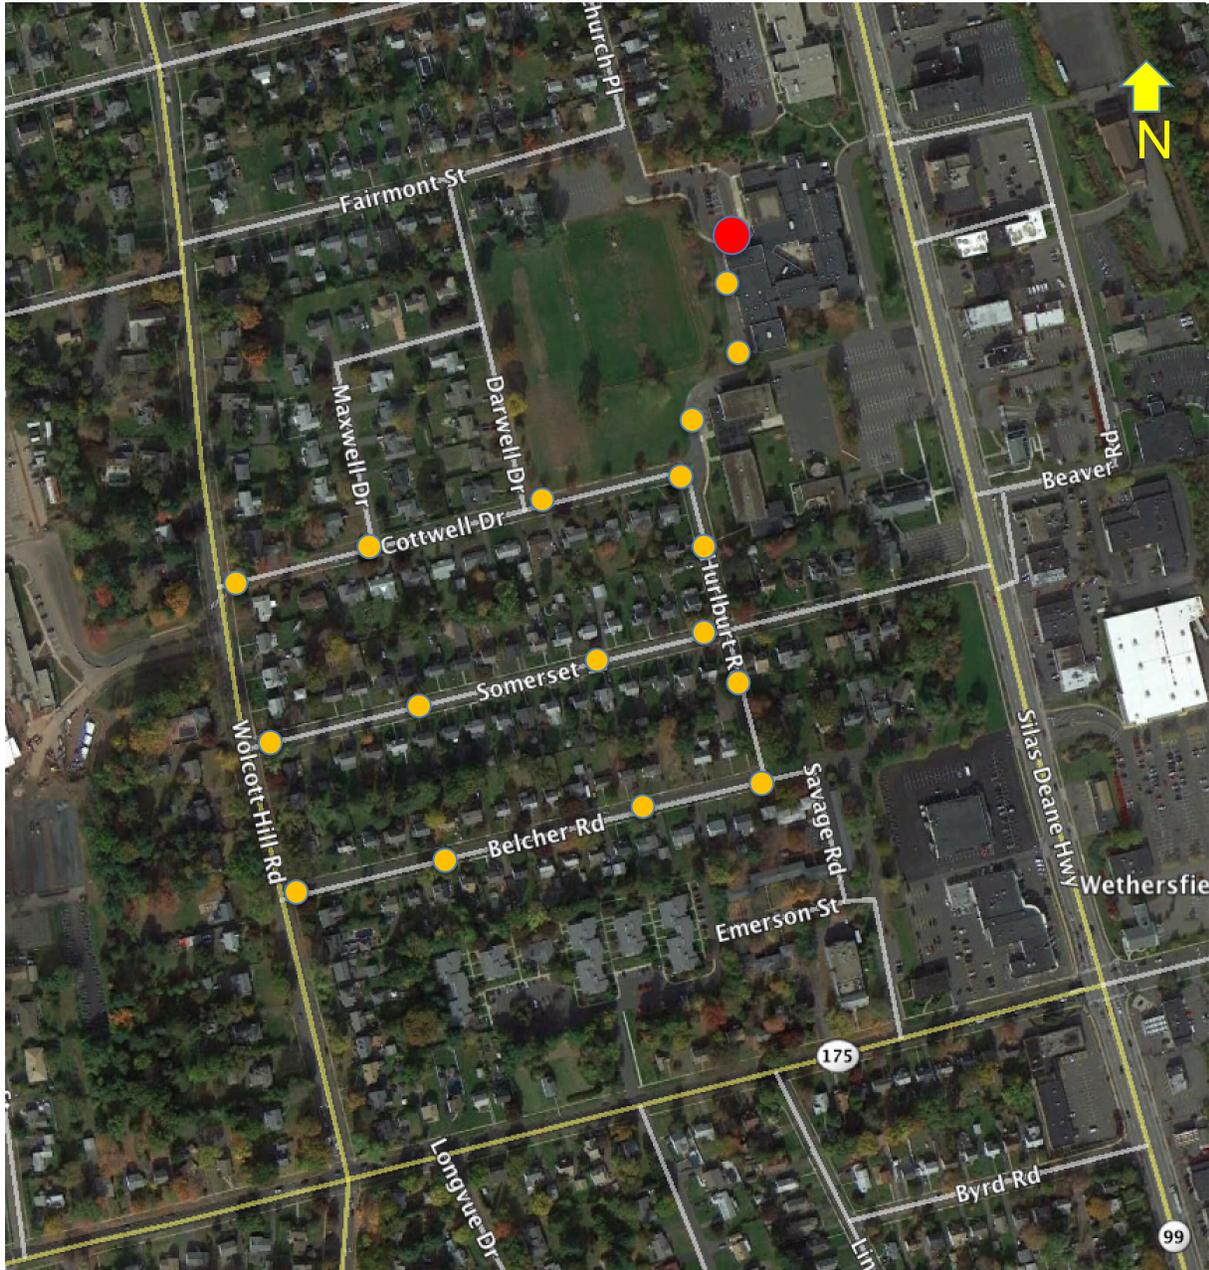
Figure 12: Walking Route 2 - Belcher Road / Somerset Street / Cottwell Drive / Hurlburt Road

Walking Route 2 begins at either Belcher Road, Somerset Street, or Cottwell Drive. The route then continues to Hurlburt Road, along the west side of the Corpus Christi School and Silas Deane Middle School until reaching the west entrance of the school (**Figure 12**).

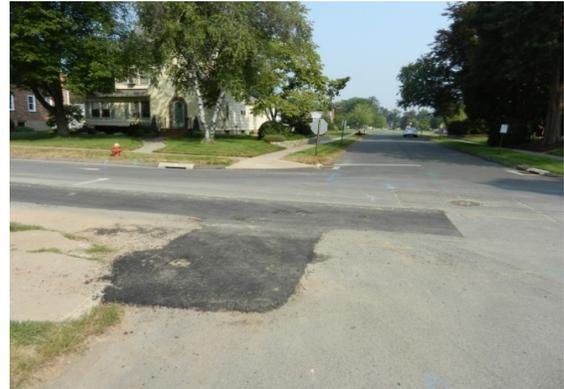
In general, the pavement quality is in excellent condition on Belcher Road, Cottwell Drive, and Hurlburt Road, as if the town recently repaved these streets. However, the pavement quality on Somerset Street is fair because there is ongoing road construction (**Figure 13**). The sidewalk quality ranges from fair to good along the entire route. Despite the low traffic volume along this walking route the absence of pavement markings are not favorable for walking and biking. There are no crosswalks, centerlines, and shoulder lines which provide appropriate safety measures for pedestrians and bicyclists. Thus, bicyclists using this route have to share the travel lanes with vehicles. After reaching Hurlburt Road students take a walking path along the west entrance to Corpus Christi School, proceeding between the athletic fields and the west side of Silas Deane Middle School and to the west entrance to the school.

**Figure 13: Pavement markings and quality on Somerset Street at Hurlburt Road**

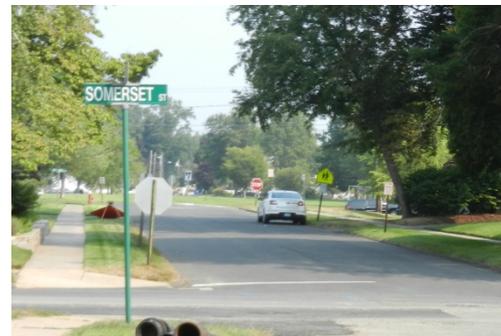
There are posted speed limit signs of 25 mph on Belcher Road, Somerset Street, and Cottwell Drive, but Hurlburt Road does not have a posted speed limit sign. On northbound section of Hurlburt Road, there The MUTCD Compliant school zone warning before the intersection with Cottwell Drive to alert motorists of potential students travelling in the school area (**Figure 14**). Additionally, a few "No Parking" signs are present on this route, as shown in **Figure 15**.

**Figure 14: School zone signage on Hurlburt Road**

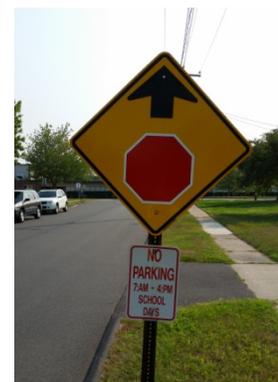
**Figure 15: Stop Ahead and No Parking signs on Cottwell Drive**

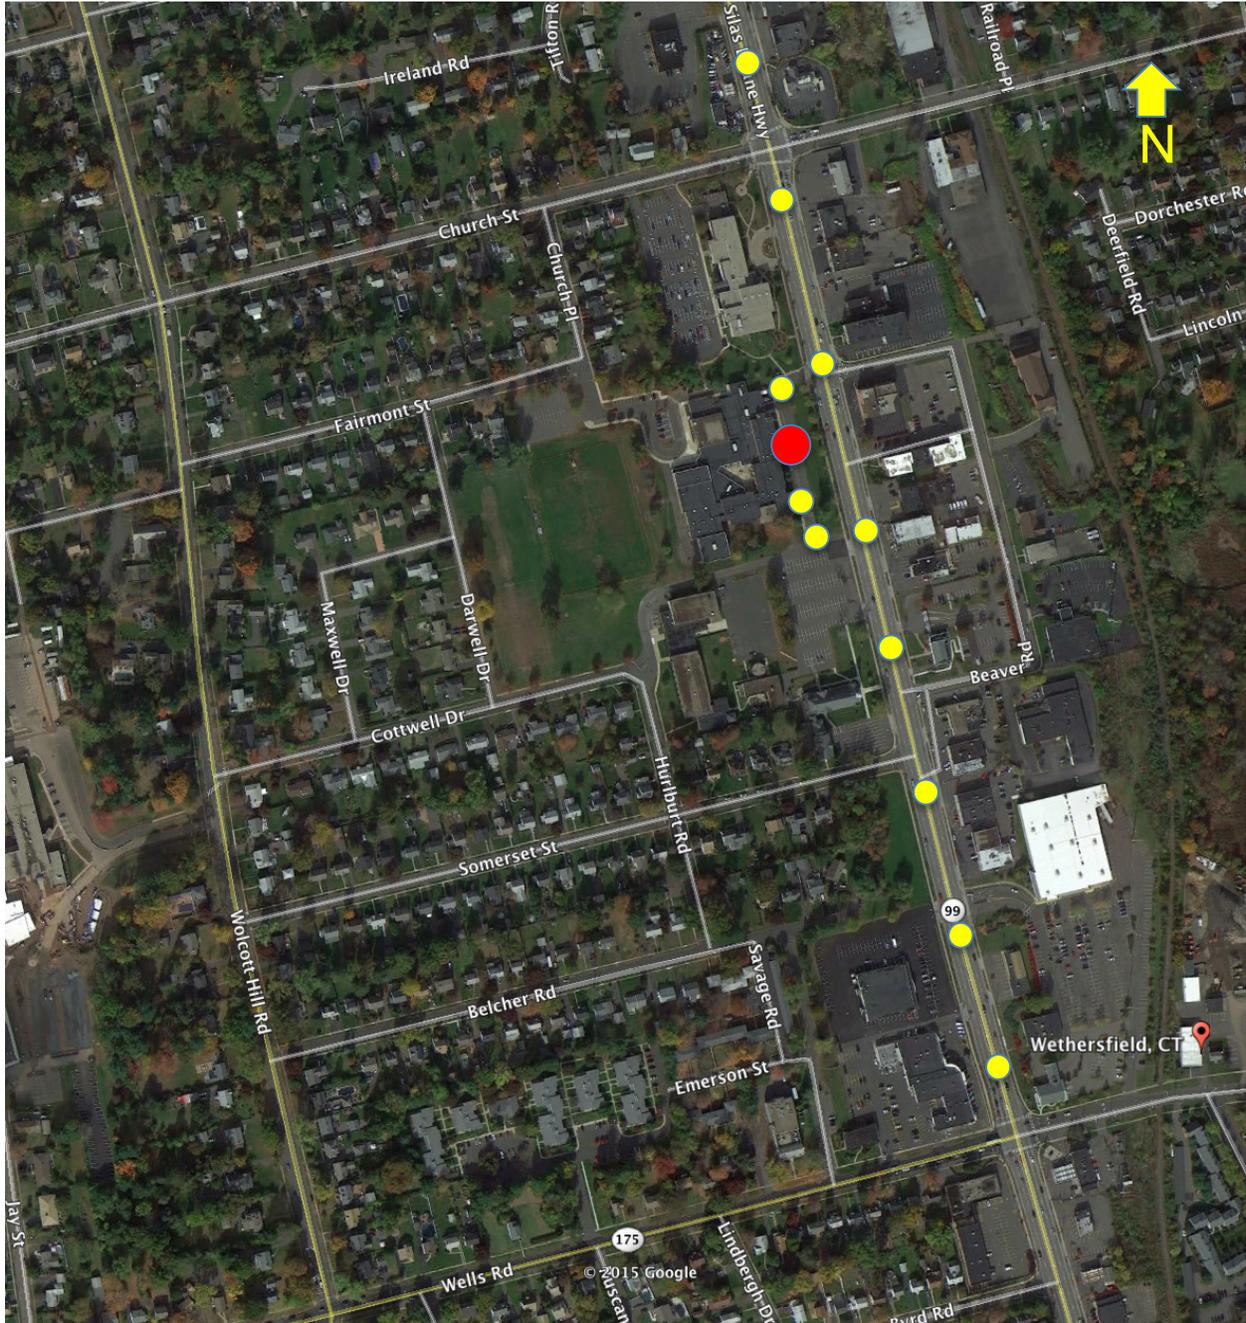
Figure 16: Walking Route 3 - Silas Deane Highway

Walking Route 3 is entirely on Silas Deane Highway, originating from either north or south of Silas Deane Middle School. Students using this walking route arrive at the bus drop-off area and enter the building through the east entrance of the school.

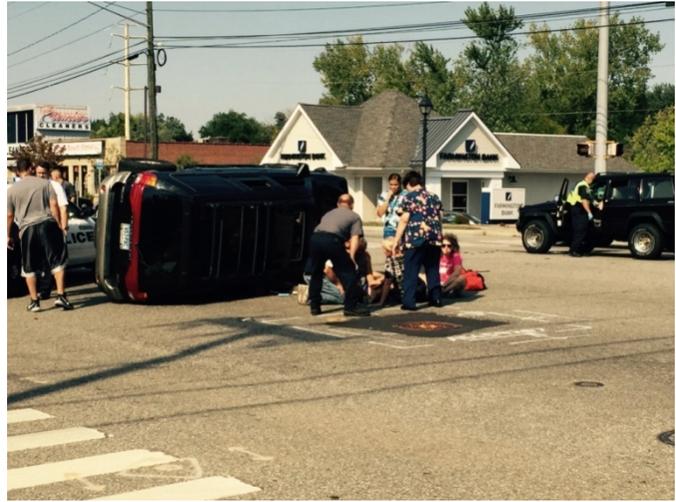
A trained crossing guard is stationed at the southwest corner of the intersection of Silas Deane Highway and Church Street which allows him to best serve pedestrians expressed safety concerns with traffic ignoring the red light on Silas Deane Highway. The team witnessed two cars travelling through the signal without heeding the red light controlled stop and a distracted driver taking a right on red without yielding to the guard and the pedestrians. The crossing guard stated that this is a common occurrence at this corner. These cited pedestrian concerns are in addition to a recent accident on Silas Deane Highway, as shown in **Figure 18**.

**Figure 18: Accident on Silas Deane Highway at Church Street**

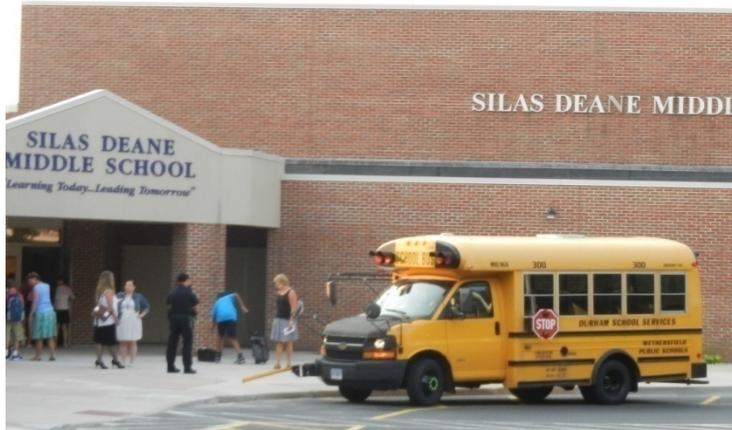
- The principal, several other staff members, and a Wethersfield police officer are outside helping with the arrival and dismissal processes, as shown in **Figure 19**.

**Figure 19: Silas Deane Middle School staff outside during the arrival and dismissal processes**

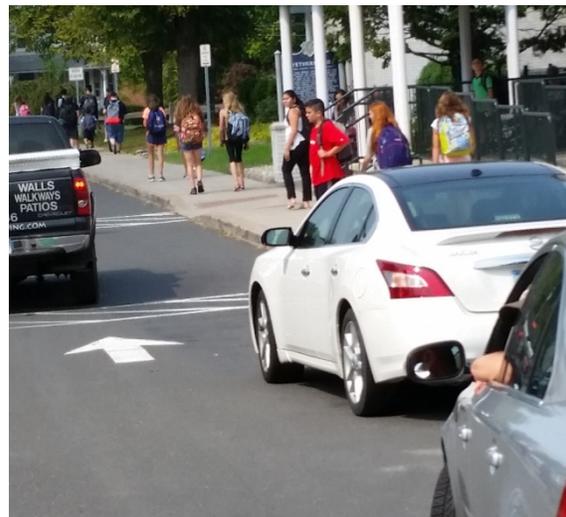
- To minimize traffic congestion, several parents use the Wethersfield Town Hall and Library Complex for the arrival and dismissal processes, as shown in **Figure 20**.

**Figure 20: Dismissal process at the Wethersfield Town Hall and library complex**

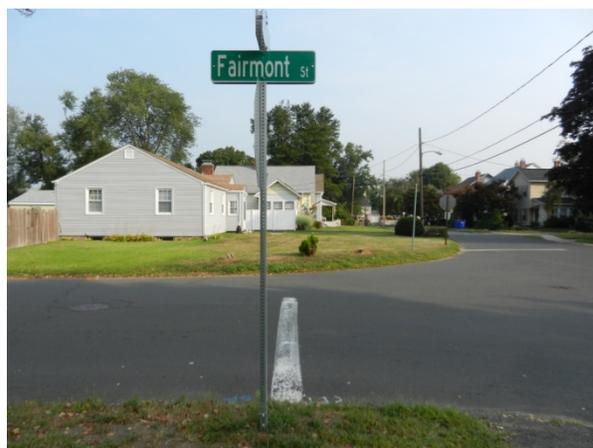
- At the intersection of Church Place at Fairmont Street, the sidewalk ends in the southbound direction of travel along Church Place and in the westbound direction of travel along Fairmont Street (**Figure 21**).
- Walking Route 2 that runs along the west side of the Corpus Christi School area highlights a problematic transition and connectivity issue, especially during the winter months.

**Figure 21: Sidewalk ends at intersection of Church Place at Fairmont Street**

- Install crosswalks at all major intersections in the school zone, crosswalks should only be considered along the walking routes.
- Replace sidewalk ramps to be directional ADA Compliant pedestrian ramps at all crosswalks and major intersections.
- The Town of Wethersfield could consider adding the missing sidewalks at the intersection of Church Place and Fairmont Street.
- The Town may want to consider adding sidewalk as shown in **Figure 24**.
- Advance school warning sign assemblies should be located based on operating speeds per the MUTCD.

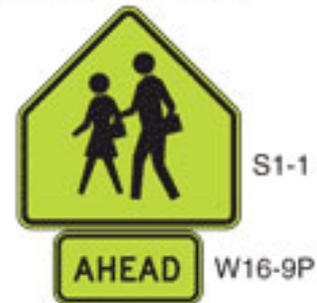
Figure 22: MUTCD S1-1 sign and W16-9P sub-plate

- At all existing and proposed crosswalks at major intersections, the S1-1 signs with the arrow sub-plate could be added to emphasize the crosswalk only at uncontrolled intersections.

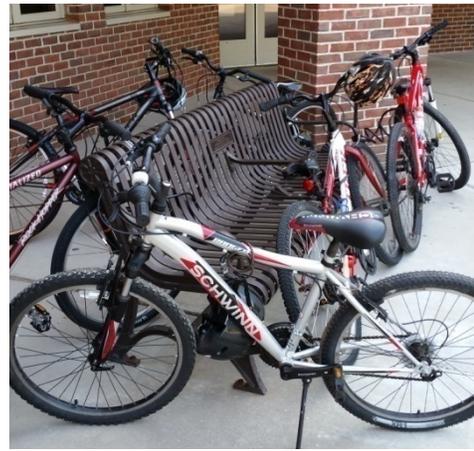
Figure 23: Bikes locked to bench at west entrance

- Consider investing in a bike rack to accommodate bicyclists. The staff noted that bicyclists are waiting on a new bike rack, so in the meantime, student are locked their bikes to a bench along the west entrance (**Figure 23**).
