2015 Safe Routes to School Walk Audit Findings Report

Highcrest
Elementary
School

*Highcrest Elementary School
Wethersfield, CT*

Submitted By:
VN Engineers, Inc.
116 Washington Avenue
North Haven, CT 06473
Phone (203) 234-7862

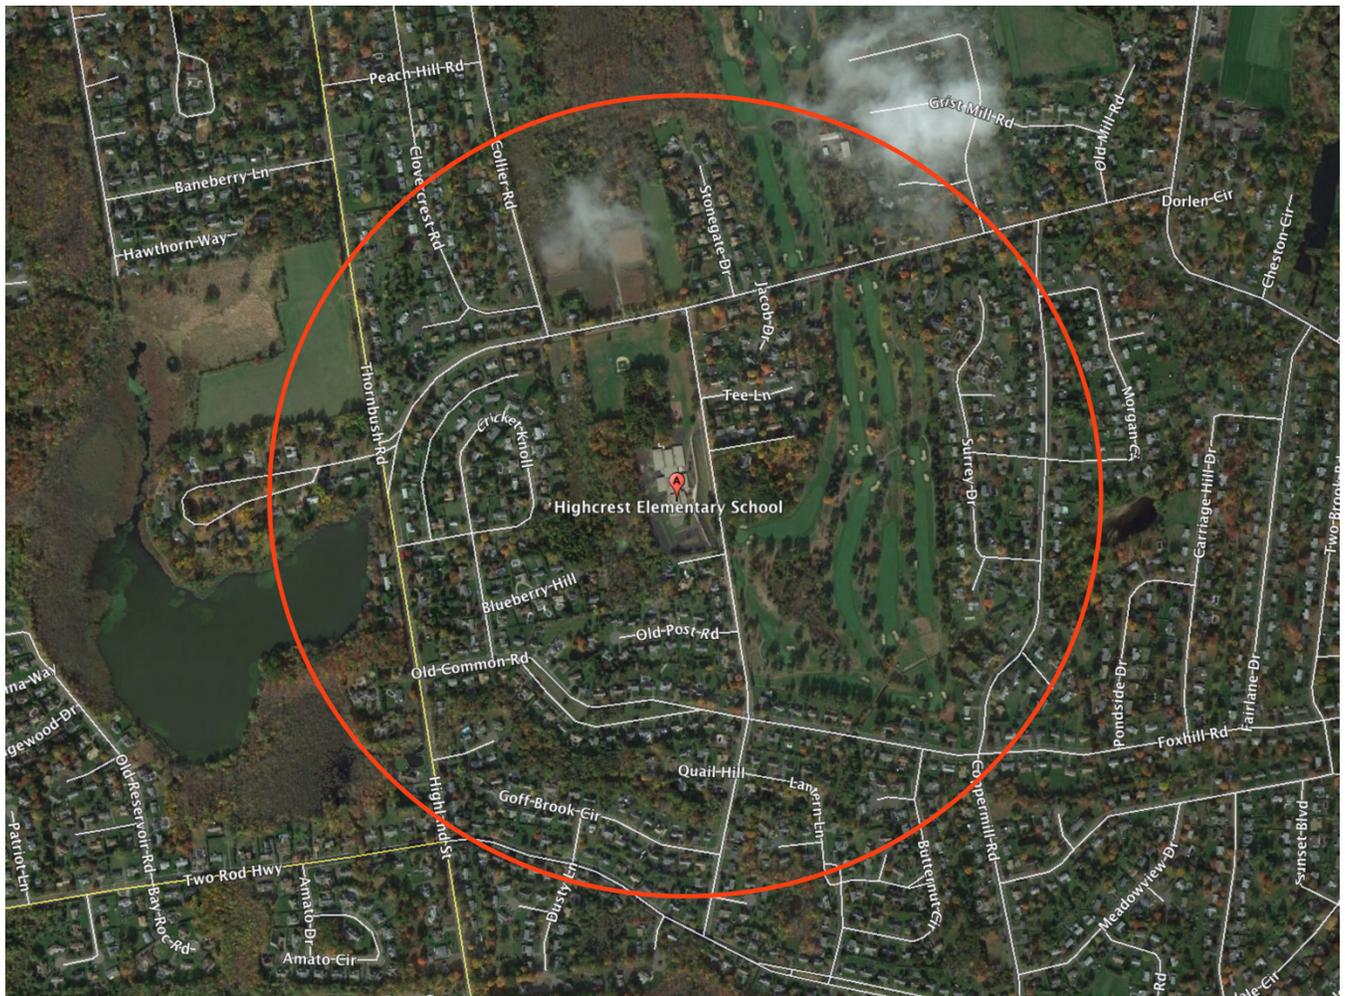
Figure 1: Aerial Map of Highcrest Elementary School Study Area

Figure 1 shows an overview of the Highcrest Elementary School study area.

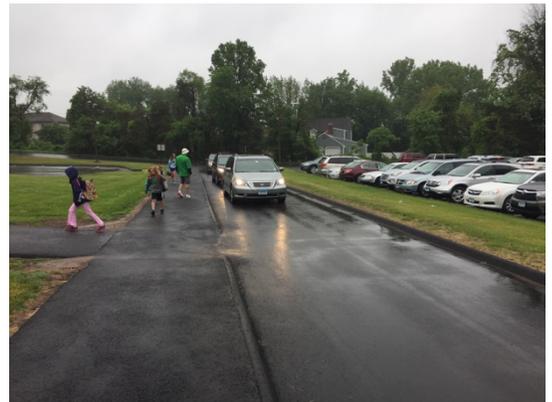
Figure 2: Morning Drop-Off Site

Highcrest Elementary School is situated in a suburban Wethersfield neighborhood. School begins at 8:55 AM., but students are allowed to enter the building at 8:35 AM. Walkers and bikers tend to arrive between 8:35 to 8:50 AM, while bussed students typically arrive between 8:35 to 8:45 AM. Student drop-offs both by driving and walking with parents, started around 8:30 AM with the highest concentration of students arriving between 8:45 and 8:55 AM, as shown in **Figure 2**. Parents were observed dropping their children off in an orderly manner. Two teachers typically oversee the drop-off and pickup and reported that there have not been any accidents. However, the teachers were not wearing safety vests.

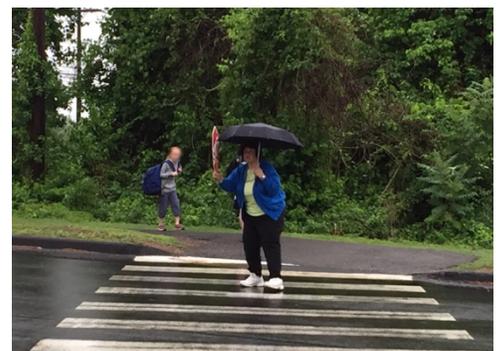
Figure 4: Crossing Guard Stationed at School Car Entry

The Town of Wethersfield has assigned three trained crossing guards to this school. They are stationed at the intersection of Highcrest Road and Foxhill Road, the intersection of Highcrest Road and Highland Street, and at the south entrance to the school. The crossing guards were observed doing an excellent job

of guiding students across the crosswalks with two of the three wearing proper personal protective equipment and all three using handheld stop signs (**Figure 4**).

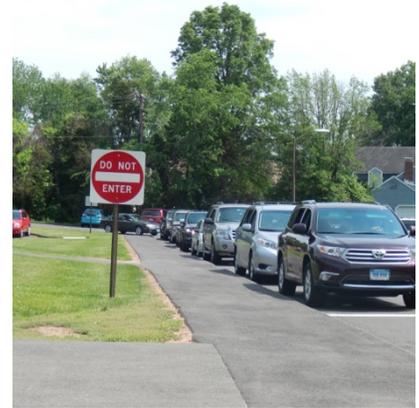
Figure 5: Drop-off and Pickup

The parent pickup process offers two alternatives for adults driving to retrieve the student passengers. One option is for the adult guardian to either meet the student at the school's south side exit or the main entrance/exit on the east side. After the adult and student reunite, they walk to the designated parent parking site on the south side of the campus. The second option is for students to be directly dismissed curbside to their parents' vehicles in the exclusive parent drop-off/pick-up loop after exiting from the rear of the school. The entry to the loop is also located on the south side of the campus (**Figure 5**).

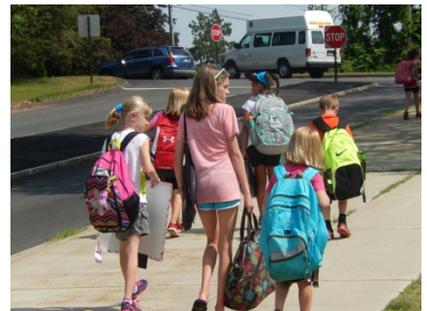
Figure 6: Students Walking Home at Dismissal

The team observed approximately fifty walkers that exited the school from the central doors and departed campus with their parents or each other as shown in **Figure 6**. The majority of students headed northeast on the campus until they transitioned to the sidewalks, heading north or south of the school. The students whose destination brought them south of the school were assisted by the crossing guard stationed at the entry way to the parent pickup driveway off of Highland Avenue. Some students were observed not adhering to the guard's instructions.

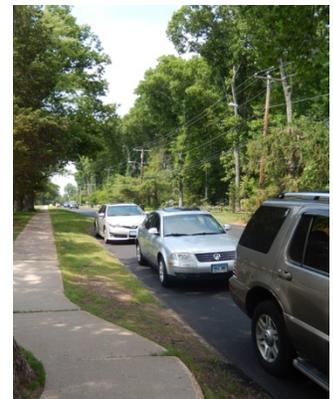
Figure 7: Cars Parked on Highcrest Road

The SRTS Team also noted that a few cars were parked along Highcrest Road for parent pick-up instead of in the designated parking lot on campus (**Figure 7**). These parents exited their vehicles and approached the school on foot by cutting through the bus lane and meeting the kids at the assigned spot. The parents and children then reentered the bus loop where the buses were either stationed or exiting. This vehicular and pedestrian conflict was minor in frequency, but the seriousness of its possible consequences mandates its documentation.

- Request an increase in police presence on Highcrest Road to prevent on street parking, as well as to reduce the speed during arrival and dismissal periods.

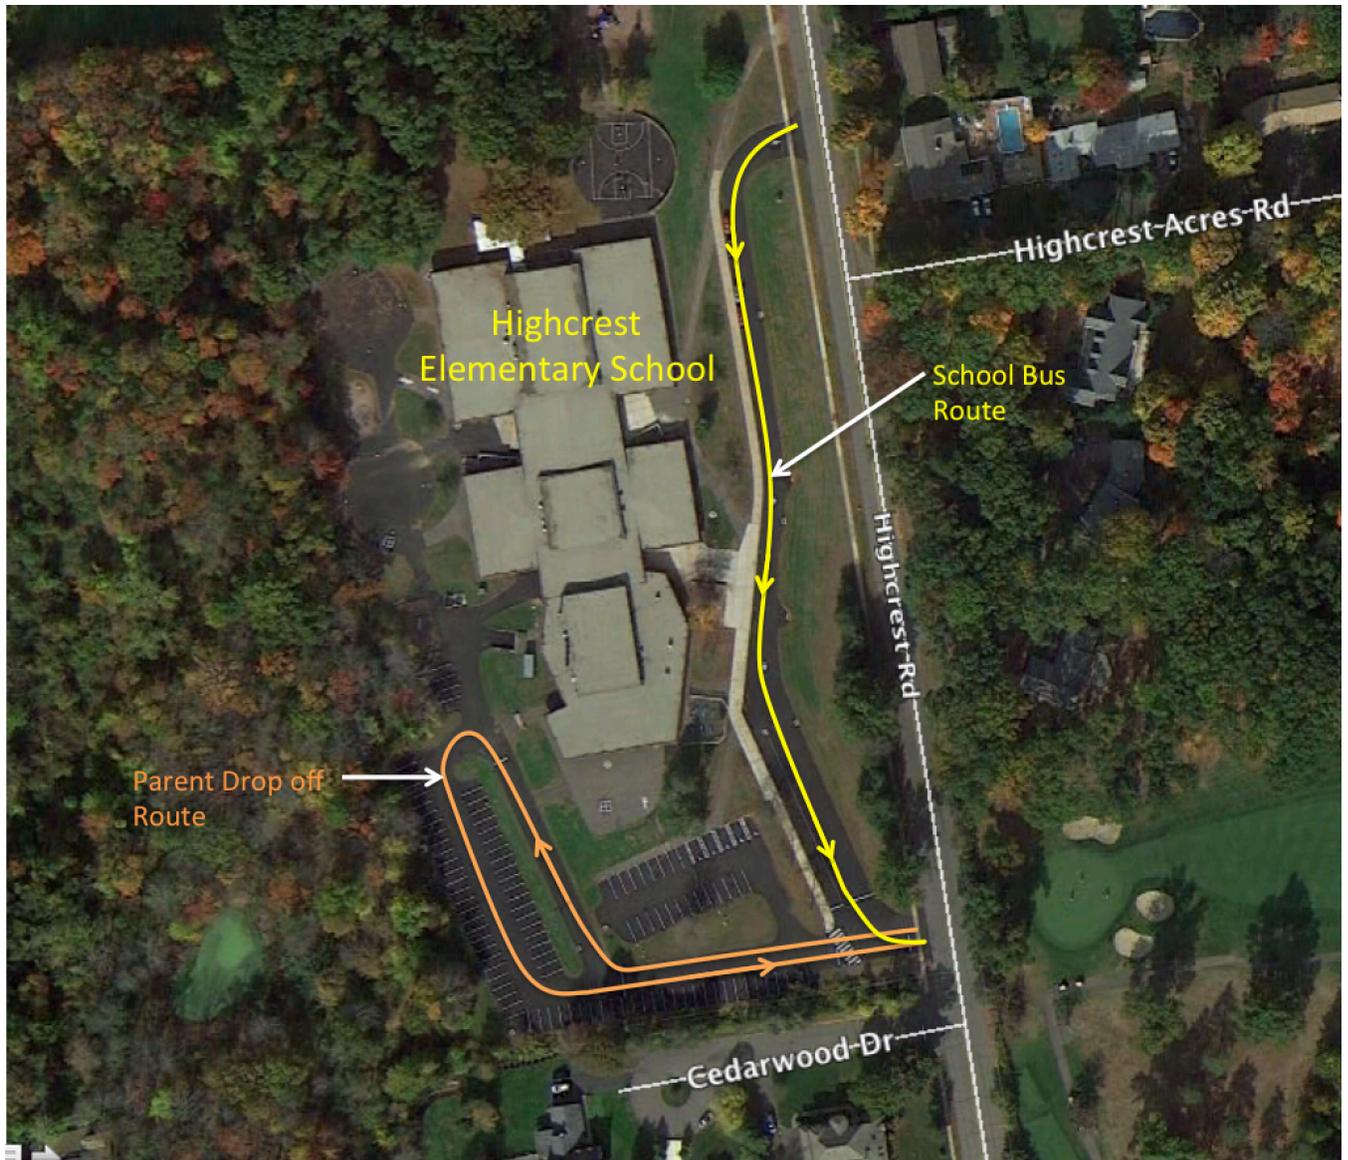
Figure 8: Highcrest School Aerial map

Dismissal Procedures: The school does not have a staggered dismissal, as all students are dismissed at 3:10 PM. The busses arrive intermittently and are boarded by students relative to their position in the bus only loop, located on the east side of the school off of Highcrest Road, as shown in **Figure 8**.

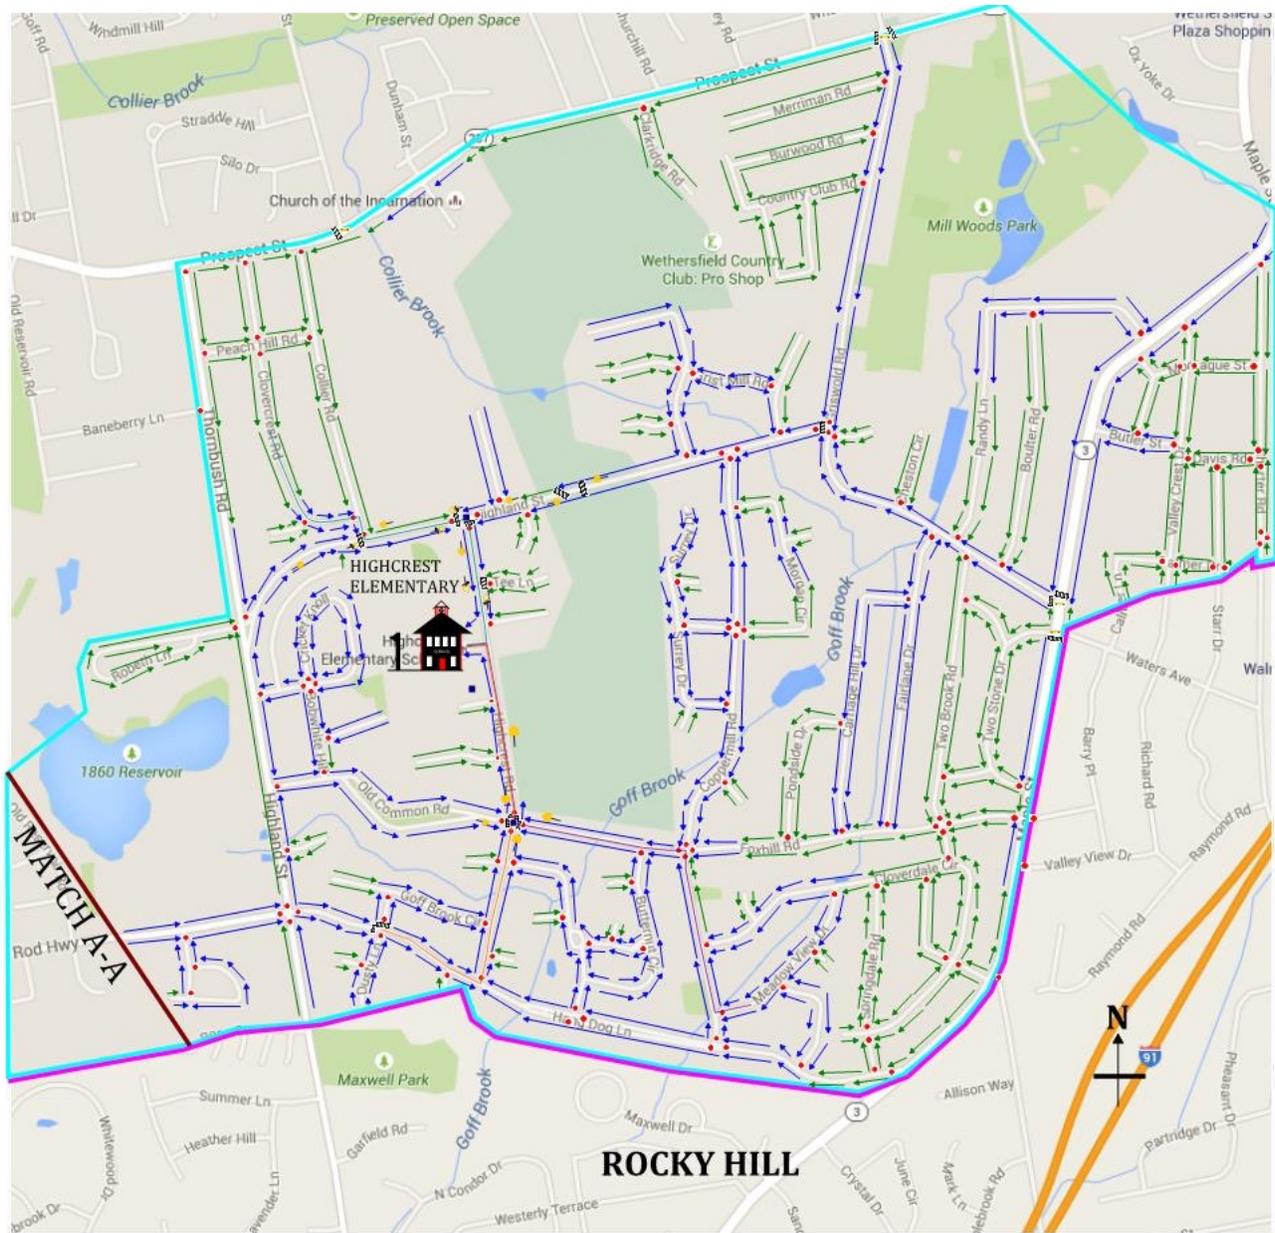
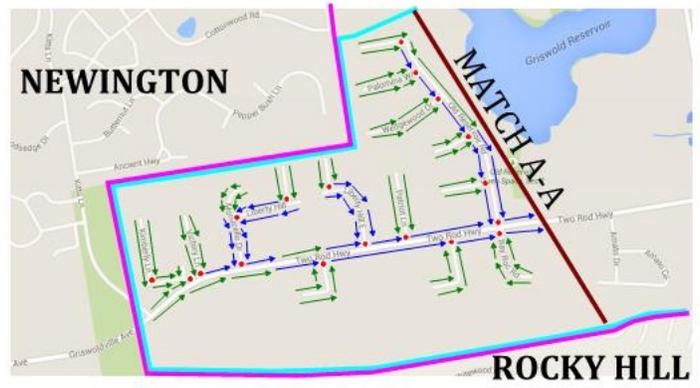
Figure 9: Primary Walking Options to Highcrest Elementary School

Although the SRTS Champion identified these three main walking routes, all streets within the Highcrest Elementary School boundary were mapped in **Figure 9** to show every possible way students could walk to school. This study examines these main routes, along with all other walking routes within an approximate 0.5 mile radius of Highcrest Elementary School.

The walk audit team walked and drove all of the major walking routes. **Table 1** provides an inventory overview of streets leading to the school. **Figure 9** depicts all of the pedestrian routes to Highcrest Elementary School. The school study limit is shown in light blue.

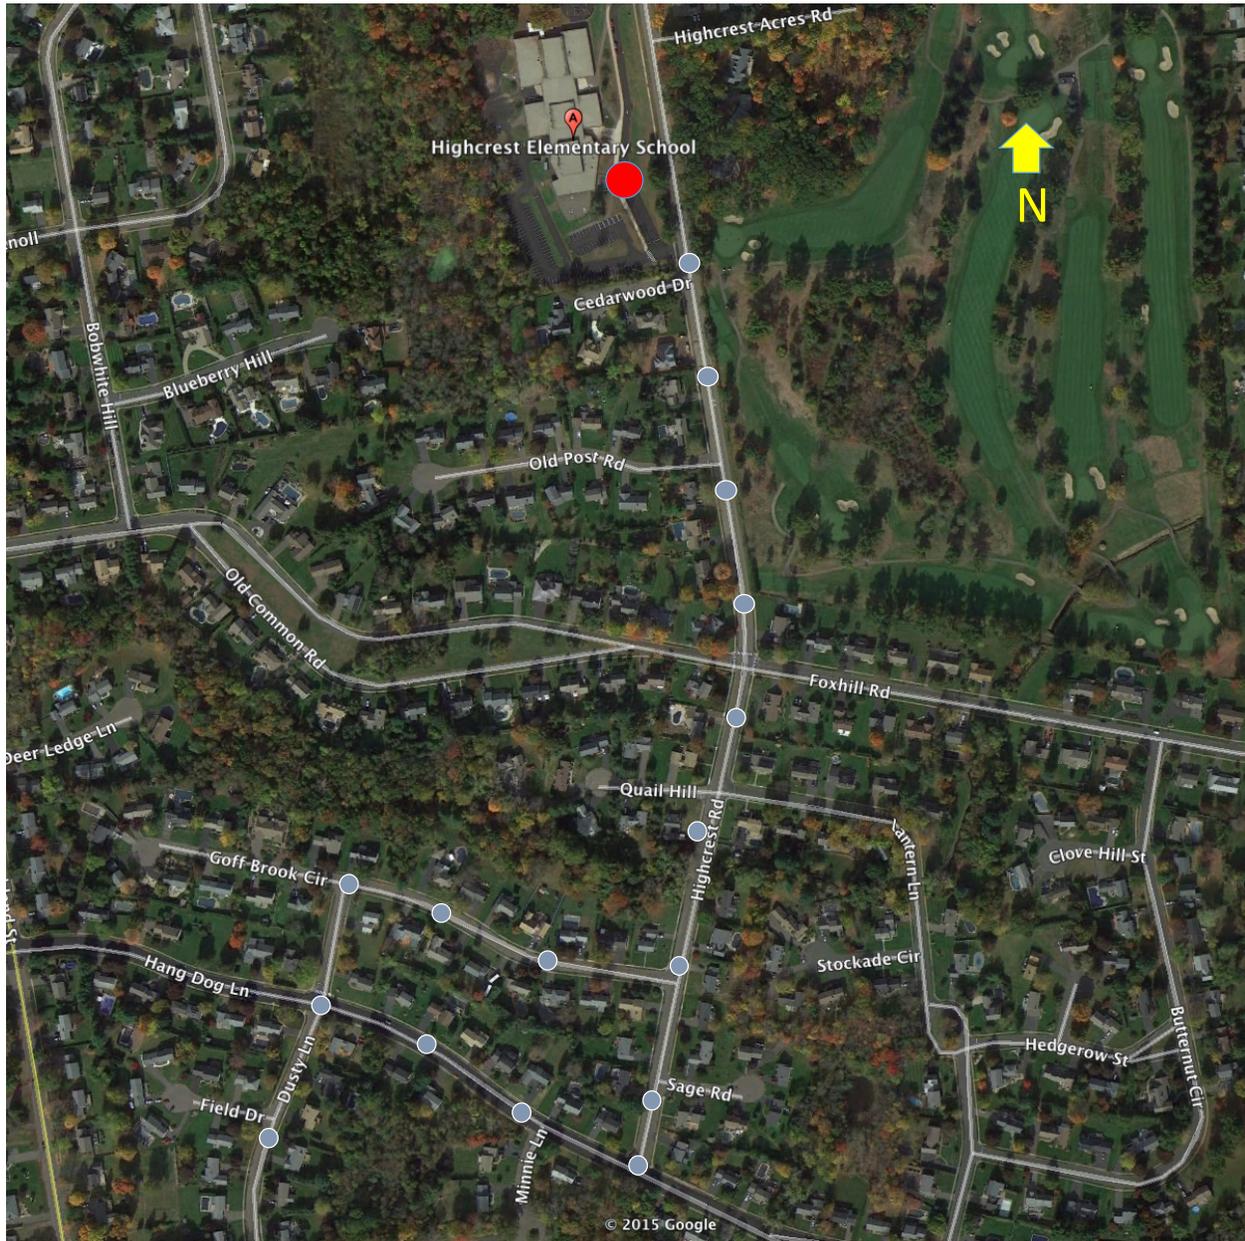
Figure 10: Walking Route 1

Walking Route 1 begins at the main entrance of the school and proceeds along Highcrest Road to the south, then turns right on Hang Dog Lane or Goff Brook Circle to Dusty Lane. From the farthest point on Dusty Lane, the path is about 0.8 miles to the main entrance of the school as shown in **Figure 10**. The SRTS Champion identified this route as the most heavily travelled. This route provides access to many homes.

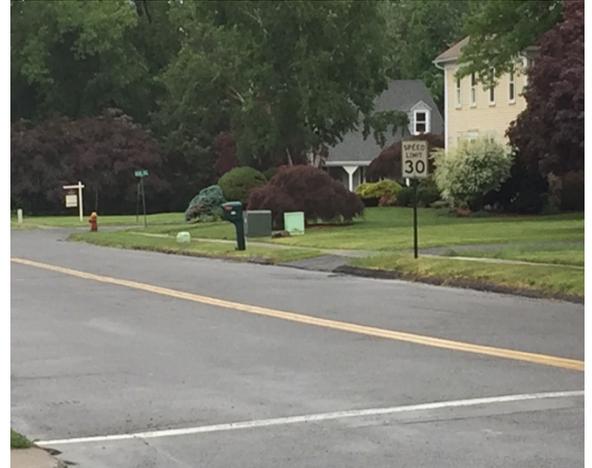
Figure 11: 30 MPH Speed Limit on Foxhill Road

The posted speed limit in the area in front of the school is 25 mph. South of Foxhill Road the speed limit is posted at 30 mph as shown in **Figure 11**. During our audit, we did not notice any cars violating this posted speed limit. In general, all the signs located on this route are in good condition.

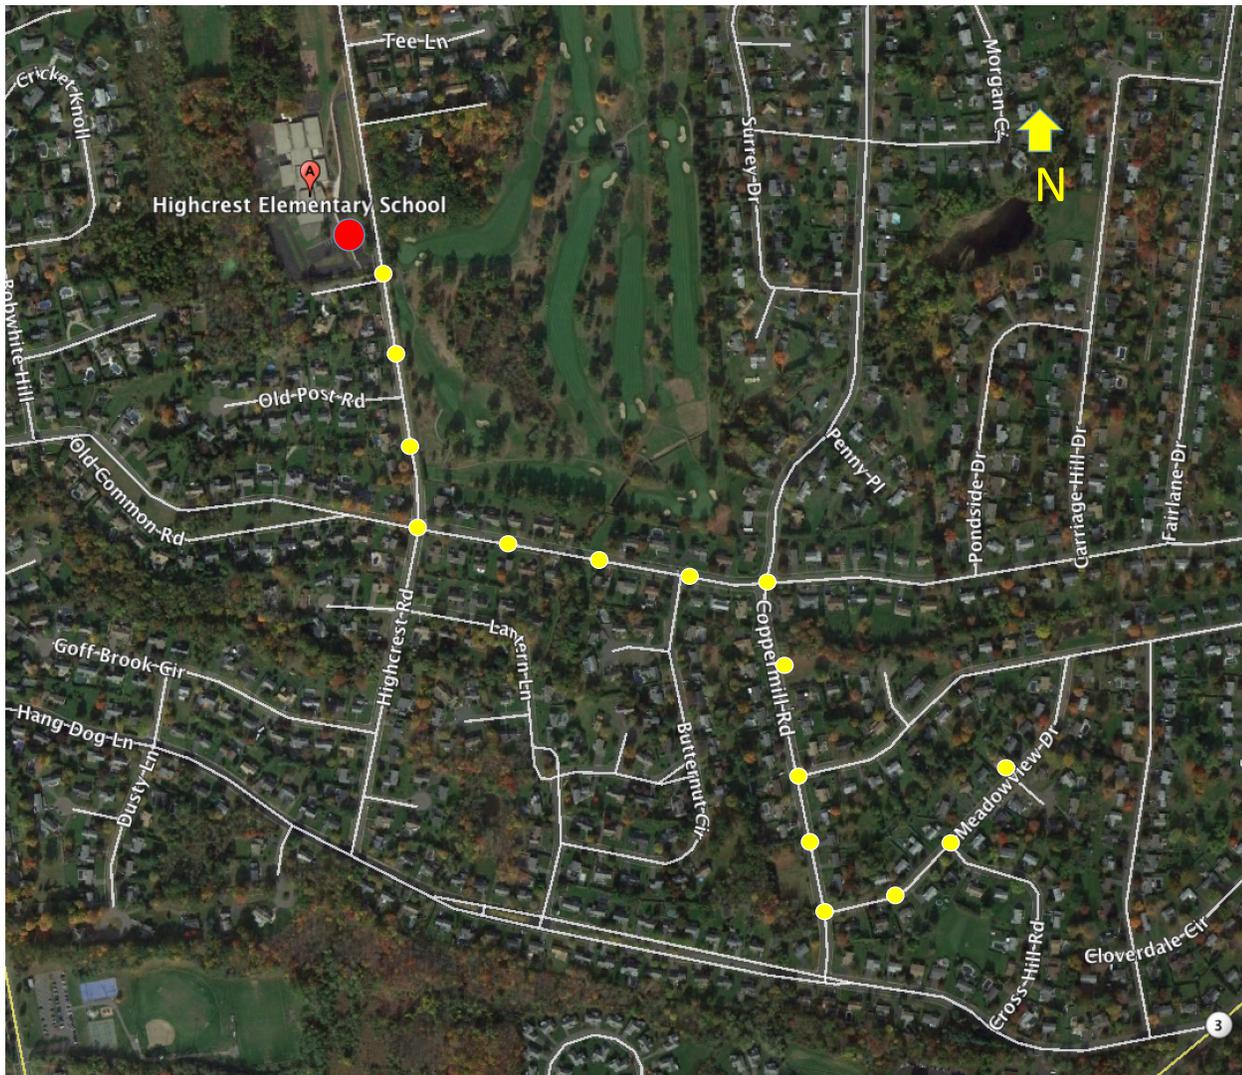
Figure 12: Walking Route 2

Walking Route 2 starts at the school's main entrance, follows Highcrest Road to the south, turns left on Foxhill Road, and then turns right on Coppermill Road to Meadowview Drive (**Figure 12**). The path is approximately 1.0 mile long to the farthest point. There is a trained crossing guard at the corner of Highcrest Road and Foxhill Road. The crossing guard has been working at this location for 10 years and has not witnessed any accidents during that time. He was wearing the proper protective equipment and carried a handheld stop sign.

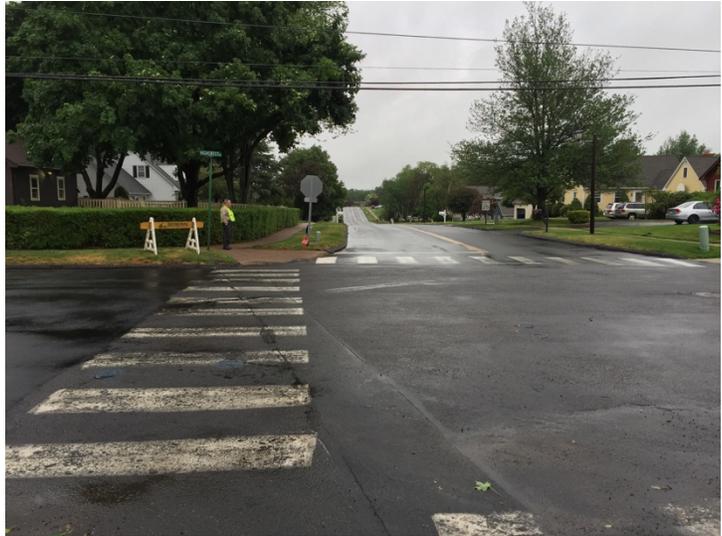
Figure 13: Sample Crosswalk on Route 2

In general, the pavement quality is in good condition. Highcrest Road was recently paved and is in excellent condition. The pavement on Foxhill Road and Coppermill Road are in fair condition, but it appears the town is in the process of repaving many of the area's local streets. This route is through a well-maintained residential neighborhood. The streets are approximately 27 feet wide with no pavement markings. The crosswalks are faded and should be repainted, as shown in **Figure 13**.

- Repaint all the crosswalks as stated in this report and add a new crosswalk at the intersection of Highcrest Road and Cedarwood Drive (**Figure 25**). Additional crosswalks could be added at any of the intersections along the main walking routes that do not have painted crosswalks. The stopping sight distance for all proposed crosswalks could be verified prior to installation for safety purposes.

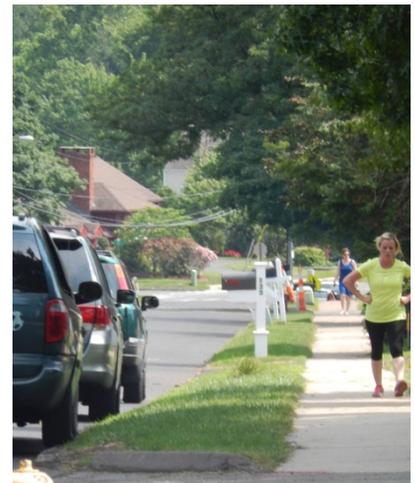
Figure 14: Sidewalk Along Highcrest Road, South of the School Campus.

There are sidewalks throughout the areas surrounding the school. The sidewalks are on both sides of the road and typically measure 4' wide with a grass buffer separating them from the roadway, as shown in **Figure 14**. The grass buffer and sidewalks on both sides of the roads along this route are ideal for walking to school.

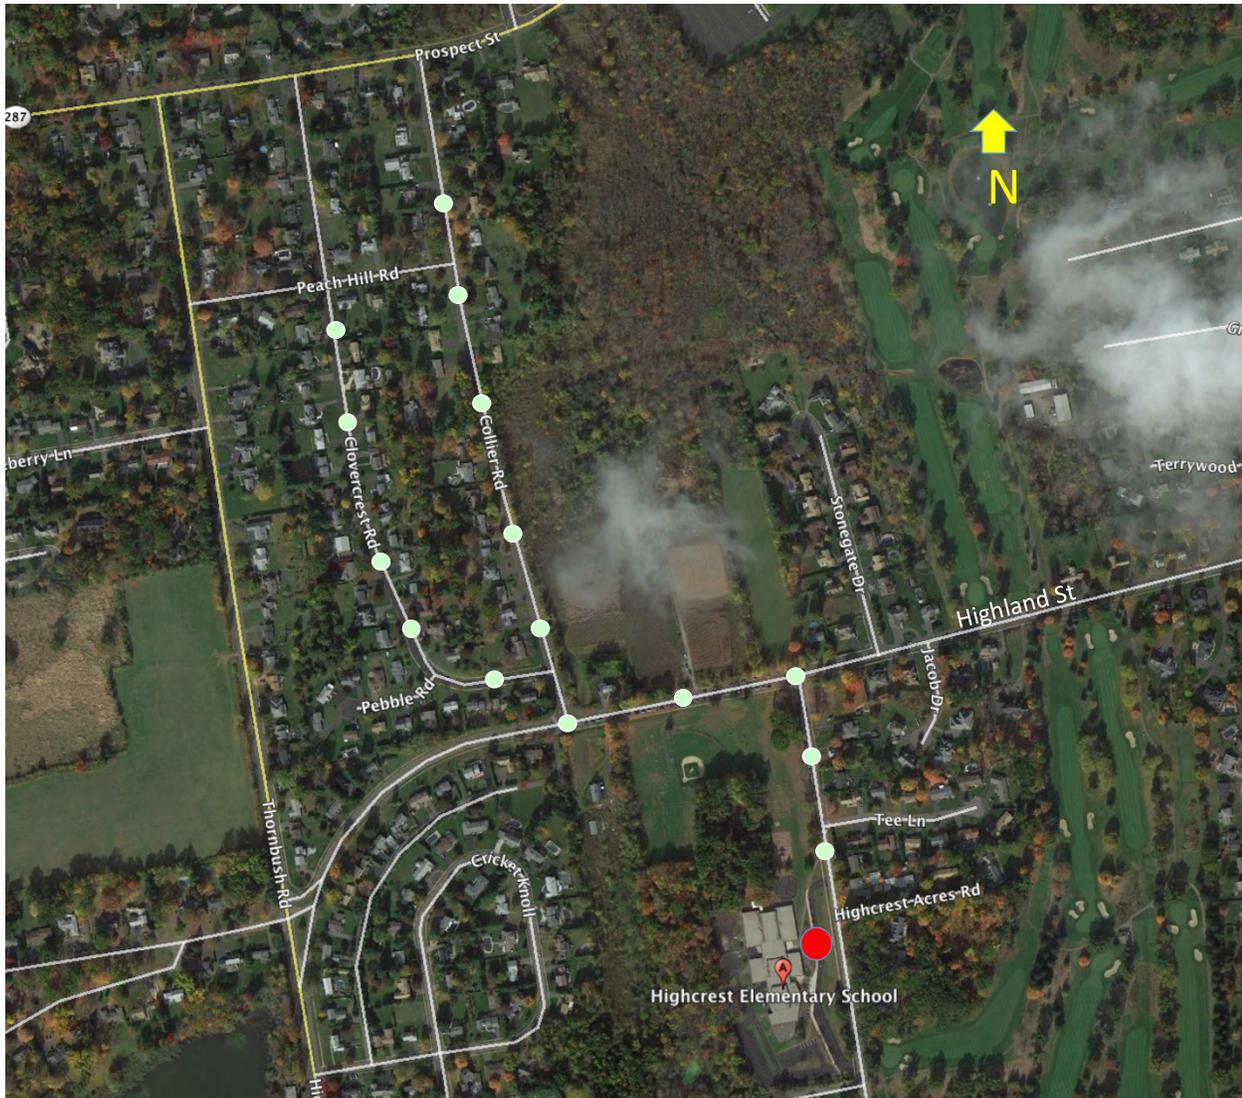
Figure 15: Walking Route 3

Walking Route 3 commences at the front of the school and heads north on Highcrest Road, turns left on Highland Street, and then right on Collier Road to the north (**Figure 15**). The path is approximately 0.8 miles long depending on the origin and destination of the trip.

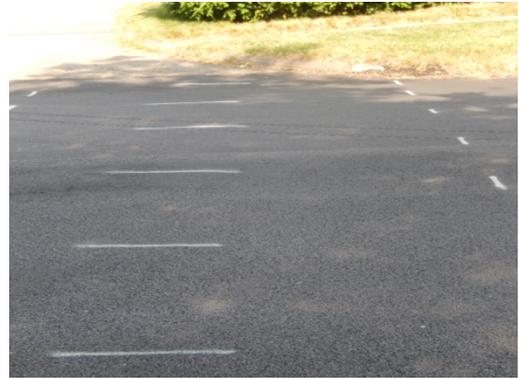
In general, the roads and sidewalks are in good condition along this route. Highcrest Road was recently repaved and during our walk audit, so the crosswalks had not been repainted even though the crosswalk signs were in the correct locations, as shown in **Figure 16** and **Figure 17**.

Figure 16: Missing Crosswalk

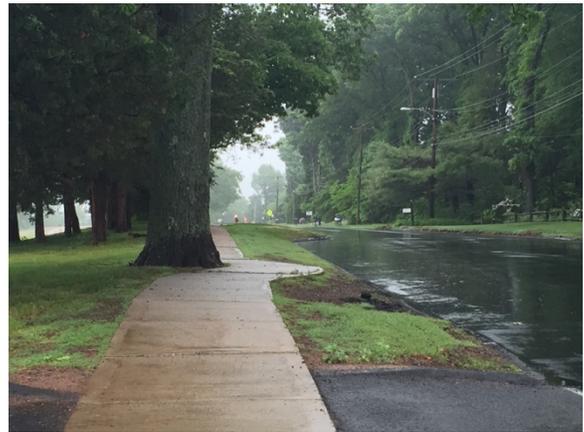
Figure 17: Sidewalk on West Side of Highcrest Road

The sidewalk in front the school is located on the west side of Highcrest Road (**Figure 17**). There is no sidewalk on east side adjacent to the golf course, as shown in **Figure 18**. The sidewalk continues beyond the golf course on the east side of the road. There are four- or five-foot wide sidewalks along both sides of all of the remainder of the streets along this route. There is only a sidewalk along a portion of the west side of Collier Road, until reaching the intersection with Clovercrest Road. Beyond Clovercrest Road, there is no sidewalk on either side of the street.

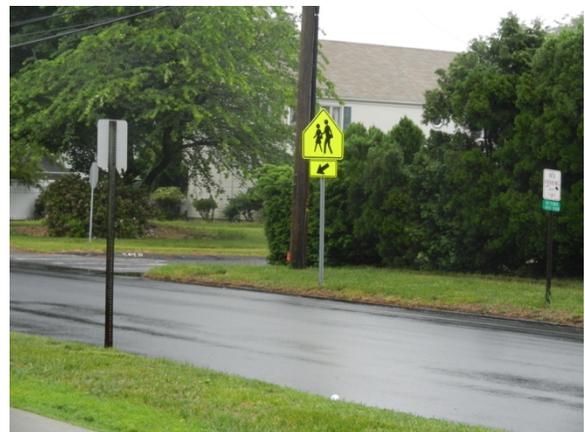
Figure 18: Crosswalk Sign with No Corresponding Crosswalk in Road

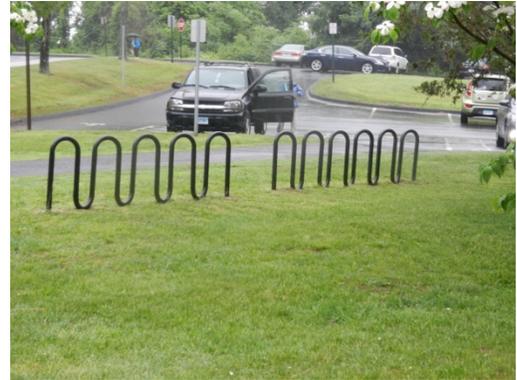
Figure 19: Bike Rack

- The school has a wide sidewalk leading to the pick-up and drop-off area.
- The school has one adequately sized bike rack in fair condition (**Figure 19**).

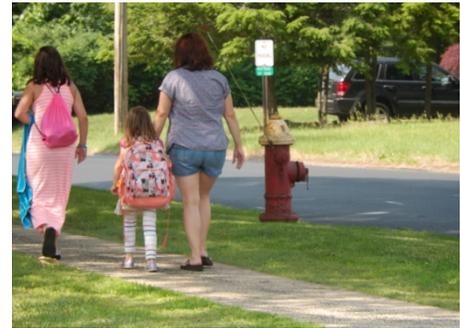
Figure 20: Parents Accompanying Students

- Parents/guardians accompany their children walking to school, as shown in **Figure 20**.
- All of the walking routes are located in residential neighborhoods and have posted 25 to 30 mph speed limits.

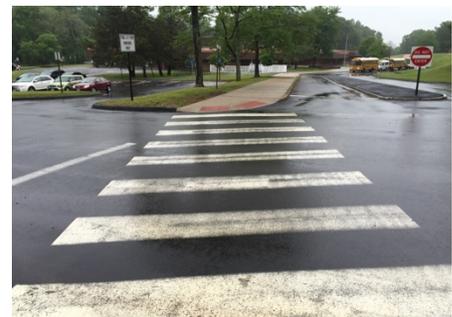
Figure 21: Highcrest Campus Crosswalk

- The painted crosswalks on school grounds and at the intersection of Highcrest Road and Foxhill Road are faded and should be repainted (**Figure 21**).
- The SRTS Team will schedule a PTO meeting to introduce the SRTS Program. They will offer pedestrian and bike training while helping to inform parents about the safest way to drop-off and

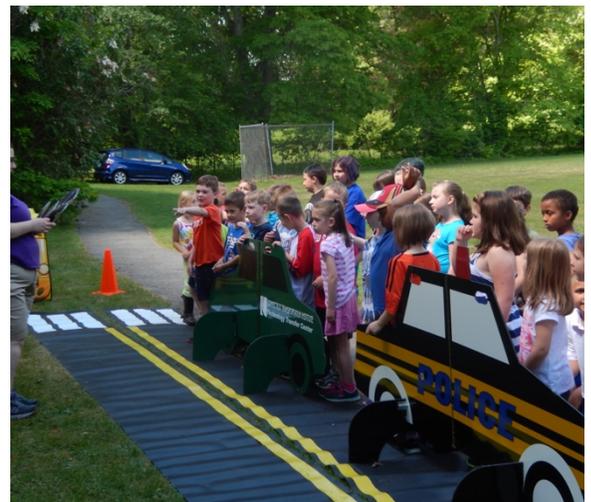
Figure 22: Pedestrian Training

- The SRTS Program provides free pedestrian and bike skills education for students and parents. The Highcrest Committee could contact the SRTS Team to arrange a skills training class or clinic. These education programs would specialize in suburban-specific pedestrian techniques (**Figure 22**).
- Establish a driver and passenger educational program targeting new students' parents to clarify drop-off procedures. This should be scheduled at the beginning of the school year, taking into account the arrival of the buses during drop-off. This discussion would deter or discourage parents from parking and waiting for children off the school site in a no parking zone on Mapleside Drive.

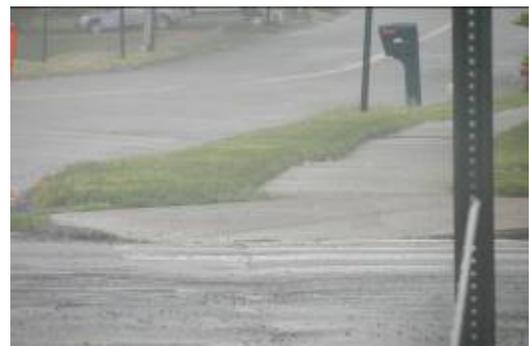
Figure 25: Intersection of Highcrest Road and Cedarwood Drive

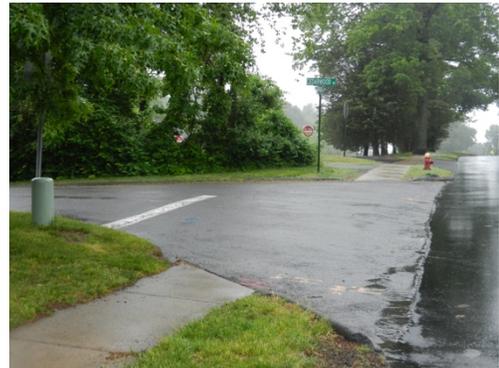
The school is located in a residential area with sidewalks on nearly all roadways leading to the school. While the sidewalks are wide enough for compliance with the Americans with Disabilities Act, the lack of handicapped ramps (specifically at critical locations near the school) and thus, detectable warning strips, are not in adherence to the act. Due to recent repaving, painted crosswalks are also missing from critical locations in front of Highcrest Elementary School.

Figure 26: Sidewalk Ramp Lacking ADA Compliance

- Any sidewalk ramp along the walking routes to Highcrest Elementary School should be ADA Compliant with detectable warning strips. **Figure 26** depicts missing detectable warning strips on sidewalk ramps.
